Service Bulletin

Subject: Exterior Lamp Condensation and Replacement Guidelines

Models: 2017 and Prior GM Passenger Cars and Trucks

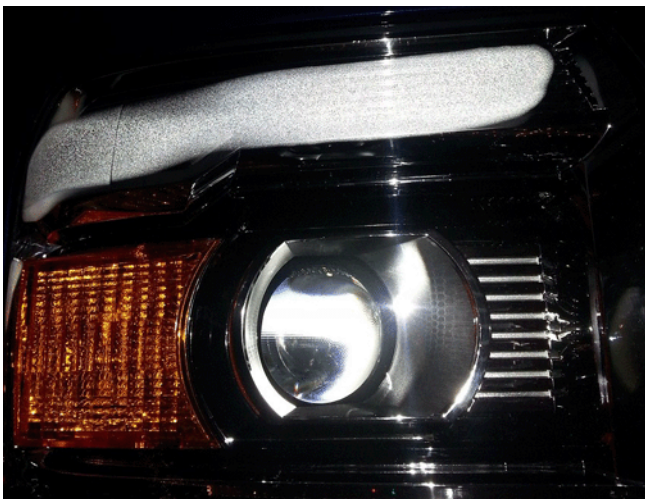
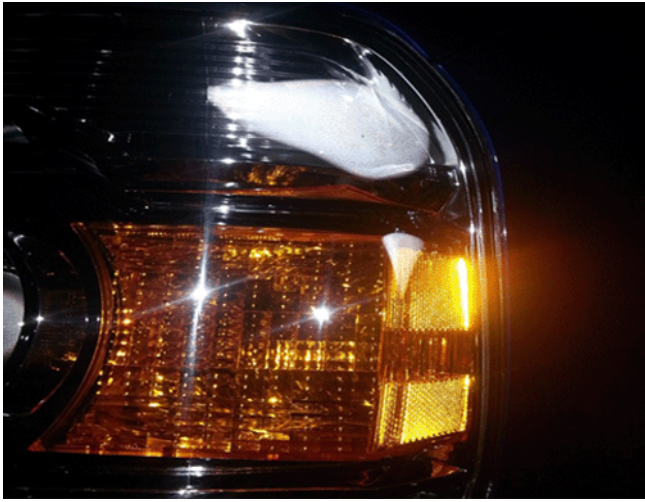
2014 Sierra Headlamp, Full and Partial Examples

Condensation

A Fine Mist or White Fog on the Inside Surface of the Lamp Lens Occurring After a Period of High Humidity

- May be located primarily in the lens corners (near the vents) and SHOULD NOT cover more than half the lens surface.
- The condition should clear of moisture when the vehicle is parked in a dry environment, or when the vehicle is driven with the lights ON.
- A comparison of the equivalent lamp on the opposing side of the vehicle indicates a SIMILAR performance.

If the above conditions are noted, the customer should be advised that replacement of a lamp assembly may not correct this condition.

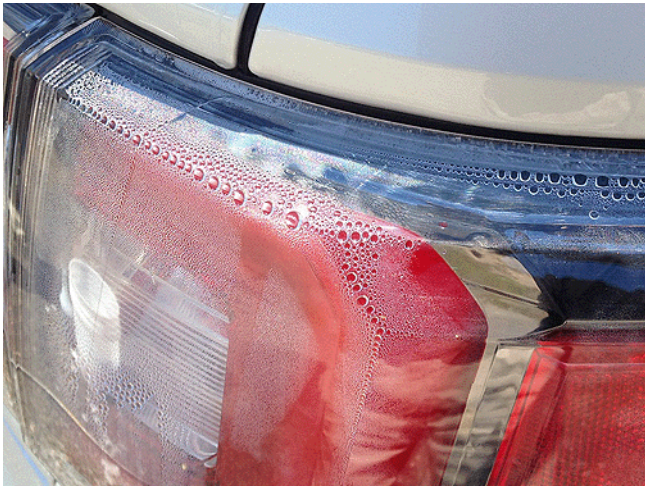
2014 Acadia Tail Lamp Example

Water Leak

Numerous & Various Size Drops of Water Collecting on the Inside Surface of the Lamp Lens After the Vehicle Has Been Exposed to Rain or a Car Washing Environment

- A condition that covers more than half the surface of the lamp lens.
- An accumulation of water in the bottom of the lamp assembly.
- A condition that WON'T clear when the vehicle is parked in a dry environment, or when the vehicle is driven with the lights ON.
- A comparison of the equivalent lamp on the opposing side of the vehicle indicates a different performance.

Note: Any of the conditions listed below would indicate the need to service the lens or lamp assembly.

If a lamp is found to be exhibiting a leak, review the most recent version of Service Bulletin 02-08-42-001 for information regarding impact damage and modification inspection.

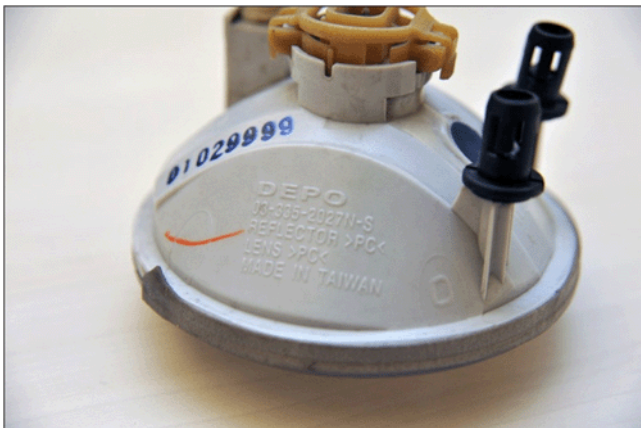
This fog lamp was returned for retaining moisture. As you can see it is marked with the Depo brand (it is also called out on the front lens).
