Service Bulletin

Subject: Excessive Oil Consumption – Perform Oil Consumption Test and/or Install Piston and Piston Ring Kit

Models: 2010-2013 Buick LaCrosse
2011-2013 Buick Regal
2012-2013 Buick Verano
2010-2013 Chevrolet Equinox
2012-2013 Chevrolet Captiva, Orlando (Canada Only)
2010-2013 GMC Terrain
Equipped with 2.4L Engine (RPOs LAF, LEA)

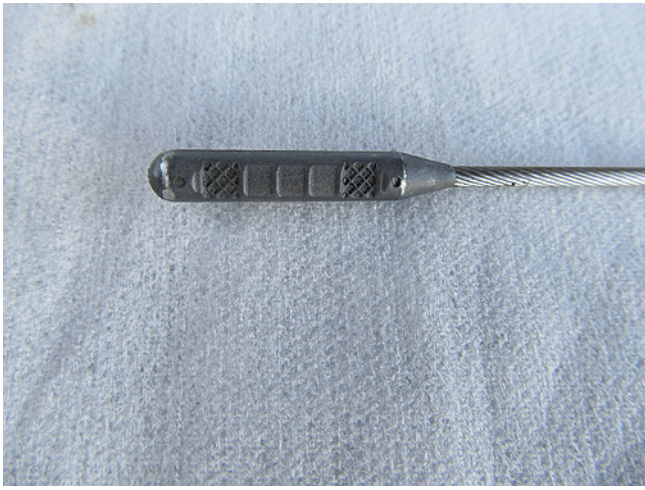
Important: When checking the oil level with the oil dipstick design shown below, please note that the oil volume per notch is not linear due to the shape of the block. The upper notches (relative to the top of the handle) equal 0.24 quart (0.227 L) between each notch while the lower notches only equal 0.14 quart (0.132 L) between each notch. As a result, no oil will appear on the dipstick if it is low on oil by approximately 1.25 quarts (1.18 L) or more. When determining the oil consumption rate, the oil volume added to return it to the starting location is the total amount of oil consumed. The consumption rate must be documented on a repair order.

Notice: Do not add too much oil. An overfill can lead to burn off of the excess oil. Advise the customer to wait until the oil is below the cross-hatched area at the tip of the dipstick before adding oil.

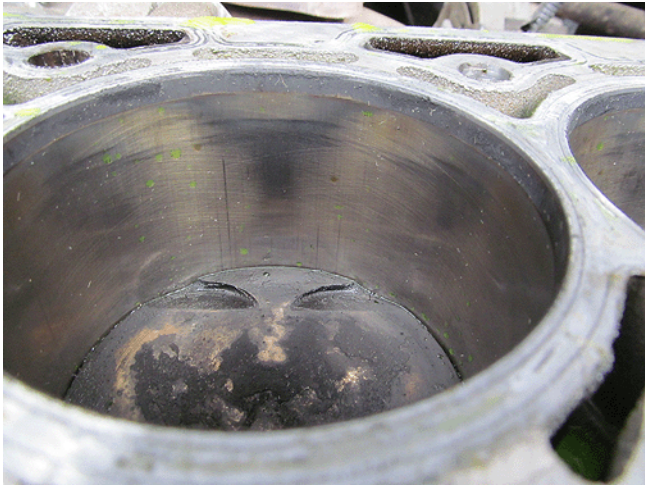
The repair is to replace the pistons and rings. In some cases the bore surface may not have a uniform look to the finish (zebra stripes) as shown below. As a result, some technicians may question whether the engine should be repaired or replaced. After careful evaluation, GM Powertrain has determined that the new pistons and rings will perform correctly in bores that have this appearance so engine replacement should not be necessary. The cylinder bores do not need any machine or honing work performed on them. Refer to the picture below for acceptable surface finishes.

Acceptable Cylinder that Does Not Appear Uniform (Zebra Stripes)

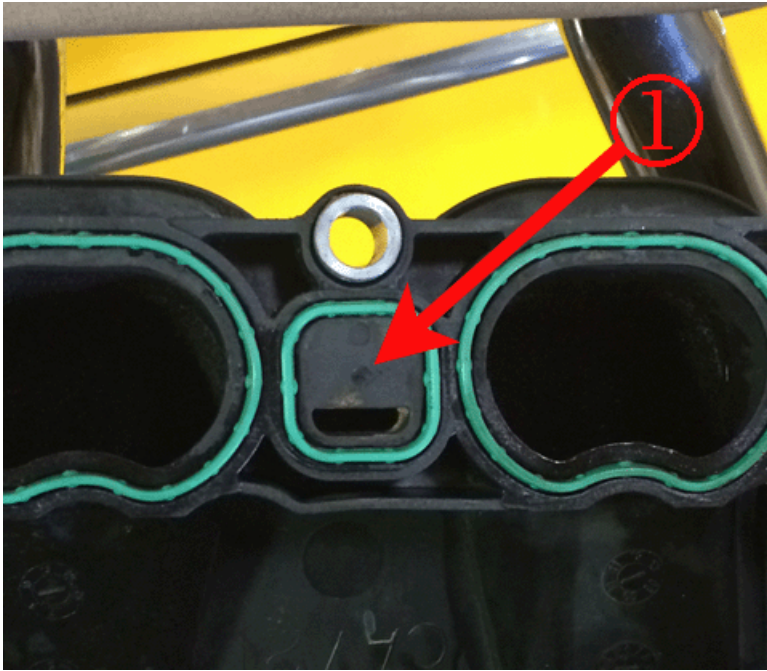
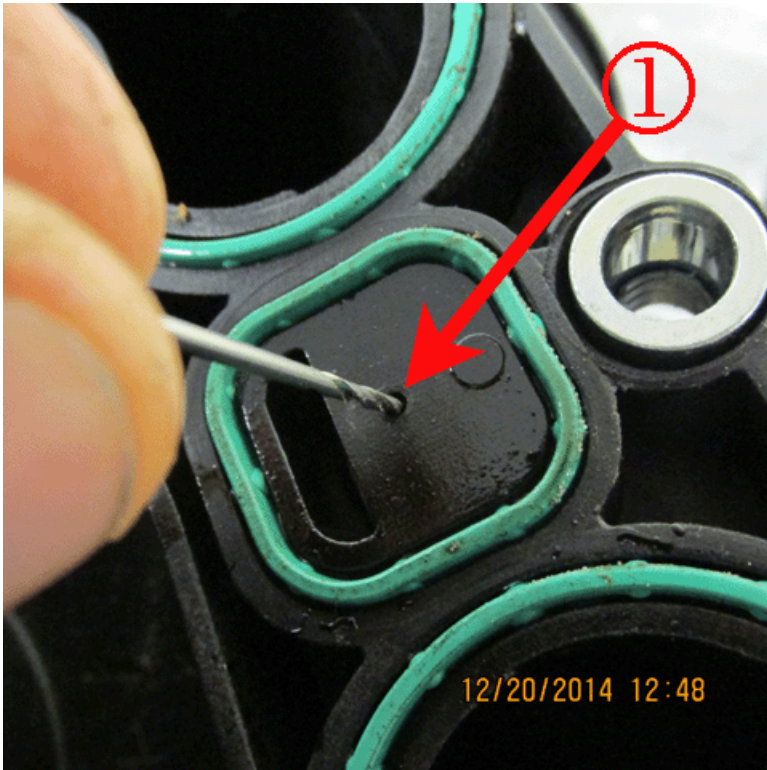
1. PCV orifice in the intake manifold

The oil consumption may have clogged/ reduced PCV flow. The PCV system should be serviced.

Clean any ice/sludge/water/carbon out of the PCV pipes/hoses, the PCV nipple on the cam cover, the PCV orifice between the #2 and #3 intake runners (use a 1/16 inch drill bit as illustrated below).

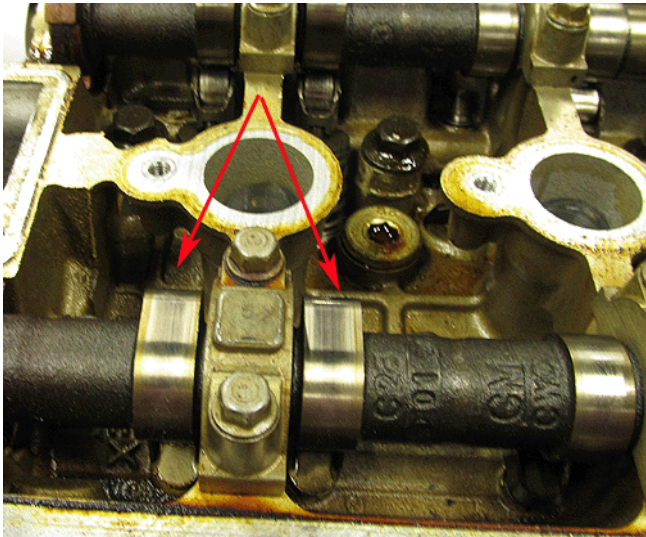
- Camshafts and roller follower will have wear markings. This is normal and do not need to be replaced (refer to picture above).

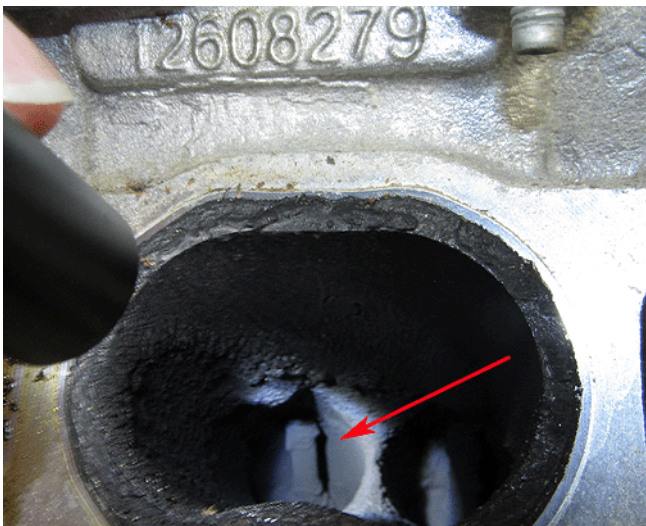
- Valves stems may have deposits build up on them. These deposits are characteristic of a direct inject engine. The valves stems do not need to be cleaned as they are not affecting engine performance (Refer to picture above).
- The oil pump does not need to be replaced as the low oil level operation did not damage the pump.
- The camshaft actuators do not need to be replaced at this time. The vehicle may have arrived with the engine knocking. If the oil level was 1 1/2 - 2 quarts low, it was the lack of oil causing the actuator noise.
- Rod bearings can be reused if there is not any excessive scoring. Some light wear marks are acceptable.
