Service Bulletin

PRELIMINARY INFORMATION

Subject: Intermittent Home Screen Icon/Navigation Overlay, Intermittent RVC Black Screen with Guidelines, Phone Pairing Not Included on the Phone Page, Routing Issues on Toll Roads in Mexico

Models: 2015 Buick Enclave
2015 Chevrolet Traverse
2015 Chevrolet Captiva
2015 GMC Acadia
Equipped with Radio RPO UI2, UI4, UI5, UI6, UI7 or UI8

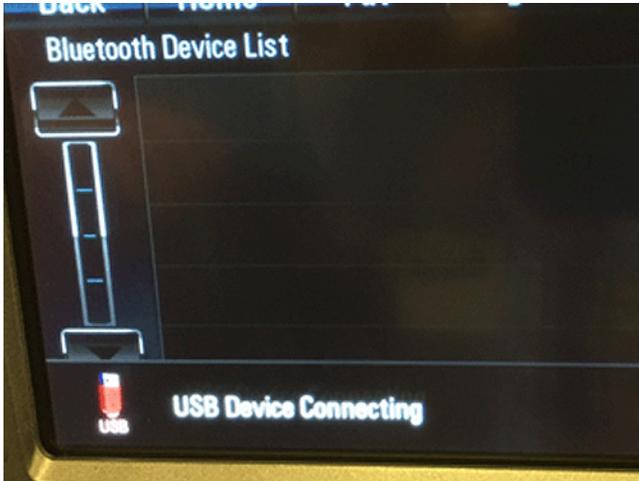
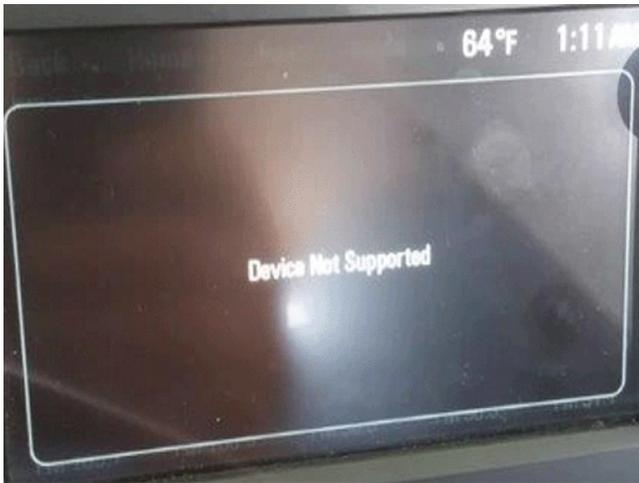
- 2.1. If the “USB Device Connecting” message below is immediately displayed at the bottom of the screen when the USB is inserted, lasts for about 1 minute, and then the “Device Not Supported” message below is displayed for a few seconds before ultimately aborting and displaying the previous screen again, the USB drive may contain corrupt files. If this is experienced, order a replacement USB by following the instructions at the bottom of this PI.

If the USB stick is lost, damaged, or is suspected of causing the "Device Not Supported" message described above in step 2a, U.S. dealers may order an additional one through the Global Connect 1store and Canadian dealers may request the USB stick by submitting the form below and sending by email (preferred) or by fax. GM Mexico dealers should contact GM TAC Mexico if it is necessary to replace the original one.

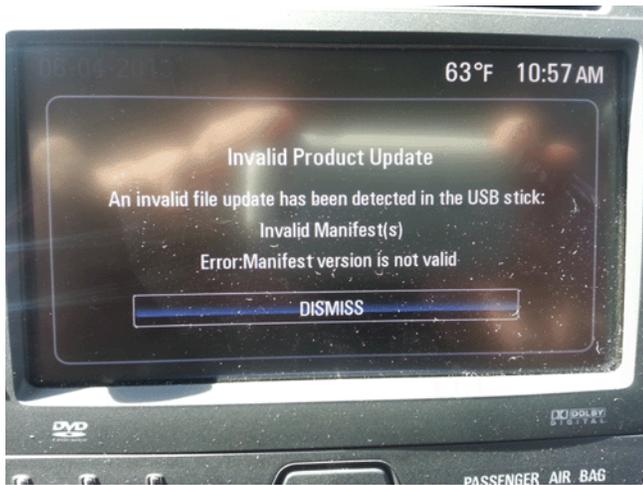
- 2.2. If the following “Invalid Product Update” and “Invalid Manifest(s)” error message is displayed, the radio already has improved calibrations and no further action is required. A DTC B124F may set as a result of this as well.
