Service Bulletin

Subject: Information on Underhood Fascia Fasteners Appear to be Loose

Brand:	Model:	Model Year:		VIN:		Engine:	Transmission:
		from	to	from	to		
Chevrolet	Malibu (VIN Z)	2016	2016			All	All

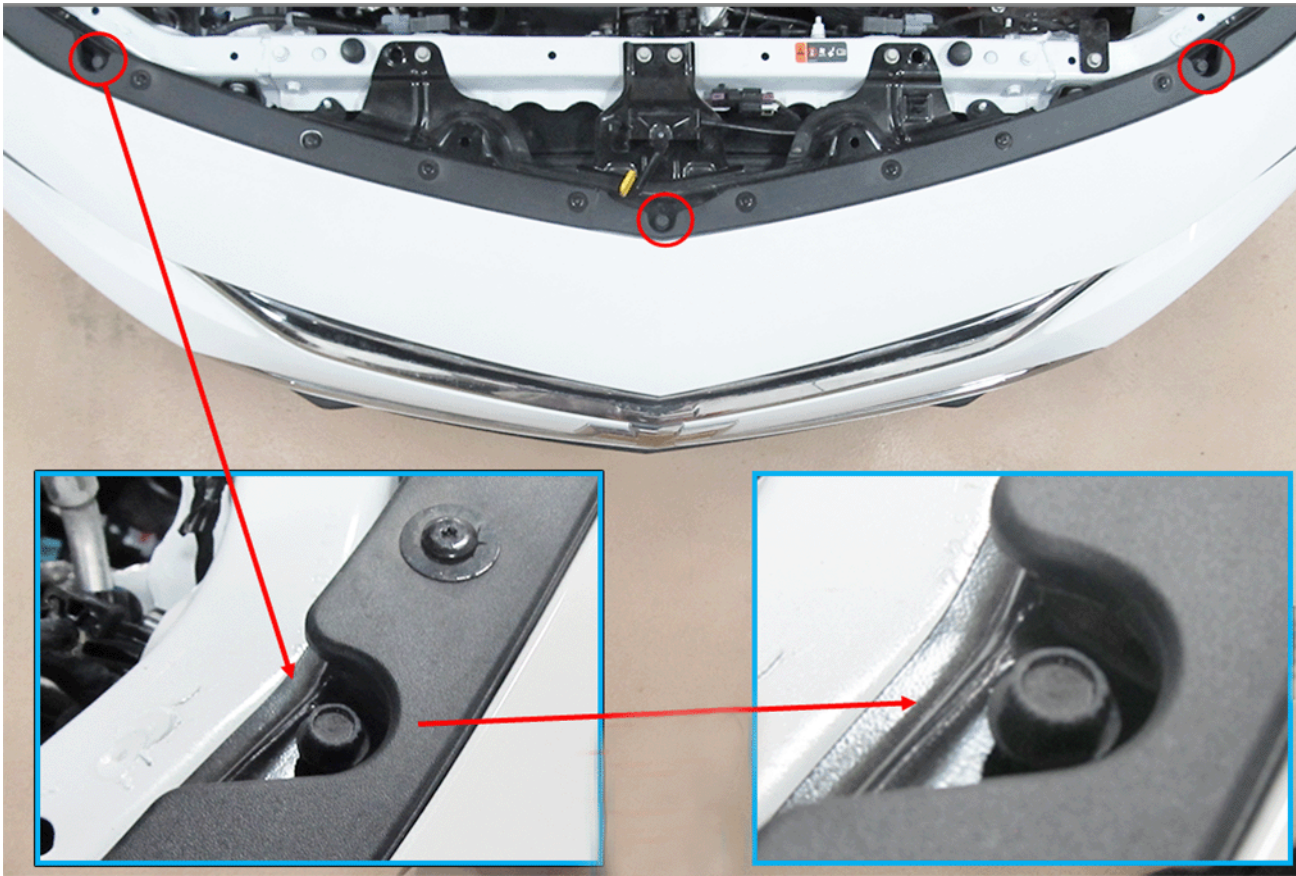
Involved Region or Country	Israel
Condition	A customer or technician may comment that three front fascia fastener locations, positioned under the hood, show a gap and appear to be loose.
Cause	The preset gap is design intent, and each fastener has Loctite applied to the threads so the preset gap does not change.

Important: DO NOT attempt to tighten or otherwise move these three fasteners. These fasteners are part of the front fascia support bracket which have a preset gap by design and the plant does not adjust these fasteners when they install the fascia assembly to the car.

Even though they may appear to not be fully seated, no correction is necessary, nor should be attempted. Any adjustment of these fasteners change the vertical clearance between the front fascia and hood, and will compromise the intended gap.
