Service Bulletin

Subject: Active Shutters Inoperative, Malfunction Indicator Lamp (MIL) Illuminated

Brand:	Model:	Model Year:		VIN:		Engine:	Transmission:
				from	to		
Chevrolet	Malibu (VIN Z)	2016	2016

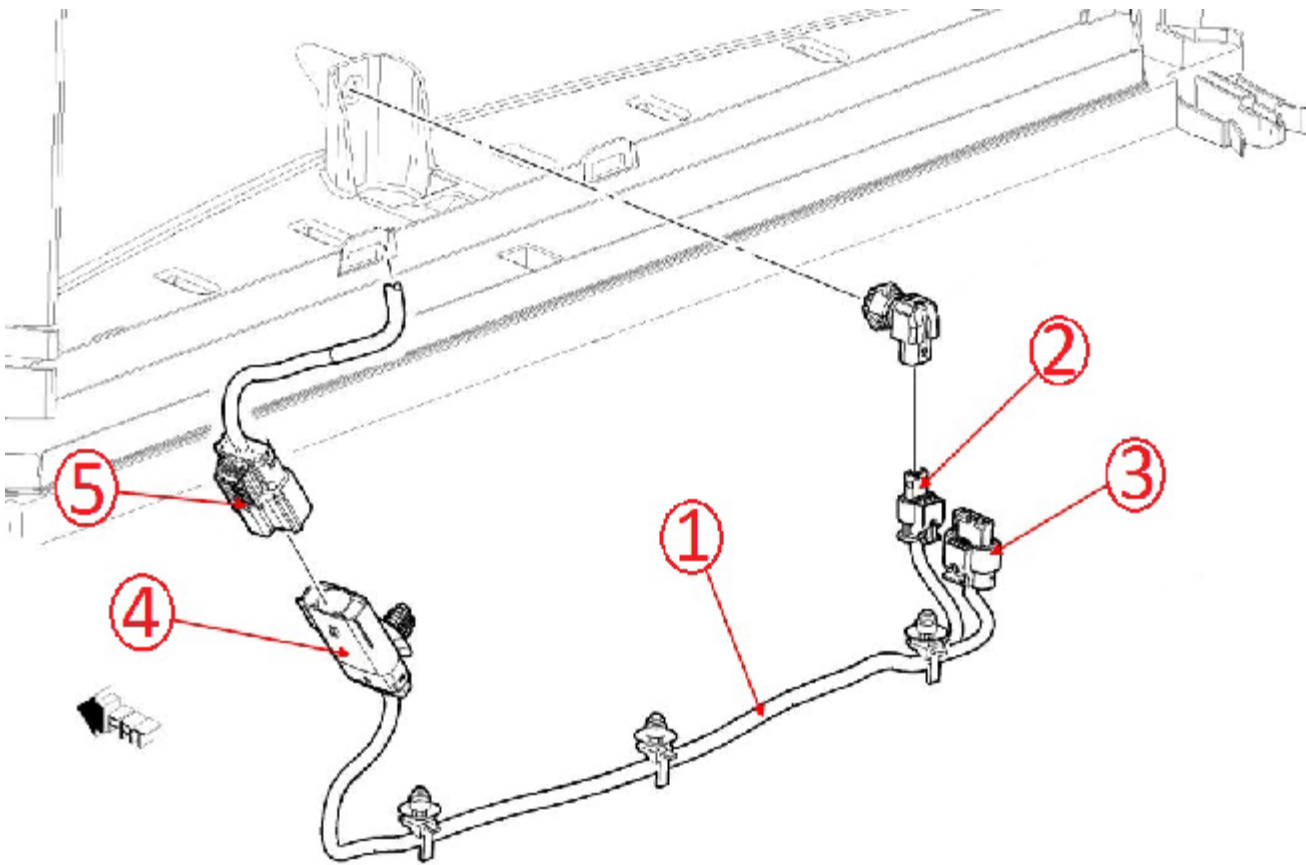
Involved Region or Country	North America and Israel
Additional Options (RPO)	VRI
Condition	<p>Some customers may comment on the Malfunction Indicator Lamp (MIL) being illuminated. The Technician may find one or more of the following DTCs set:</p> <ul style="list-style-type: none"> • P059F • U1501 • U1510 • U1511
Cause	<p>This condition may be caused by the following conditions:</p> <ul style="list-style-type: none"> • Moisture intrusion in the B9, M60B and/or X119 connector for the Ambient Air Temperature Sensor Wiring Harness. • Snow and/or ice buildup in the front lower grille area of the vehicle, which could prevent the active aero shutters from opening or closing.

Inspect the Ambient Air Temperature Sensor Wiring Harness connectors B9 (2), M60B (3) and the X119 (4, 5) for any signs of corrosion.

- If any corrosion was found on the Ambient Air Temperature Sensor Wiring Harness (1), it must be replaced.
- If the corrosion was found at the X119 connector (5), the main body wiring harness connector must be repaired as needed.
- If the corrosion was found on the B9 connector (2), the Ambient Air Temperature Sensor must be replaced.
- If the corrosion was found on the M60B connector (3), the active shutter must be replaced.
