Service Bulletin

Subject: Diagnostic Tip for DTC P305F

Models: 2014-2015 Chevrolet Malibu
2016 Malibu Limited (VIN 1)
Equipped with Start/Stop System (RPO KL9)

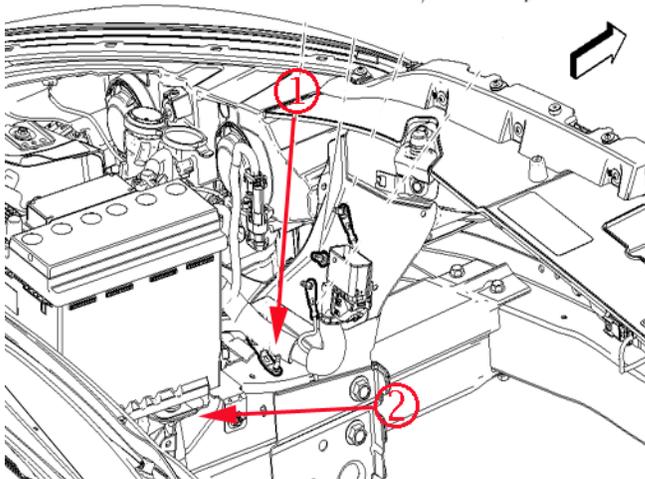
Technicians may find the diagnostic trouble code (DTC) P305F: Dual Battery Control Module Performance has been set in the Engine Control Module (ECM). There may be several different causes of this code setting and before any component replacements, please follow the recommendations below.

- Inspect for loose unsecured electrical ground at G103 (1).
- Verify the engine harness is not pinched underneath the main battery tray (2).
- Inspect both main and auxiliary battery cables for being secured.
- Perform the battery inspection/test in SI (Document ID# 3469663) to the auxiliary battery.

Important: Do NOT replace the ECM for this DTC.
