LTB00866NAS2

TECHNICAL BULLETIN

'Rattle' Noise From The Second Row Seat Area

MODEL:	MODEL YEAR:	VIN:	ASSEMBLY PLANT:
Discovery Sport (LC)	2015-2016	500429-549203	Halewood

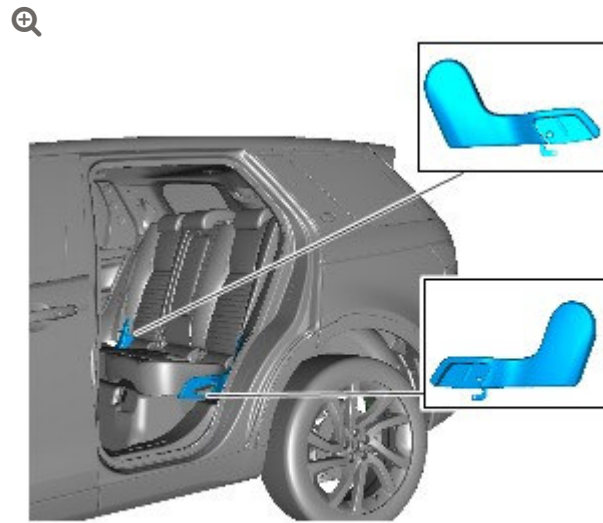
E185610

A 'rattle' noise may be evident from the second row seat area of the vehicle. This will occur when the second row seat is pushed fully back and the valance trim is in contact with the quarter panel trim.

This may be caused by the second row seat outer hinge mechanism cover having insufficient clearance to the quarter panel trim, causing this rattle to occur when the seat is pushed fully back and the valance trim is in contact with the quarter panel trim.

Component location.
