## TECHNICAL BULLETIN LTB00846NAS2 04 NOV 2016

#### <u>SECTION: 501-05</u>

Front/Rear Door Interior Trim Panel Detached

**Discovery Sport (LC)**

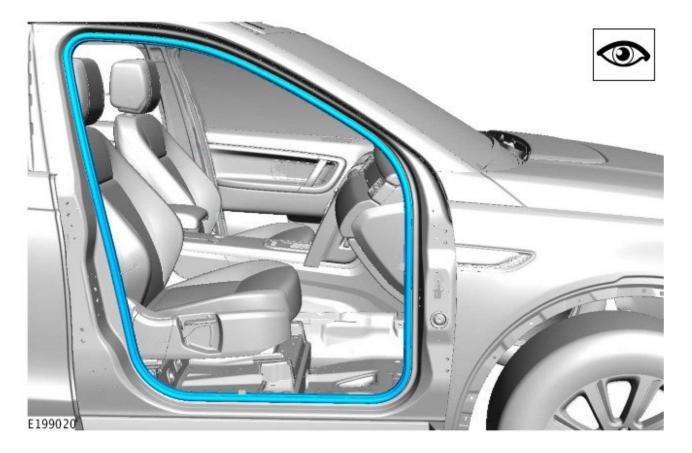
Visually inspect the front door aperture seal for damage caused by the detached front door interior trim.

- If the seal is damaged, go to Step 7. If the seal is not damaged, go to Step 9.

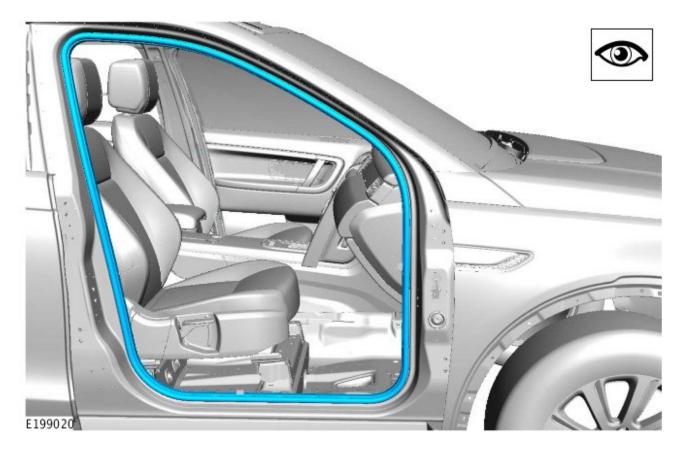
Visually inspect the front door aperture seal for damage caused by the detached front door interior trim.

- If the seal is not damaged, do not continue with this bulletin.
  If the seal is damaged, go to Step 20.

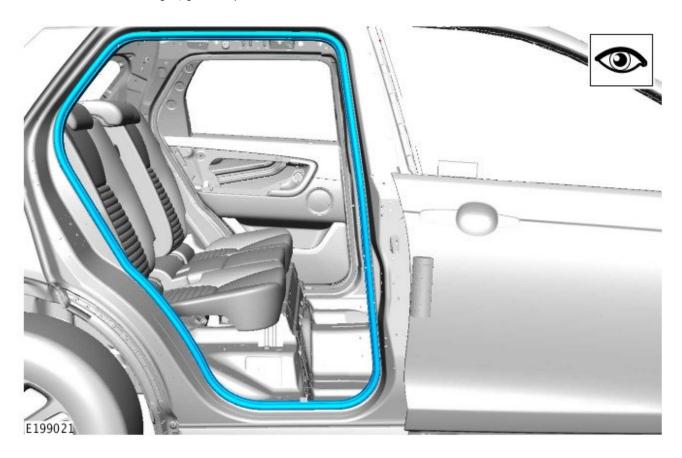
- 26. Install the new rear door interior trim (see TOPIx Workshop Manual section 501-05: Body and Paint Interior Trim and Ornamentation - Rear Door Trim Panel).
- 27. Visually inspect the rear door aperture seal for damage caused by the rear door interior trim.
  - If the seal is not damaged, go to Step 30. If the seal is damaged, go to Step 28.

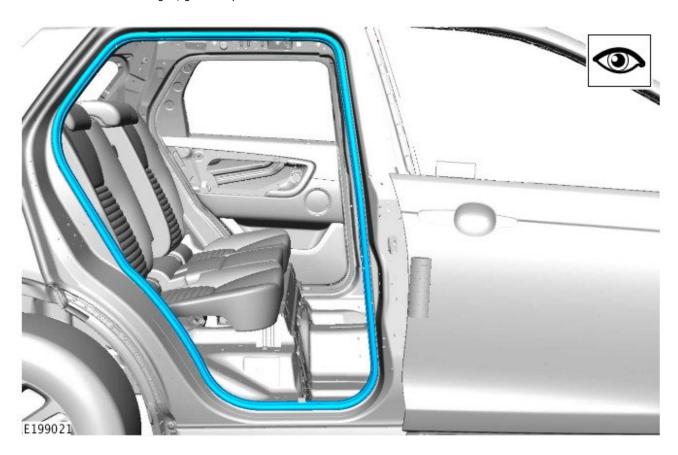
Visually inspect the rear door aperture seal.

- If the seal is not damaged, do not continue with this bulletin.If the seal is damaged, go to Step 41.
