TECHNICAL BULLETIN
LTB00916NAS3
01 NOV 2016

SECTION: 303-01

Intake Camshaft Variable Cam Timing Actuator - Component Failure

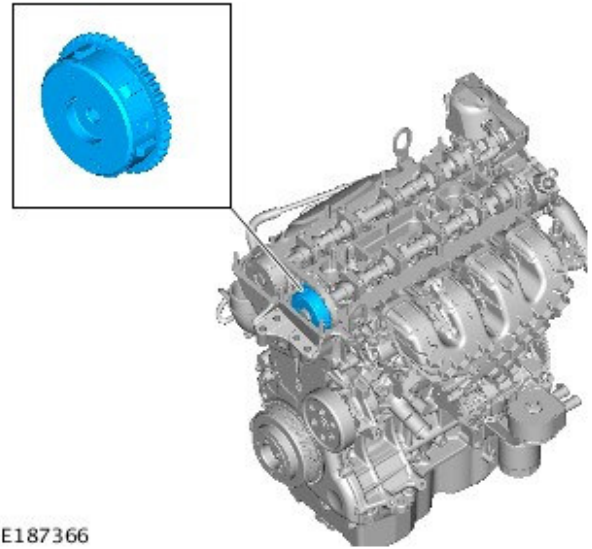
E187366

1. Intake camshaft Variable Camshaft Timing (VCT) actuator location

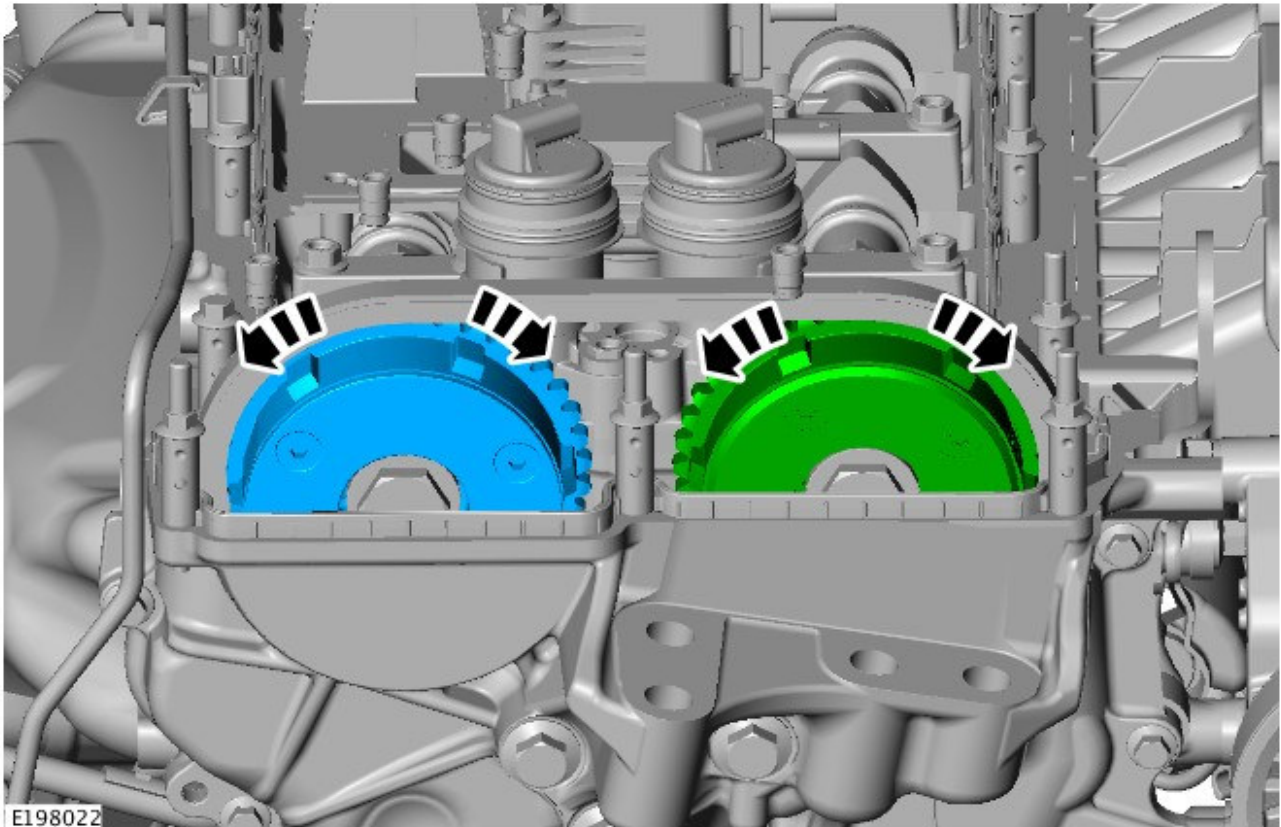
E198022

The exhaust camshaft Variable Camshaft Timing (VCT) actuator unit (shown in blue) has restricted movement when turned. The intake camshaft VCT unit (shown in green) has a less restricted movement when turned.

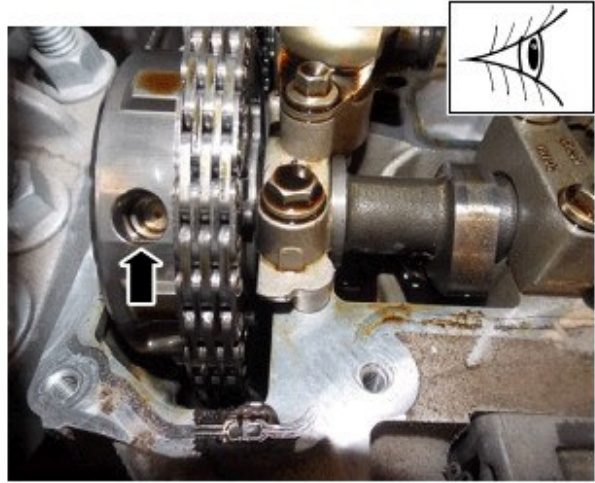
E186694

2. Inspect the Variable Camshaft Timing (VCT) actuator.

- If the VCT actuator is noisy but the 'stopper' is in place, go to Step 3.
- If the 'stopper' is not in place in the VCT actuator, go to Step 4.

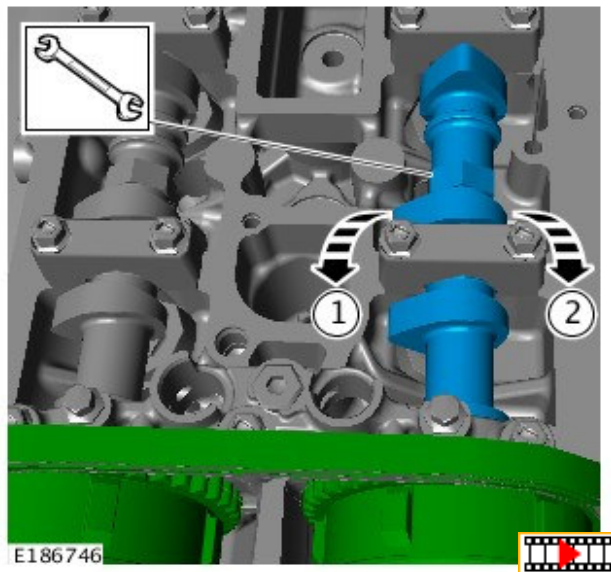
E186746

**NOTE: Clockwise movement should NOT be possible without also rotating the engine.**

Fully rotate the camshaft anti-clockwise (1) and then attempt to rotate the camshaft clockwise (2).

- If the camshaft rotates freely in both directions, the VCT actuator is NOT functioning correctly; go to Step 4.
- If no clockwise movement was possible without also rotating the engine, the VCT actuator is functioning correctly.
 - Reverse the removal procedure.

4. Refer to intake camshaft VCT actuator (see TOPIX Workshop Manual section 303-01A / 303-01B: Engine - GTDi 2.0L Petrol - Variable Camshaft Timing Actuator).
