TECHNICAL BULLETIN  
LTB00740NAS3  
14 NOV 2016

'Gearbox Fault' Message Displayed In Instrument Cluster

**Range Rover Evoque (LV)**

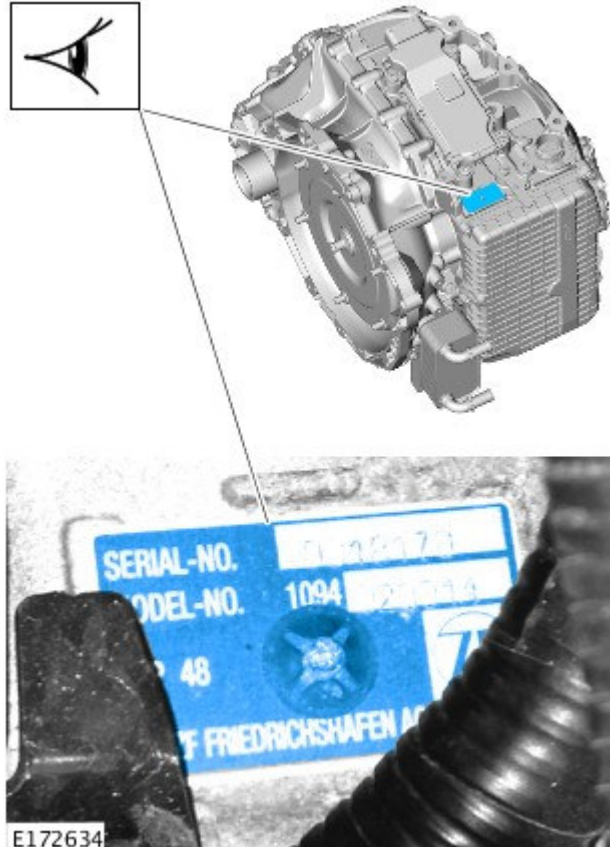
**1. Inspect the Transmission serial number.**

- If the serial number is **141772 or lower**, go to Step 2.
- If the serial number is **141773 or higher**, do not continue with this Technical Bulletin.
  - Follow a normal diagnostic process using the instructions listed in TOPIx Workshop Manual section 100-00: General Information).
