**Countries:** CANADA, UNITED STATES **Document ID:** IK0800520  
**Availability:** ISIS, FleetISIS, Body Builder **Revision:** 3  
**Major System:** ELECTRICAL SYSTEM **Created:** 10/29/2015  
**Current Language:** English **Last Modified:** 2/19/2016  
**Other Languages:** NONE **Author:** Charles Schroeder  
**Viewed:** 2123

**Title:** Ground Splice 6747 Causing Multiple Fault Codes

**Applies To:** N9 and N10 powered vehicles built prior to Sep 28, 2015

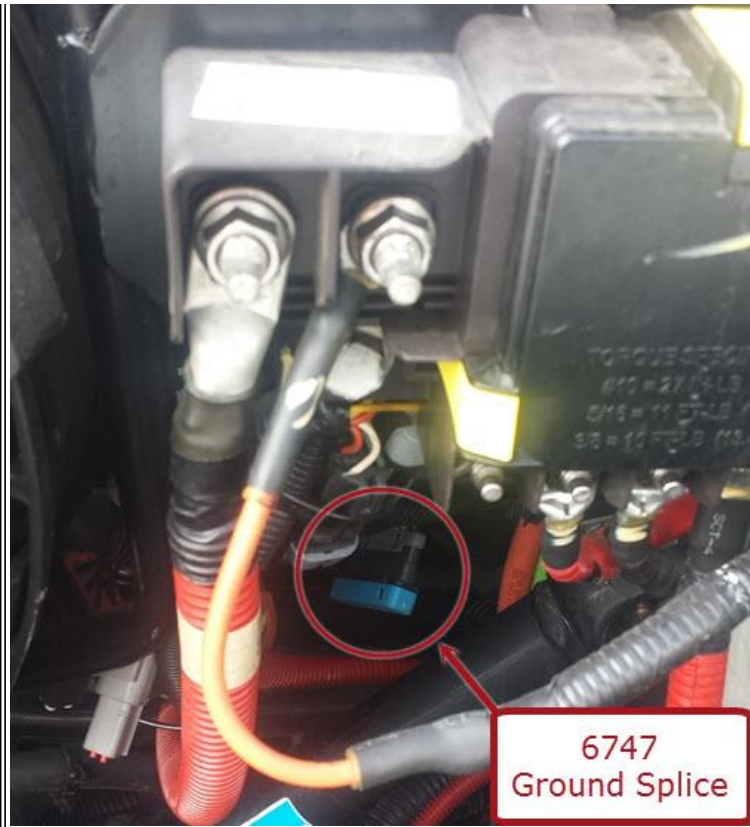
**Figure 1 - 6747 Connector**

- The 6747 Ground Splice Connector is located on the left side (driver side) of the engine bay.
  - Refer to Figure 1 and Figure 2
- Inspect the connector and ground splice for any damage
  - Refer to Figure 3

Note: The 6747 may be located closer to the wiper bracket depending on truck model and configuration. Verify circuit numbers to ensure you are at the correct connector.

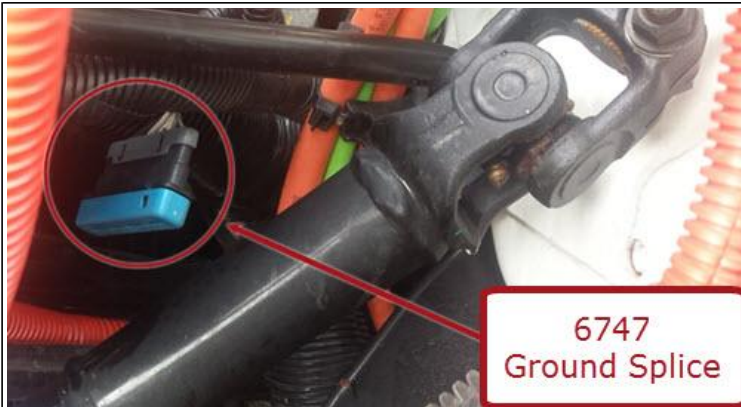
**Figure 2 - 6747 Connector**

Note: The 6747 may be located closer to the wiper bracket depending on truck model and configuration. Verify circuit numbers to ensure you are at the correct connector.

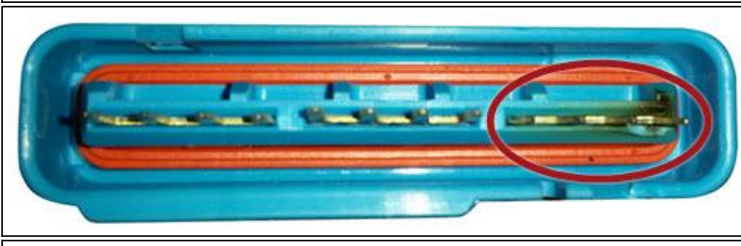
**Figure 3 - 6747 Splice Bus Bar**

Inspect the 6747 connector, terminals, wires, and splice block cap for any damage. If no damage is found, clean the terminals on the splice block cap gently with emery cloth. Even if no damage is found the repair steps should be followed if your N9 or N10 equipped vehicle was built prior to September 28th, 2015.

Note the damage to the connector and terminals

Replace any damaged components on the 6747 connector using the parts listed above.

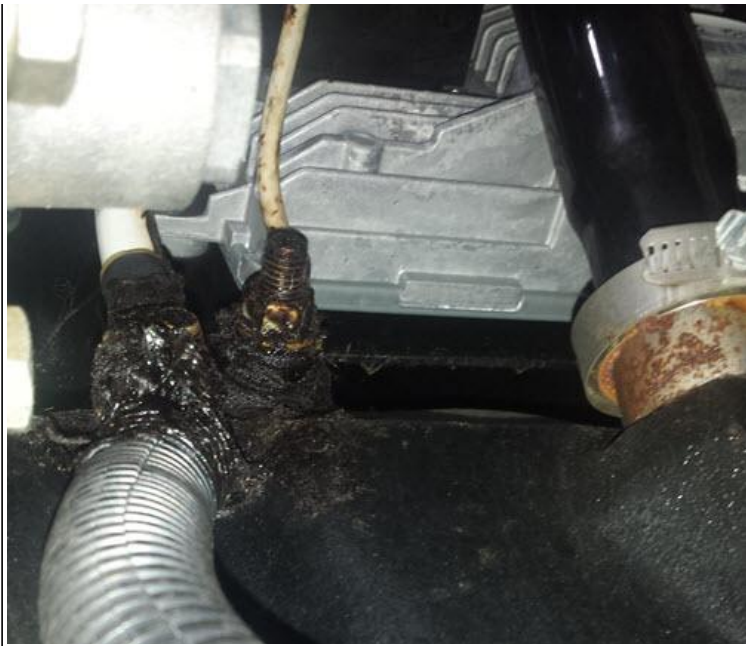
**Figure 5 - Engine Block Ground Stud**

Ground Stud is located on the left side (driver side) of the engine block, just under the ECM.

- Refer to Figure 5 and Figure 6.
  9. Install a 3/8 inch eyelet on the white wire at the ground stud.
  10. Unplug the fuel heater connector (if equipped).

16. Route the wire along the harness towards the engine block ground stud.
    - Refer to Figure 5 and Figure 6.
  17. Install a 3/8 inch eyelet on the white wire at the ground stud.
