**Document ID:** IK0800522

**Title:** Repair Information for Damaged Headlight Connector

**Applies To:** Certain DuraStar, CE / BE Bus, WorkStar, 1300, TranStar

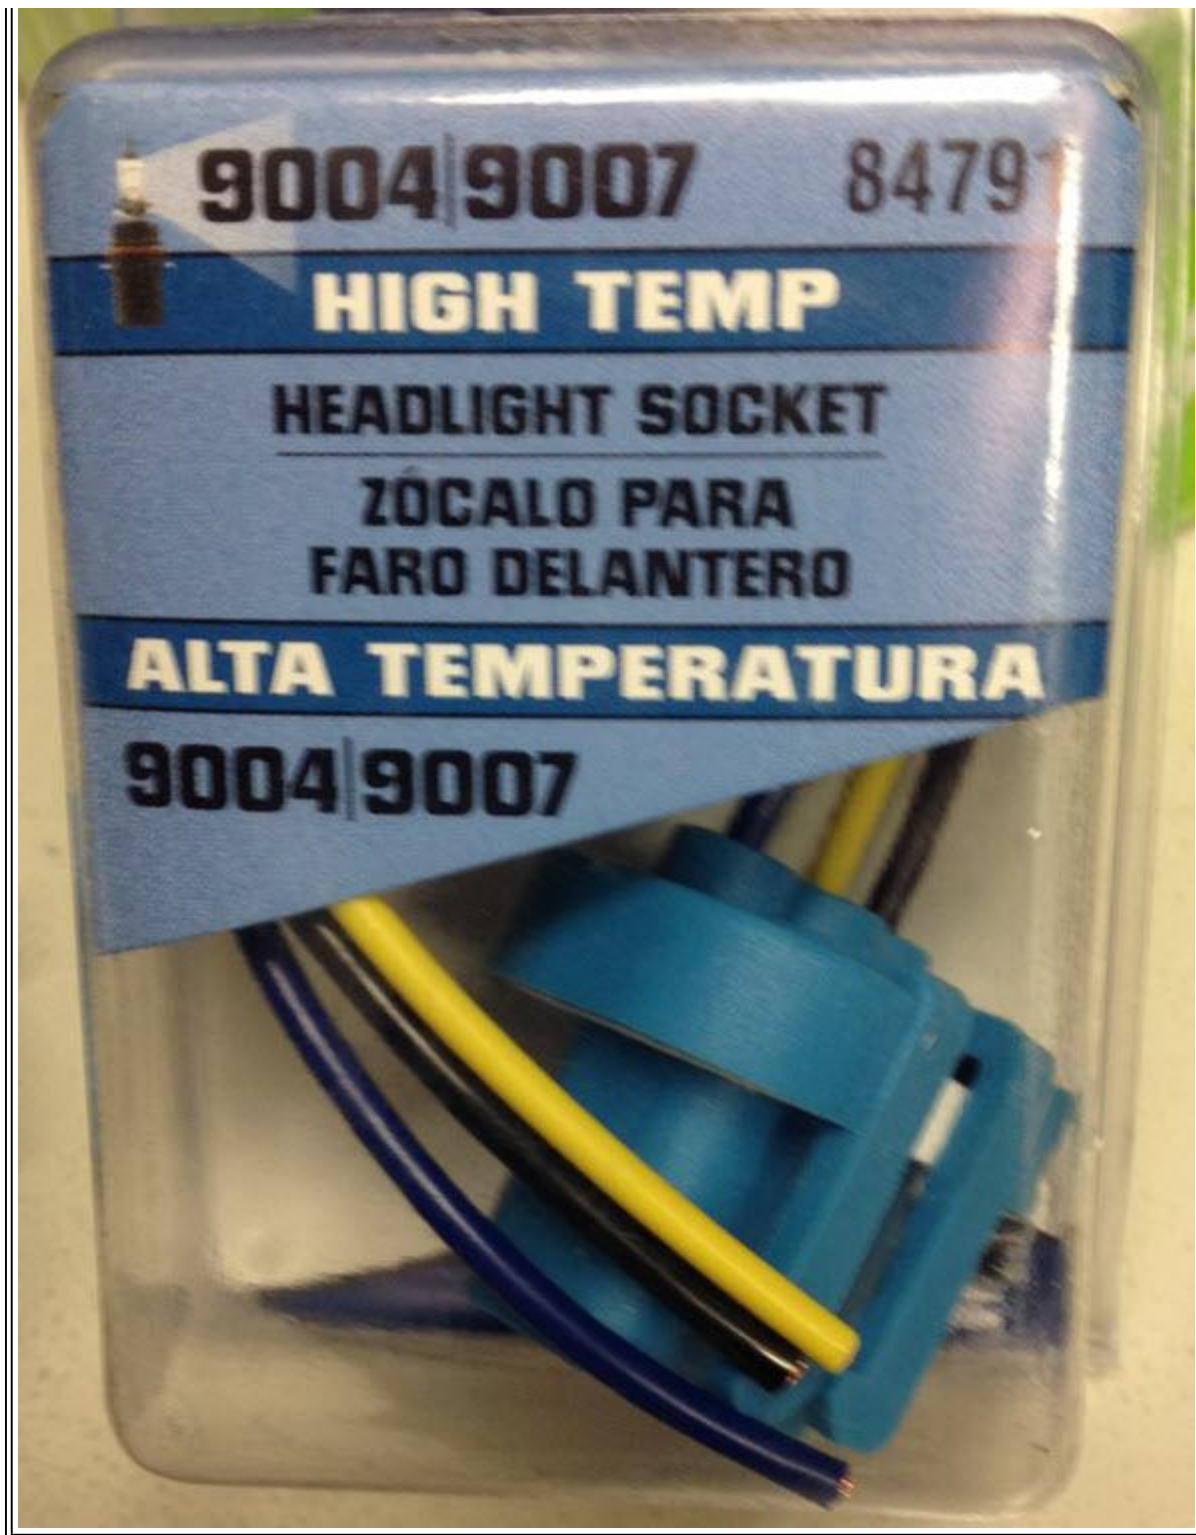
**Figure 1**

| Dorman Light Bulb Socket 84791 | 84791 | 1-2 | Must be "High Temp"<br>*Obtain Locally (Figure 1 below) |

Replace the damaged connector with the Dorman 84791 High Temperature Socket Pigtail. Replace the headlight bulb if damage is present. It is recommended to replace the headlight bulb in pairs.

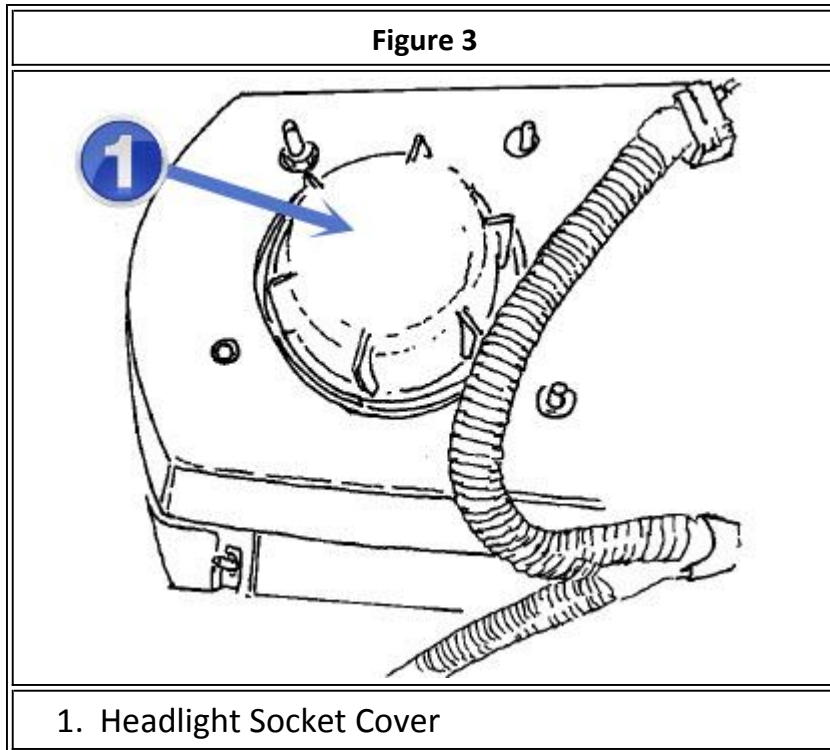
The 9007 connector that is part of the headlight assembly may have terminal or connector damage resulting in an inoperative headlight. The connector should be inspected as part of normal circuit diagnostics.

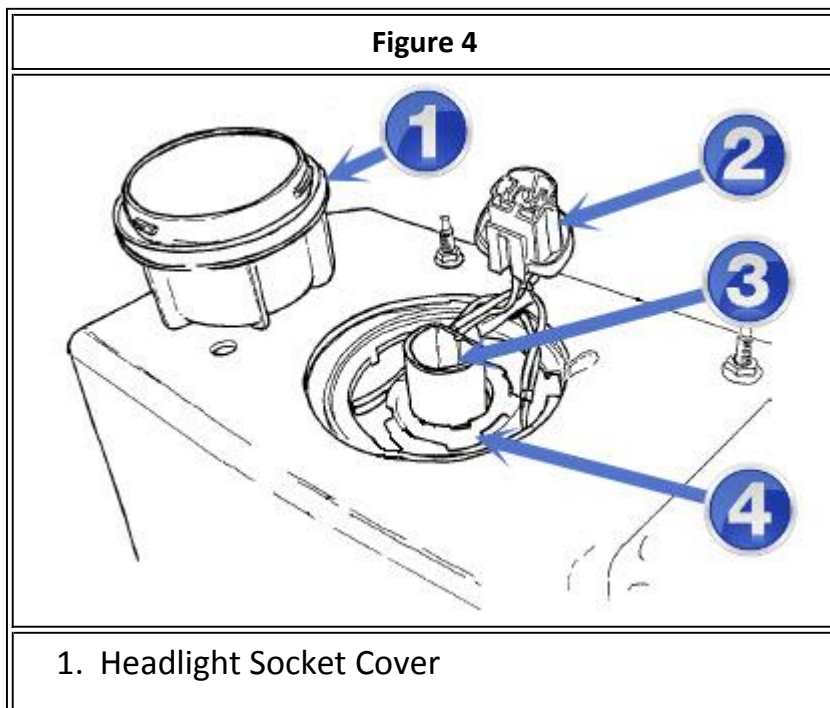
| <ol style="list-style-type: none"><li>2. Headlight Socket Pigtail Plug</li><li>3. Headlight</li><li>4. Headlight Retaining Bezel</li></ol> |

5. If the headlight connector, headlight body or terminals are damaged continue to Repair Steps.

1. Replace the socket pigtail plug, with the high temperature pigtail.
  - Use the closed barrel butt connectors to crimp and solder the wiring.
  - Follow proper wire repair procedures as outlined in [IK0800269 - Proper Wire Repair](#).
2. To replace the headlight, if required, remove the headlight retaining bezel. See Figure 7 below.
