Document ID: IK1201075

Title: 2010-2012 MaxxForce 11/13L Intake Throttle Valve Causing Regen Issues

Applies To: 2010-2012 IBB Maxxforce 11/13/15L Engines

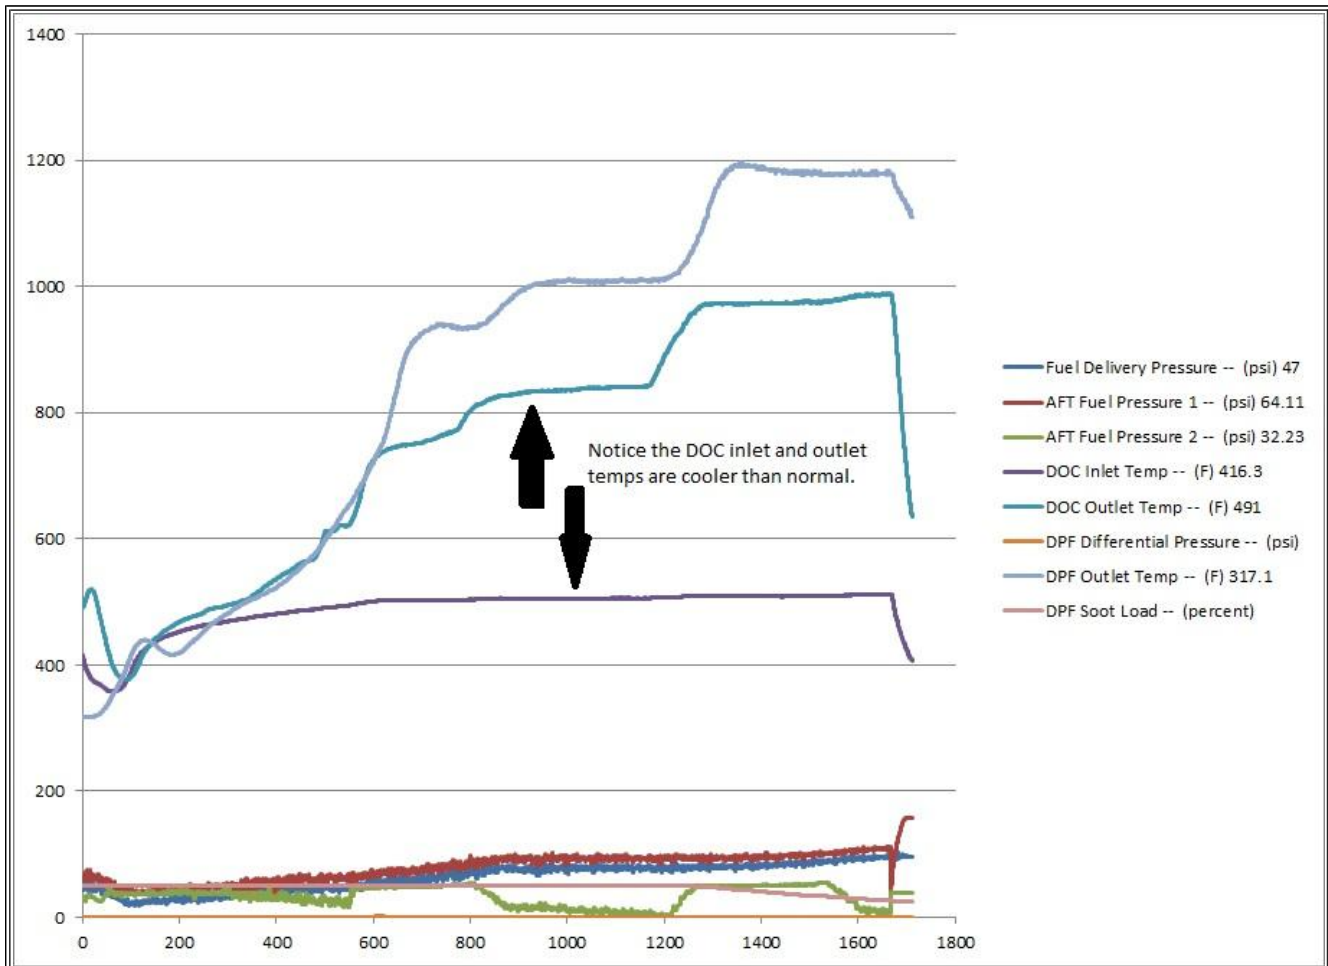
Figure #1: OBFCT with a Bad ETV

Item 1: Notice the DOC inlet and outlet temps are cooler than a normal regen should be. DOC inlet should be in the 550-700°F range. This is due to the ITV not working properly to produce enough heat in the exhaust system.

Item 2: Notice the length of time it takes for the temps to start rising

Replace the ITV and rerun the OBFCT to verify the repair

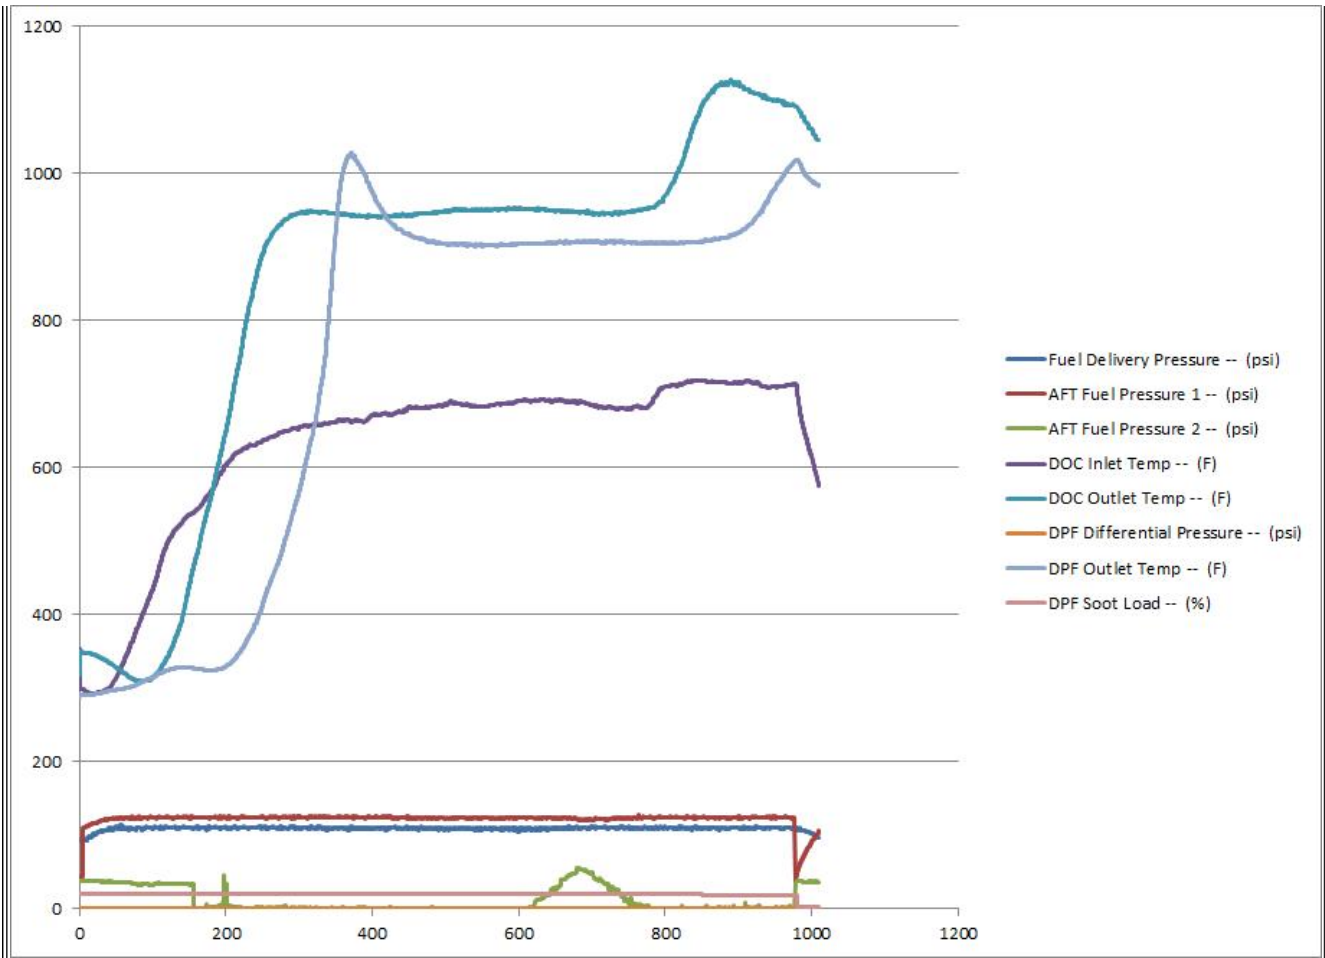
Figure #2: Good Regen

Item 1: Notice the temps rise much quicker than the bad regen shows

Item 2: DOC Inlet temp is in a good range
