**Title: 2010 MaxxForce 11 & 13 and 2013 N13 HT EGR Core Removal/Installation**

**Applies To: 2010 MaxxForce11/13, 2013 N13, All Truck Models**

A faster, more effective procedure for High Temp (HT) Exhaust Gas Recirculation (EGR) Cooler repair has been developed. This document will guide the user through the procedure of in chassis replacement of the cooler core for a 2010 Emissions MaxxForce 11 or 13 or 2013 Emissions N13. The new procedure must be followed in lieu of HT cooler assembly replacement for **INTERNAL** leaks.

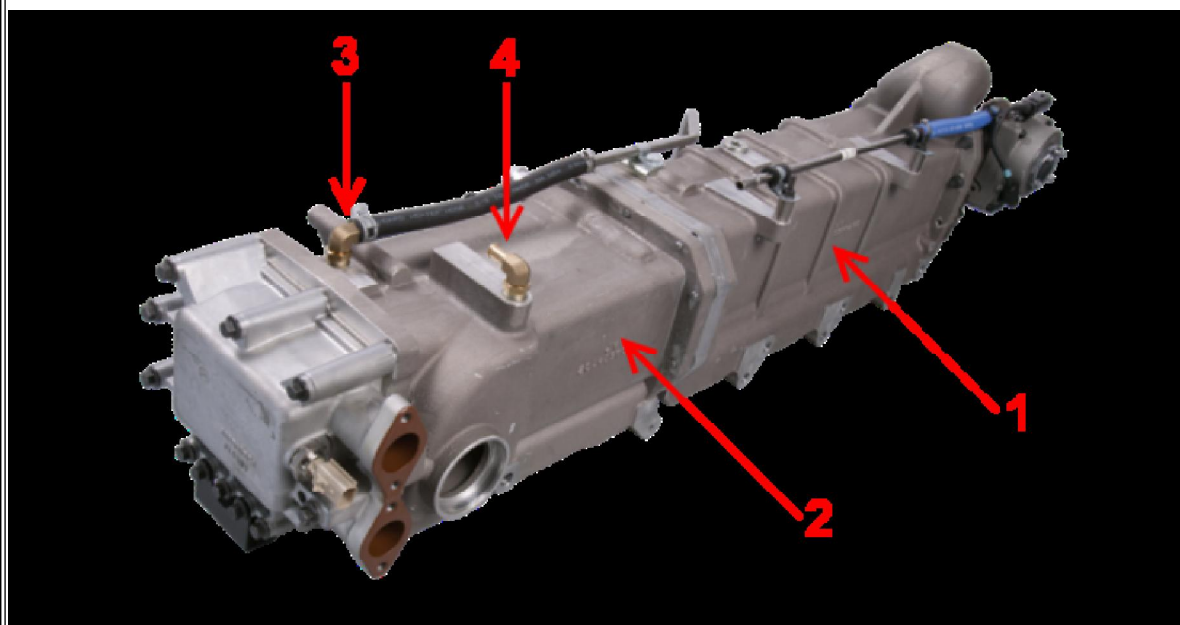
**Figure 1: 2010 MaxxForce 11/13 EGR Cooler Assembly**

Item 1: High Temp (HT) Cooler

Item 2: Low Temp (LT) Cooler

Item 3: LT Cooler Pressure Test Port (dearation fitting)

Item 4: HT Cooler Pressure Test Port (dearation fitting)

\*Visual inspection should never be used for diagnosing a bad cooler. The cooler (especially when constantly operated cold--read, moving the truck around the lot) will cause condensation build-up, and when mixed with soot/exhaust constituents, can be easily confused with coolant. ALWAYS pressure test the cooler.\*

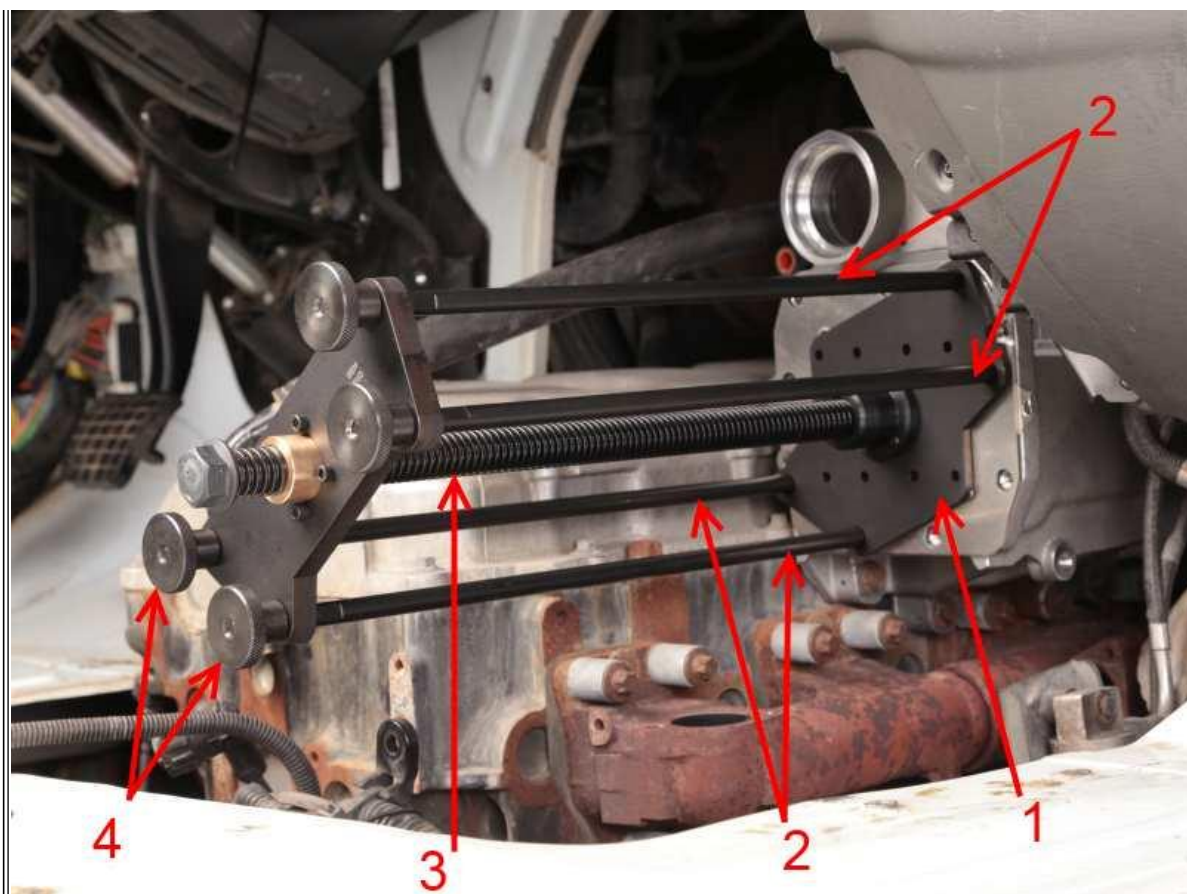
**Figure 2: HT Core Removal Tool**

Item 1: Removal plate  
 Item 2: Support rods  
 Item 3: Forcing screw  
 Item 4: Thumb screws

It is critical that the rods get torqued to the housing. There is a bevel between the threads and the shaft, designed specifically to drive the cooler header onto the shaft. **There is a distinct difference between bottoming out on the header plate, and bottoming out in the housing (hard stop).** Failure to do so will lead to the header being caught on the rod and breaking/bending the rod. There have been instances of the housing being damaged to the point of replacement, as well.

a. Screw in the support rods in the two upper right, and lower, bottom left corner, holes (**Figure 2**, Item 2). **Tighten using a 9mm open-end wrench.**

b. Slide the puller over the rods

c. Attach/tighten the thumb screws (**Figure 2**, Item 4).

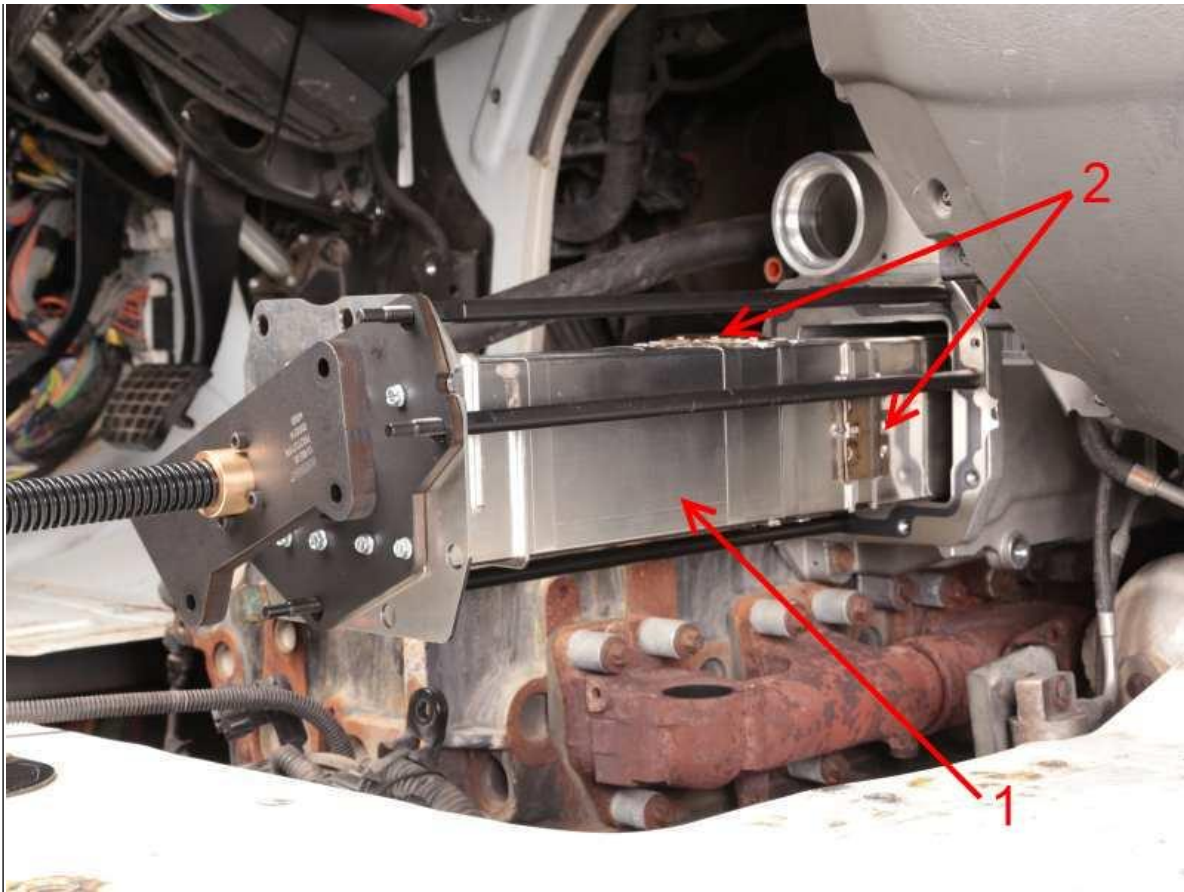
**Figure 4: High Temp Core and Spring Clips**

Item 1: HT Cooler Core

Item 2: Spring Clips

-There are two pairs of spring clips supporting the core in the housing. Therefore, the core will need to be pulled about 16 inches before it will be free to remove.

**-NEVER use an impact on the tool.** The tool was not designed to handle the stresses because core and/or housing damage will result from the uncontrolled force. Always use a ratchet.

5. Back out the bolt to extract the core from the housing (**counter-clockwise**).

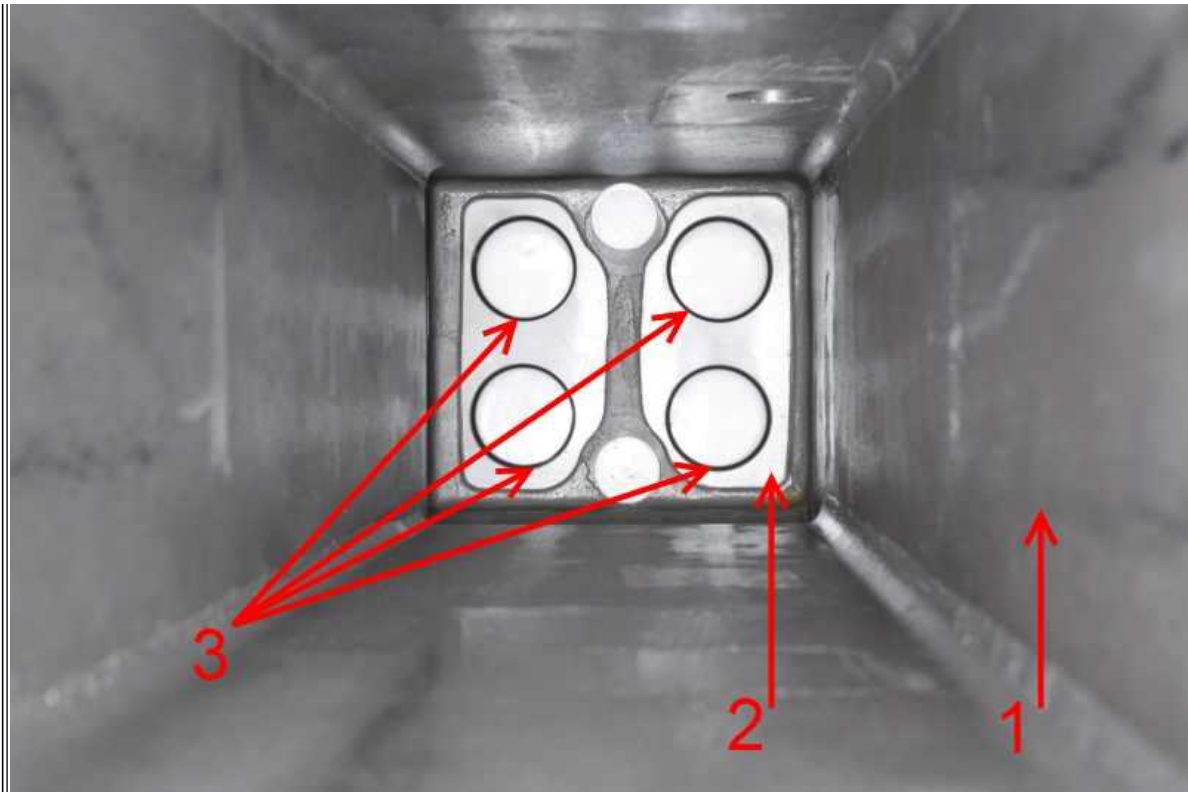
**Figure 5: HT Diffuser O-Rings**

Item 1: HT Housing  
Item 2: Manifold (joint) Plate  
Item 3: O-Rings

**10.** Use a pick to remove the four o-rings in the center of the cooler and discard. *The o-rings must be replaced every time the core is replaced. Non-compliance will result in premature failure of the core.*

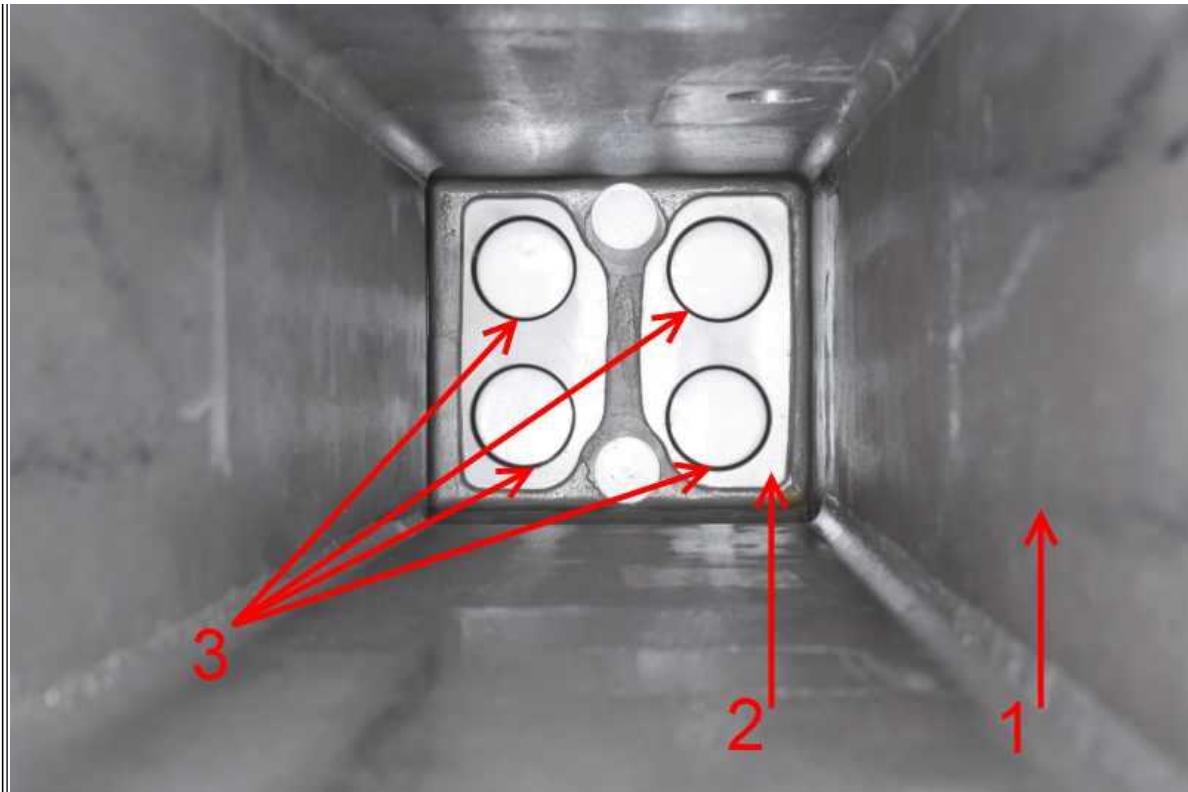
**Figure 6: HT Diffuser O-Rings**

Item 1: HT Housing  
Item 2: Manifold (joint) Plate  
Item 3: O-Rings

**Make sure there is no debris in the o-ring grooves prior to installing the o-rings** (they don't need to be spotless, just no soot chunks that will push the o-ring out of round). In development, this was the only instance of damaged o-rings (core outlet manifold cut off a section of the o-ring), outside of not actually seating them.

1. Install the four o-rings from the HT kit (**Figure 6**, Item 3) and ensure they are seated properly.

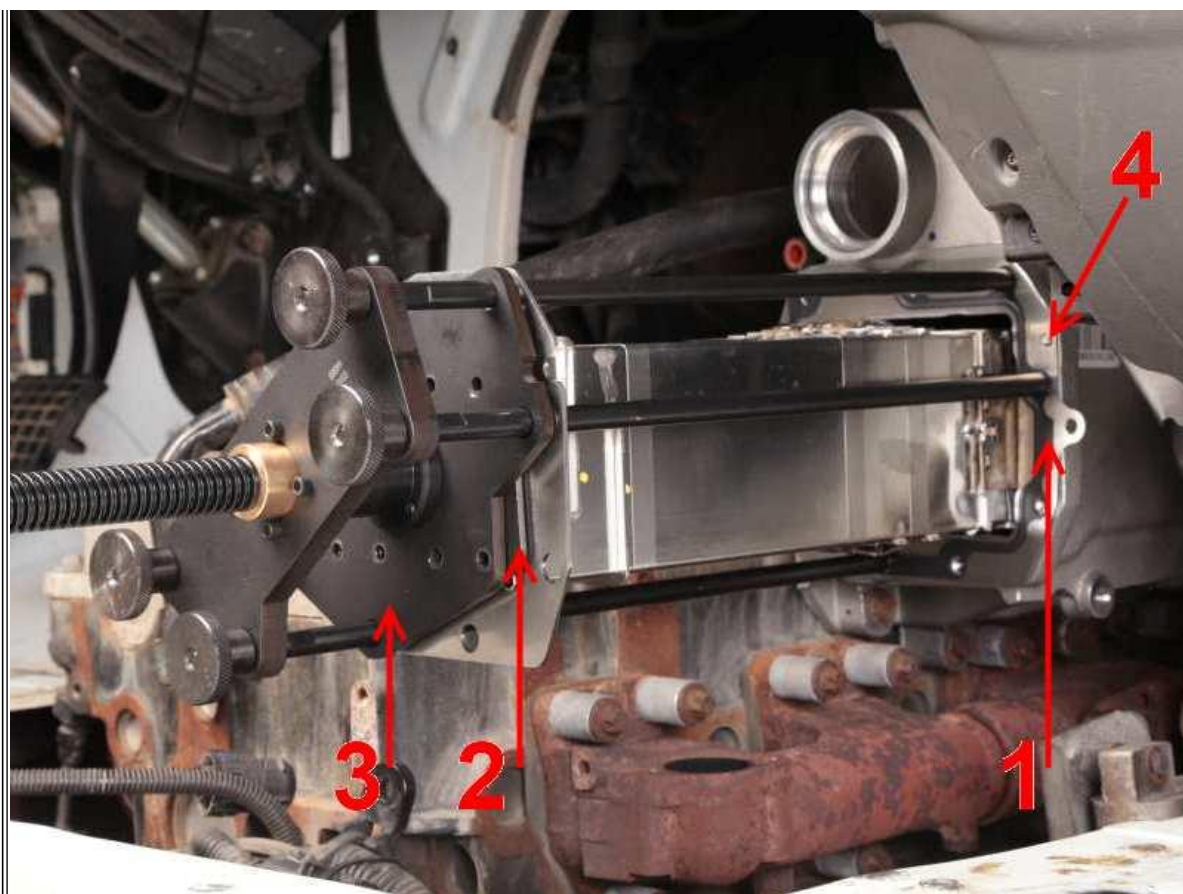
**Figure 8: HT Core Installation**

Item 1: Core to Housing Gasket  
 Item 2: Installation Plate  
 Item 3: Removal Plate  
 Item 4: Dowel Pin

**DO NOT OVER TIGHTEN.** Stop when the plate merely touches the gasket/housing. The core should take up to 10 lb-ft of bolt torque to slide in. **Damage to the tubes will occur if the torque exceeds 15 lb-ft (equates to 1000 lb force).**

If the previous core and new core are on the opposite ends of the position spec, it's possible the plate will not line up and will cause the core to bottom out (on the plate, before sliding into the O-rings). The core/housing can be saved by loosening the HT/LT joint bolts (would require removing the cooler from the engine). This won't save time but will save a good core from being scrapped.

6. Apply liberal amounts of P-80 to the outlet manifold and spring clips of the HT core.
7. Slide the HT Core into the housing.
8. Attach the insertion plate to the tool and slide it over the rods.
9. Screw the thumbscrews onto the rods.
10. Use a torque wrench to tighten the bolt, which will drive the core into the housing. Stop when the core header touches the gasket.
