Document ID: IK1600116

Title: ProStar Mirror / Map Light / Visor LED Lighting Up when CB MIC is Keyed

Applies To: ProStar and LoneStar

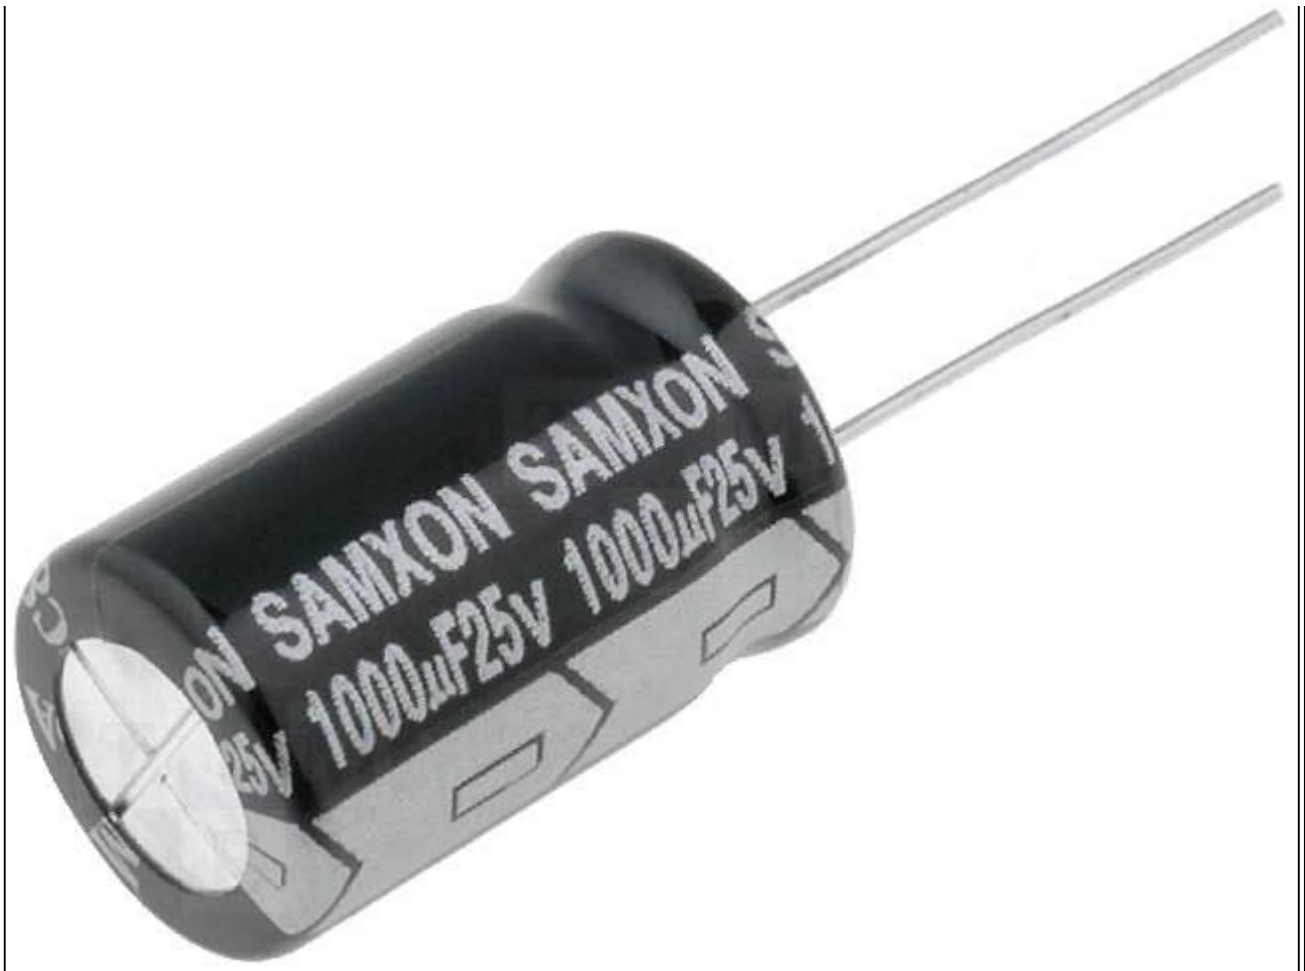
Figure 1

1000µF (micro farad) capacitor.

Technician should obtain locally a 1000 μ F (micro farad) capacitor and install it across the LED lead (from power to ground) for the LED that is affected.

The capacitors have specific polarity. Make sure the + lead on the capacitor is soldered to the power wire to the light.
