FIELD SERVICE CAMPAIGN – 16106

Incorrect Mounting Bolts Installed on Front Crossmembers

PayStar®

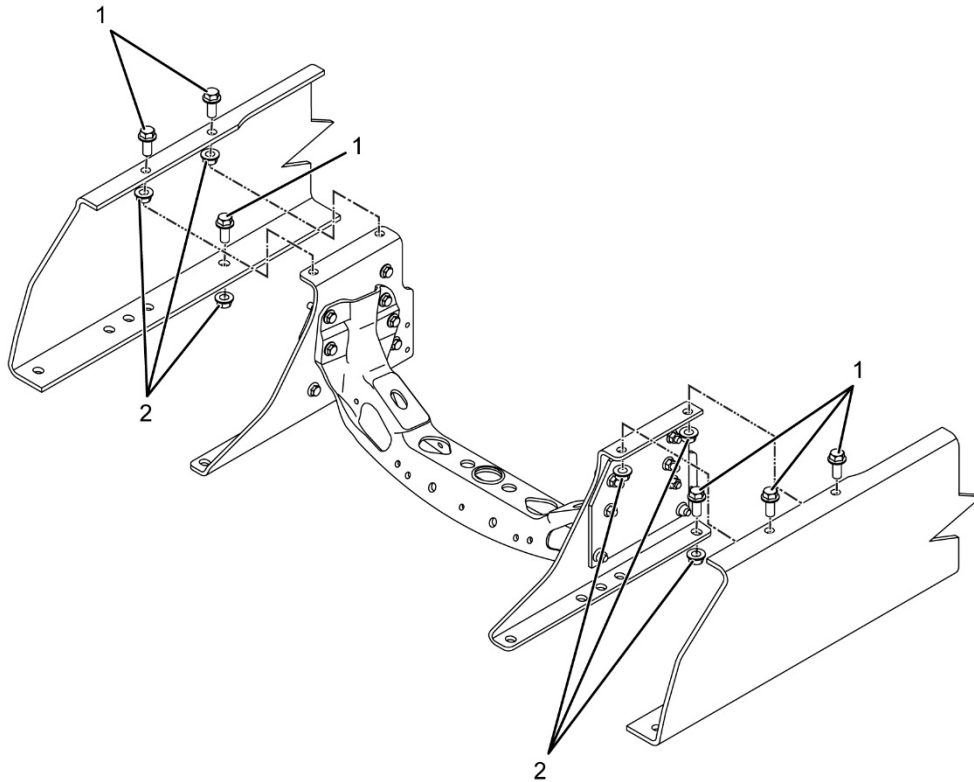
Figure 1. Front Crossmember

Certain PayStar® vehicles may have front crossmembers installed with incorrect bolts or missing bolts.

NOTE: For clarity, only affected fasteners are depicted in graphic.

4. Access front crossmember bolts, remove four upper bolts and nuts and lower rear bolts and nuts (Figure 1, Items 1 and 2). Discard bolts and nuts.
5. Obtain bolts and nuts and install into upper and lower rear crossmember bolt locations. Using torque wrench, tighten new fasteners to 220 lb-ft (298 N·m).
6. Remove wheel chocks.
