## FIELD SERVICE CAMPAIGN – 16116

24 May 2016

Incorrect Torque Applied to Power Steering Fitting

ProStar®

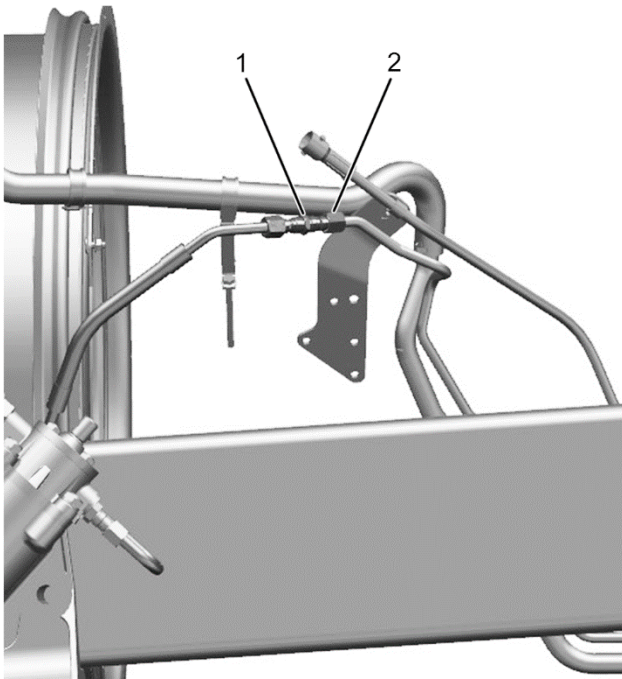
**Figure 1. Power Steering High-Pressure Fitting**

Incorrect torque may have been applied to a power steering fitting on certain ProStar® vehicles.

6. Hold compression fitting (Figure 1, Item 1) using combination wrench. Using crowsfoot-equipped torque wrench, tighten compression fitting nut (Figure 1, Item 2) to 46 lb-ft (62 N·m).
7. Verify power steering fluid level. Refer to Operator and Maintenance Manual for specifications. If necessary, fill to appropriate level.
