TECHNICAL SERVICE BULLETIN

Group:	48-SUSPENSION
Bulletin No:	SB-16-006
Issue Date:	4-20-2016
Vendor Ref.:	HMM-160308-B1

REAR SPRING PAD LOOSE

SUBJECT VEHICLES: 11MY-16MY Conventional Trucks (238, 258, 268, or 338)

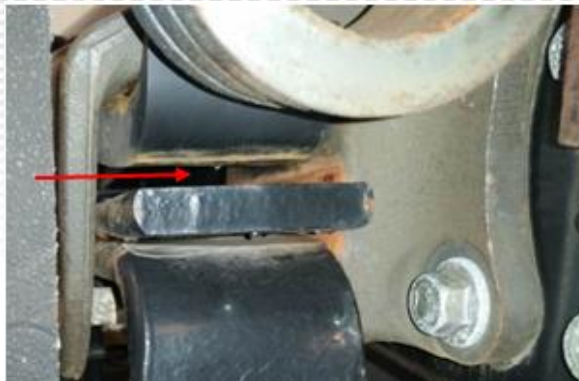
2. Lower the jack supporting the rear axle until the weight of the vehicle is placed on the jack stands. Allow the jack to continue to support the axle. When the axle is properly supported, there will be clearance between the spring pads and the leaf springs.
