# SERVICE MANUAL INFORMATION

| Bulletin No: | SB-16-031 |

## Subject: CORRECTION OF WORKSHOP MANUAL FOR HINO300 SERIES Revision of Troubleshooting Procedure for the DTC P20DF

**RELEVANT MODEL:** 2015MY COE Trucks

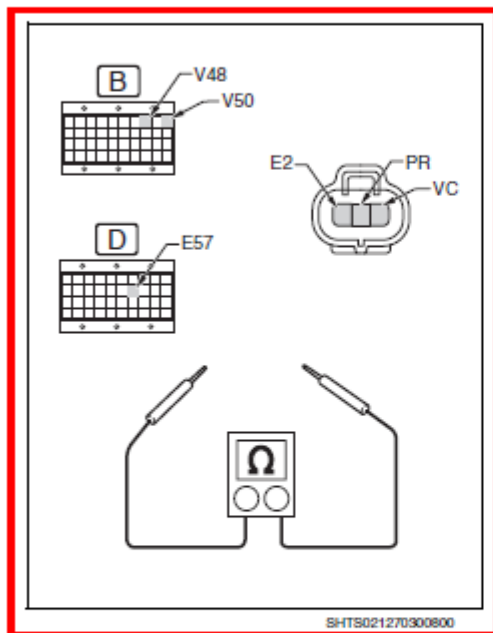
#### 4 Inspect the aftertreatment fuel injection line pressure sensor wire harness for disconnection

1. Using the electrical tester, measure the resistance from the engine ECU (signal check harness) to the terminals of the aftertreatment fuel injection line pressure sensor vehicle side connector.

| Measurement conditions | Tester connections | Standard values |
|---|---|---|
| Starter key: LOCK | Engine ECU (signal check harness) – Aftertreatment fuel injection line pressure sensor vehicle side connector<br>VCPA (V50) terminal – VC terminal<br>FPR (V48) terminal – PR terminal<br>E3 (E57) terminal – E2 terminal | 1 $\Omega$ |

Repair or replace the wire harness.
