**TO:** All Mazda Dealership Service Managers  
**DATE:** January 2016  
**SUBJECT:** 2014 Mazda6 - SBS & MRCC system concern  
Special Service Program (SSP) A1

2014 MAZDA6 – SBS & MRCC SYSTEM CONCERN

**Special Service Program (SSP) A1  
2014 Mazda6 - SBS & MRCC System Concern**

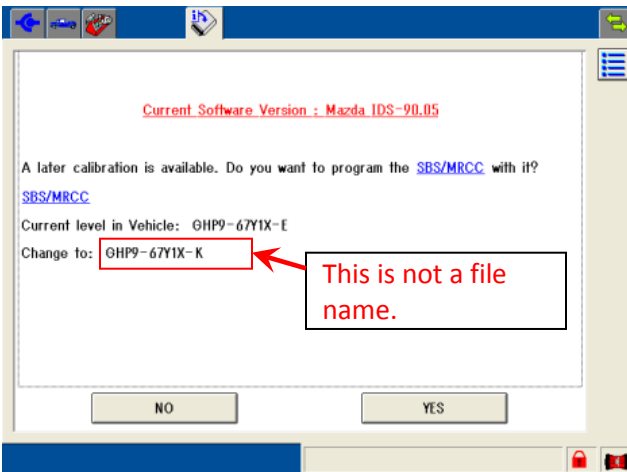
**Figure 1:** Subject for VCM reprogramming

- If the Figure 1 is displayed, the VCM is before the latest calibration. Click “YES” and follow the IDS instructions to reprogram the VCM.
- If the Figure 2 is displayed, the VCM already has the latest calibration.
