TO: All Mazda Dealership General Managers, Service and Parts Managers
DATE: February 2016
SUBJECT: 2014-2016 Mazda3 - Engine Coolant Concentration Concern
Special Service Program (SSP) A2

2014-2016 MAZDA3 ENGINE COOLANT CONCENTRATION CONCERN SSPA2

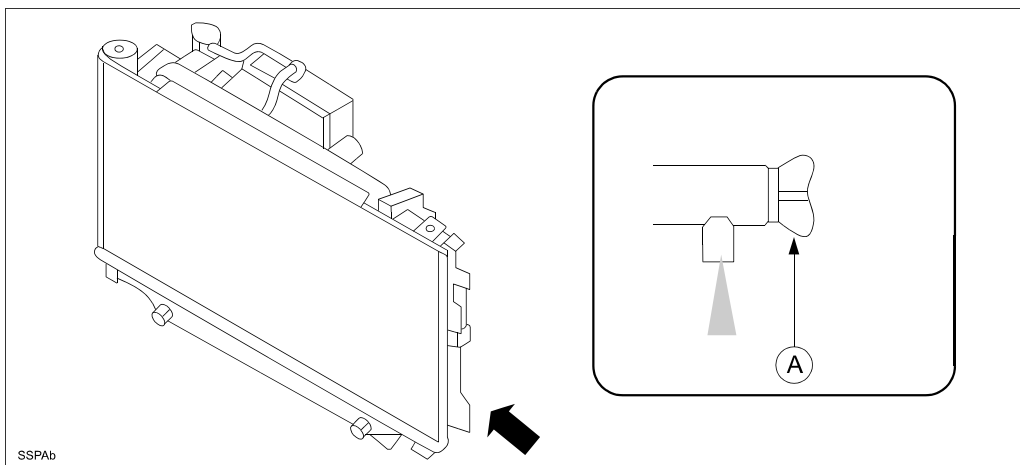
NOTE: The sample has to be taken from the bottom of the radiator for an accurate reading.

3. Loosen the radiator drain plug (A) and take a small sample of the coolant.

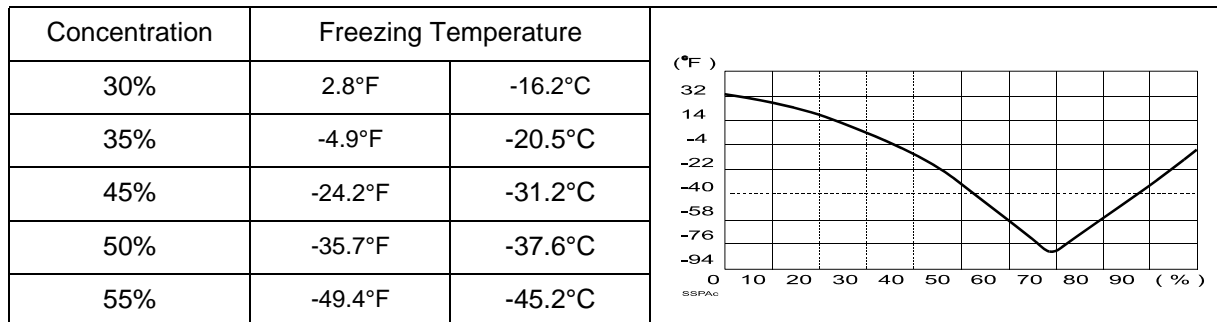
- Upper limit is 70% concentration.
NOTE: Coolant with a concentration greater than 70% could cause overheating due to lower cooling efficiency.
- Lower limit depends on environmental condition (see below).

- If the concentration is in the appropriate range, inspect the engine coolant level and adjust with new FL22 as needed.
- If the concentration is NOT in the appropriate range, go to Replacing the Coolant.

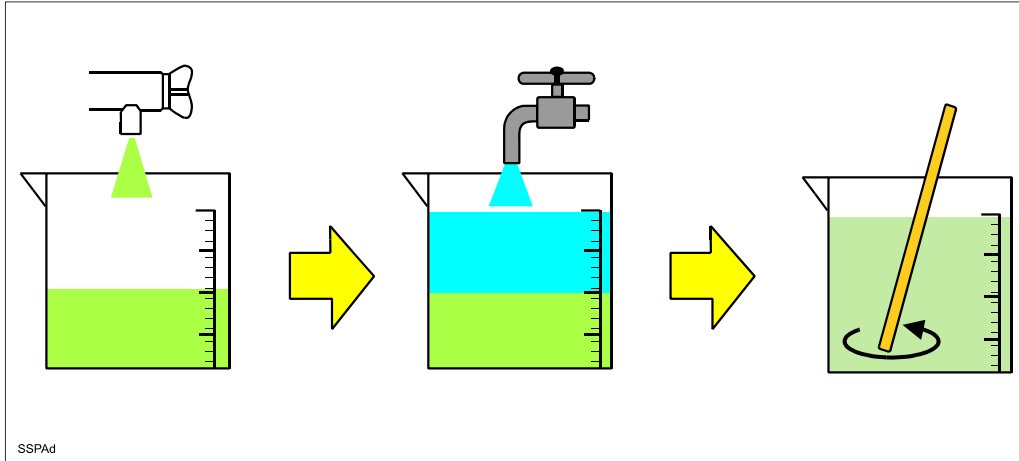
NOTE: If the concentration is over the measurable range of the coolant tester, obtain the value by following these steps.

- a. Measure a certain amount of coolant with a measuring cup.
- b. Dilute the coolant with equal amount of water.
- c. Mix the solution well.
- d. Measure the concentration and obtain the original concentration value by multiplying by two.
