**SUBJECT:** 2013 CX-5 - Steering Wheel Core Cover Concern

Special Service Program (SSPA4)

# 2013 CX-5 - Steering Wheel Core Cover Concern Special Service Program (SSP) A4

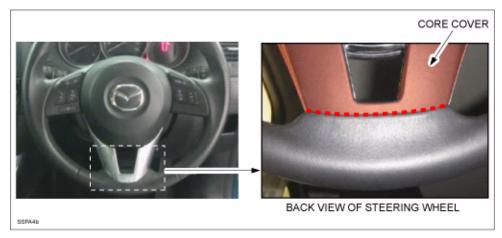
Using an emery board or file, gently file off any flashing that is found on the back-side, bottom edge of the steering wheel core cover (as shown below).

**CAUTION:** Use care not to scratch the other parts close to the back of the steering wheel.
