## Technical Service Bulletin

**Solitude 360RL Slide Room Flex-Guard Strap -  
DS Dinette Slide**

16-005

Solitude 360RL

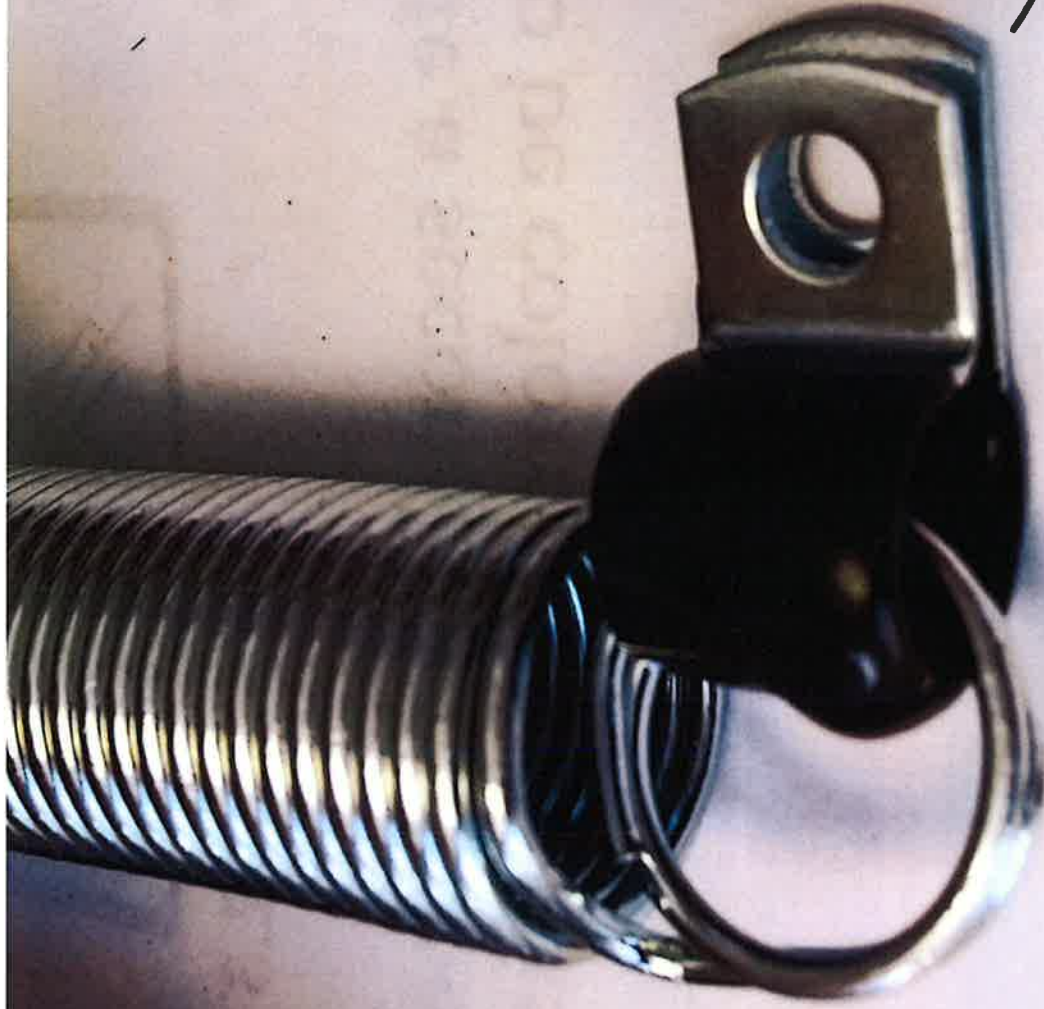
*Part # 550046*

**Spring guide with p-clamps on  
each end for securement...**

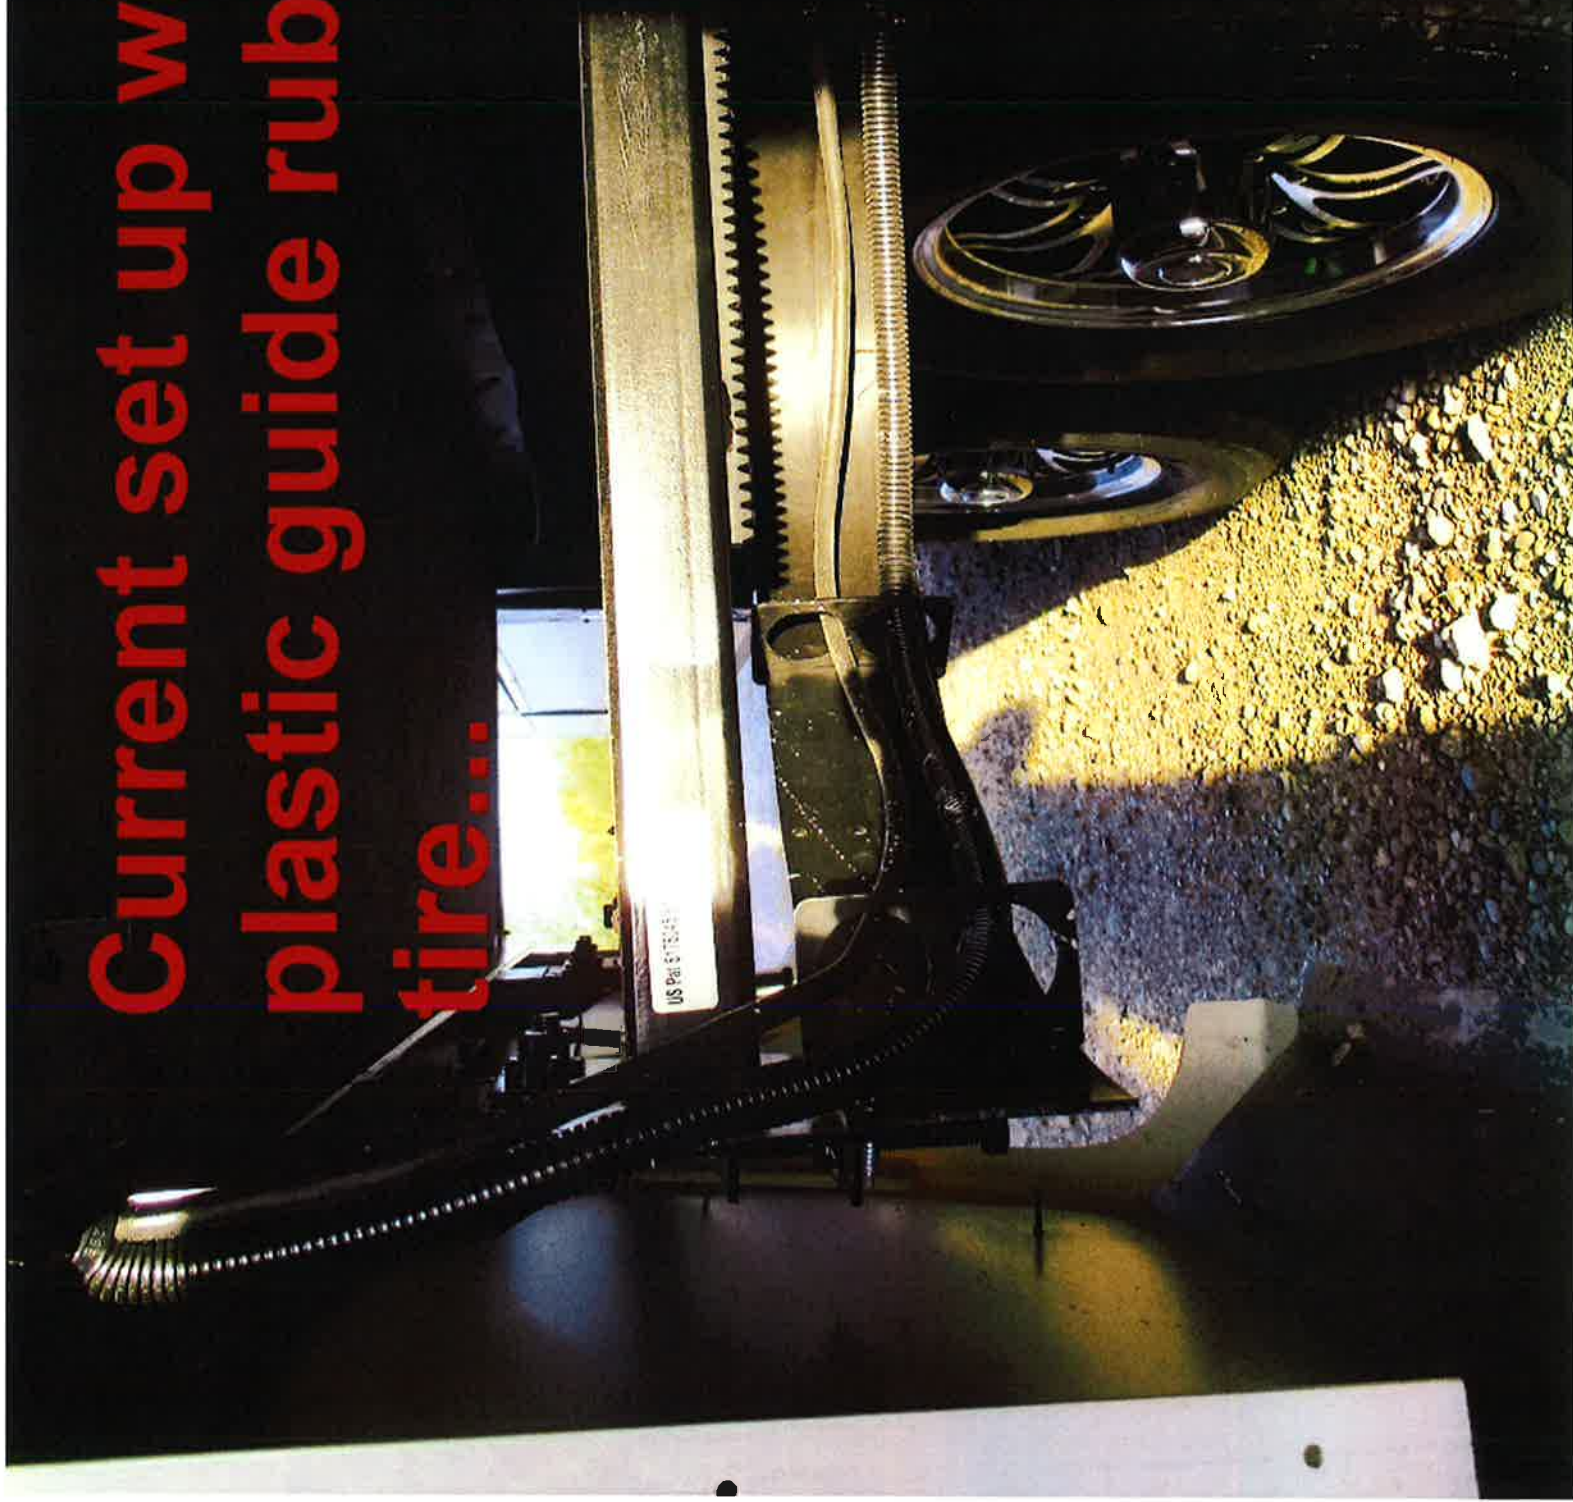
Under the door-side slide out and in the travel mode, the plastic wire guide/belt could fall within 2-3" of the front tire, which is inside the minimum required distance of 4".

Current set up with  
plastic guide rubbing  
tire...
