# Technical Service Bulletin

## 91 Audi connect GEN2: Vehicle Code Entry Fails for Key User with message "Query user list manually"

91 16 94 2045540/2 December 7, 2016. Supersedes Technical Service Bulletin Group 91 number 16-79 dated October 5, 2016 for reasons listed below.

Model(s)	Year	VIN Range	Vehicle-Specific Equipment
A4, Q7	2016 - 2019	All	With Audi connect

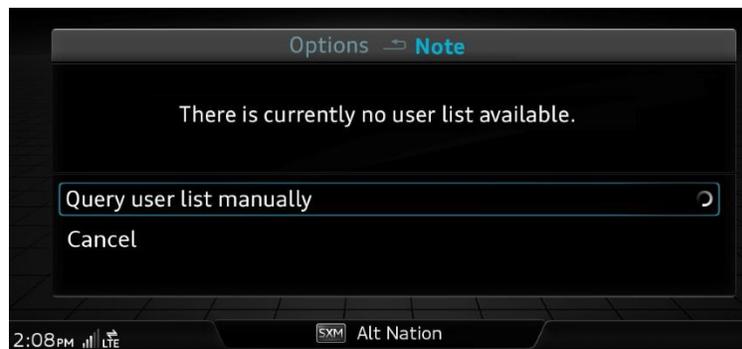
- The customer sees the warning message "There is currently no user list available" (Figure 1) when accessing the Audi connect user management screen in the MMI and cannot enter the vehicle code to become key user.

Figure 1. Warning message.

The connected gateway software will need to be updated and in some cases the hardware may need to be replaced. The customer's vehicle code and myAudi user name will need to be used to setup the Key User if the customer is not already Key User. Replacing the connected data bus diagnostic interface (J533) (address word 0019) will not resolve the condition.

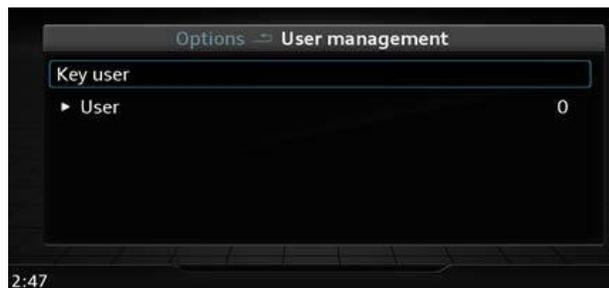
**Figure 2.** User management menu.

2. After the update is complete, park the vehicle outside the shop where there is a good to very good mobile network reception and GPS reception.
3. Switch the ignition on and allow the MMI to fully initialize.
4. Switch the MMI to the Navigation map view and use the MMI Knob to select the right option drawer >> Scroll down to “Save Current Position” >> then view the number of received satellites.
5. Wait until the MMI shows a minimum of “4” satellites. Once the four satellites are received, then go to the next step. A strong GPS signal is required for the vehicle location and time.
6. Go to the Audi connect user management screen by navigating to: *MENU >> Audi connect >> Right option >> Audi connect user management.*
7. Select “Key user” (Figure 2). If the customer’s user name is already entered in the MMI then step 7-10 can be skipped. Proceed to step 11.

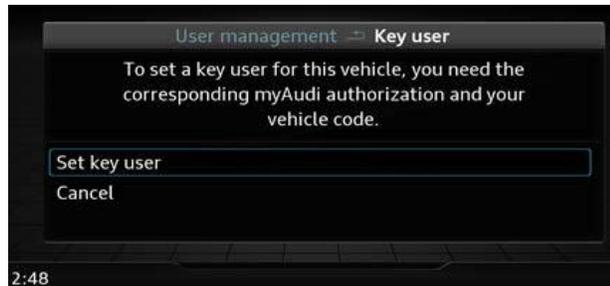
**Figure 3.** Set key user.

8. Select “Set key user” (Figure 3).

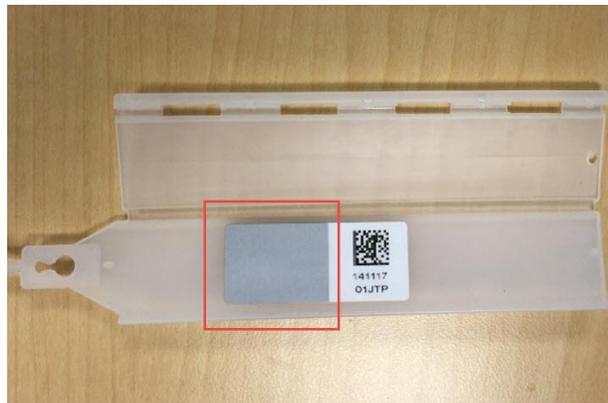
**Figure 4.** Vehicle code (F-PIN)

9. Enter the customer’s vehicle code (Figure 4) and myAudi user name (email address) and select “Log in” (Figure 5).

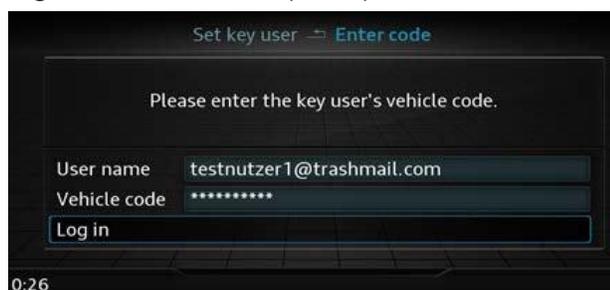
**Figure 5.** Log in.
