Technical Service Bulletin

91 SOS Warning Displayed On Instrument Cluster

91 16 95 2046155/1 December 12, 2016.

Model(s)	Year	VIN Range	Vehicle-Specific Equipment
A4	2017	All	With connected gateway

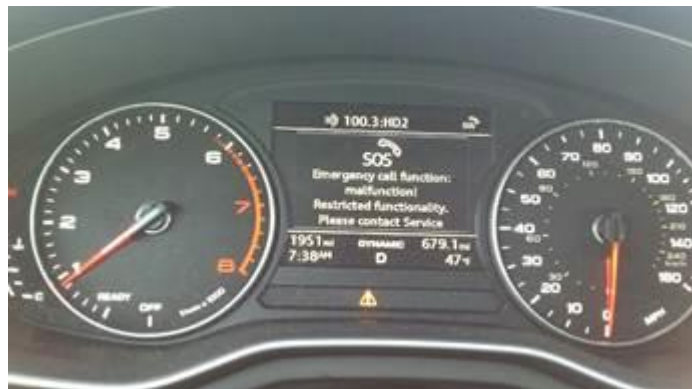
- Customer may report a SOS warning message is displayed on the instrument cluster (Figure 1)
- DTC B105313 GSM antenna Open Circuit stored in connected Gateway Module (databus onboard diagnostic interface) (address word 0019)

Figure 1. SOS warning in instrument cluster.

Poor connection in the coaxial wiring from the Gateway Module J533 to the external R263 antenna.
