# Technical Service Bulletin

## 91 MIB1 Audi connect and Online Services Inoperative with SIM not recognized

91 16 97 2045723/1 December 19, 2016.

Model(s)	Year	VIN Range	Vehicle-Specific Equipment
A3	2015 - 2016	All	MIB High with Audi connect

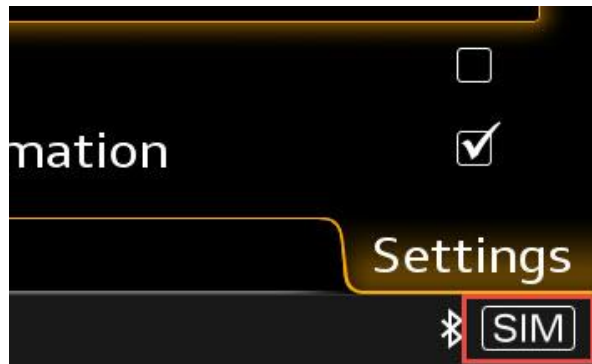
The customer complains no online services are available via the inserted SIM card. The inserted SIM card cannot be recognized by the MMI (Figure 1).

*Figure 1. SIM not recognized*

The internal USB port for the phone module cannot be initialized. Therefore the phone module is not recognized in the Information electronics control module 1 (J794) (address word 005F) and any SIM inserted into the MMI cannot be utilized.

If it is determined the customer's SIM card and Audi connect subscription are okay, and the SIM cannot be recognized in the customer's MMI, then the telephone module must be replaced in the MMI.

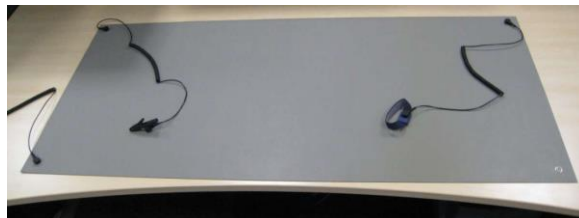
*Figure 3. ESD Work Surface.*

1. **Important:** Before removing the control unit take out all inserted media such as SD cards, CDs, and the SIM card.
2. Remove the Information electronics control module 1 from the vehicle according to the Elsa repair manual.
3. Lay out the ESD work-bay VAS 6613 in an area free of dirt and dust (Figure 3).

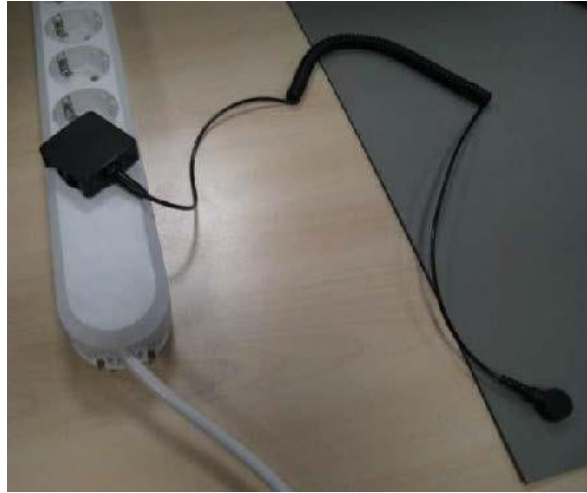
**Figure 4.** Grounded ESD Work Surface.

4. Connect the plug of the ESD work-bay to the grounding outlet (Figure 4). If necessary observe the work-bay instructions provided in the VAS 6613 kit.

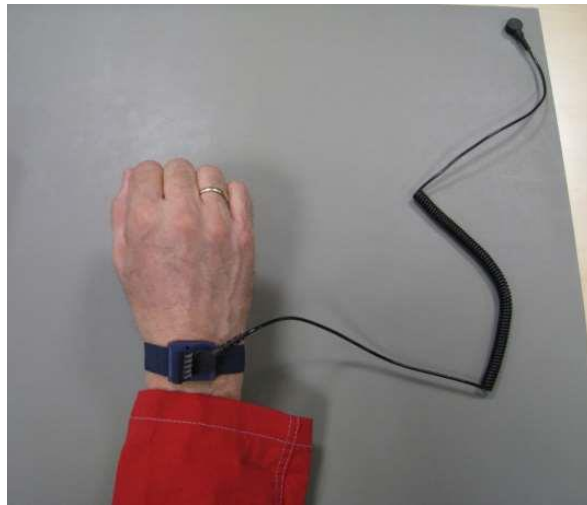
**Figure 5.** Human Ground Strap.

5. Attach the grounding strap (loop) of the ESD work-bay to your wrist (Figure 5).

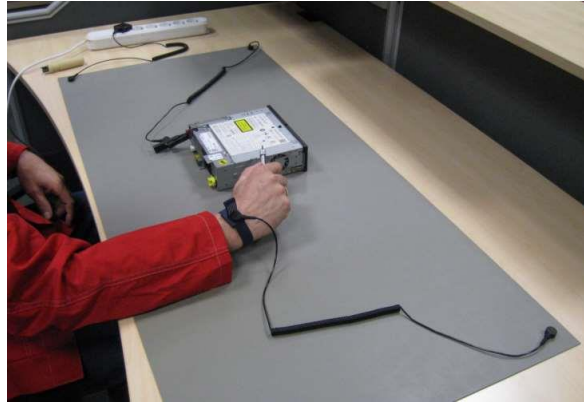
*Figure 6. ESD Complete Setup.*

6. Place the removed Information electronics control module 1 on the ESD work-bay (Figure 6).

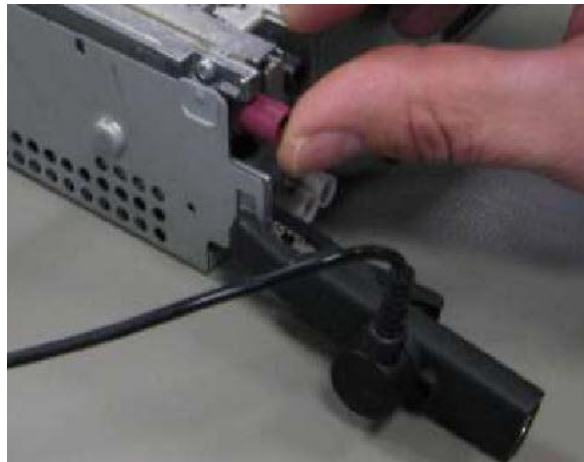
*Figure 7. Alligator clip on MMI housing.*

7. The housing must also be grounded with the alligator clip (Figure 7).

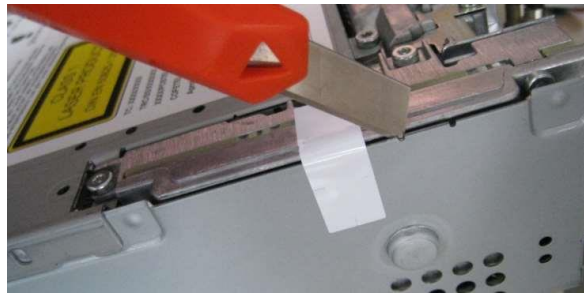
*Figure 8. Warranty Seal.*

8. Cut through the seal of the unit using the utility knife (Figure 8).
