Technical Service Bulletin

91 MIB2 MMI Bluetooth quality at the other end of call is distorted; caller cannot hear driver or hears only an echo

91 16 98 2041925/3 December 21, 2016. Supersedes Technical Service Bulletin Group 91 number 15-15 dated September 23, 2015 for reasons listed below.

Model(s)	Year	VIN Range	Vehicle-Specific Equipment
A6, A7	2016	All	MIB-2 Navigation

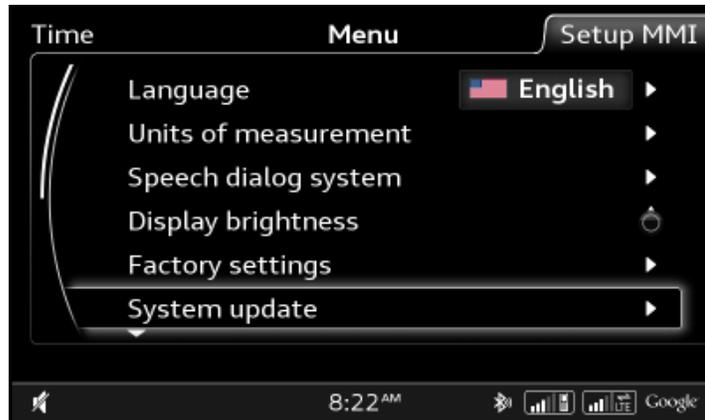
Figure 2. Choose “System Update”.

5. In the menu screen, choose “Setup MMI”, then “System Update” (Figure 2).

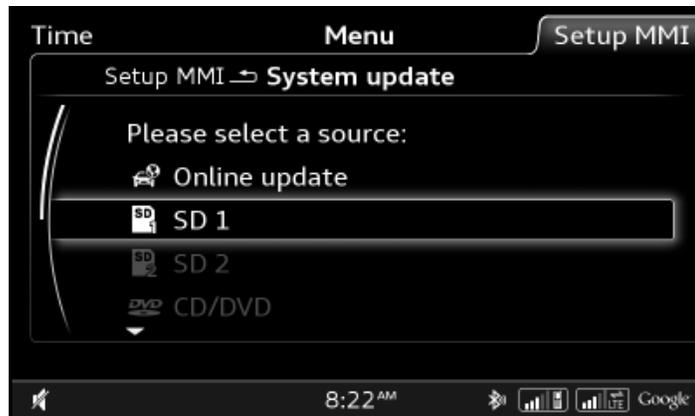
Figure 3. Select the SD card or CD/DVD.

6. Select the SD card or CD/DVD from the list and start the update (Figure 3).
During the update, the SD card or CD/DVD must not be removed (Figure 4).

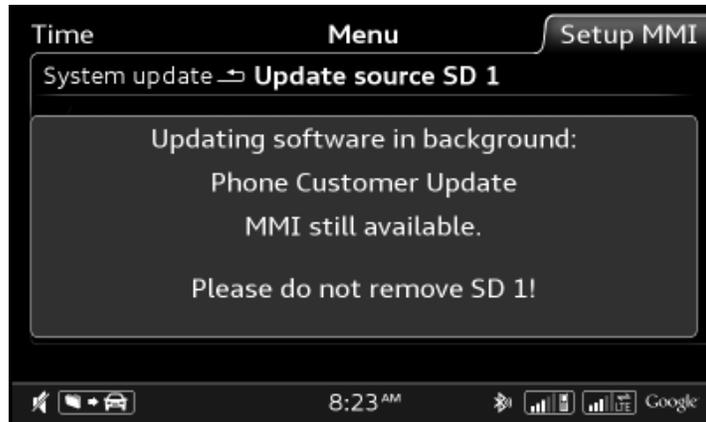
Figure 4. Do not remove SD card (or CD/DVD) during the update.

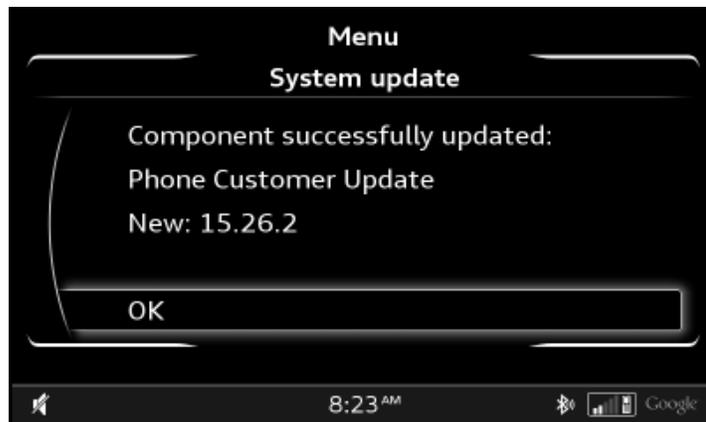
Figure 5. Successful update message.

7. After a successful update, a message will appear in the MMI display (Figure 5).

The SD card or CD/DVD can be removed. The MMI is now fully functional. An MMI reset is not required.
