## Technical product information

| <b>Topic</b> | New Continental GT - GTC and Flying Spur - Steering wheel noise |
| <b>Transaction No.</b> | 2027022/7 |

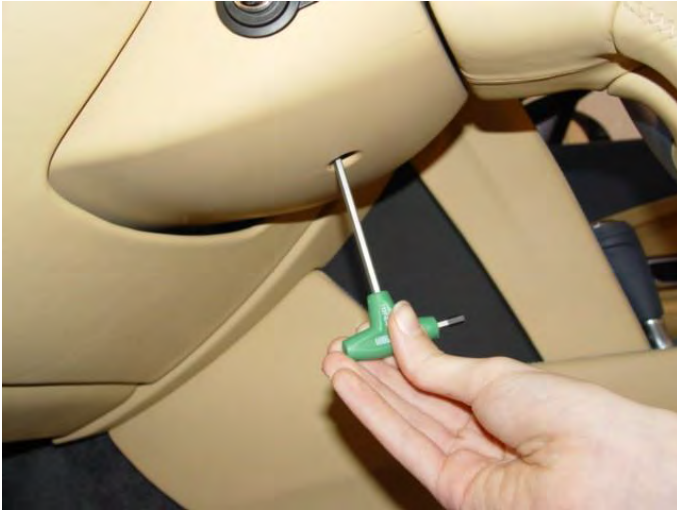
Figure 1

Chafing/grinding noise from the steering wheel/steering column area.

The chafing/grinding noise occurs when turning the steering wheel from lock to lock. The noise is not always evident throughout the full cycle.

1. Slacken off the multi-function steering column (J453) switch 4mm Allen bolt fixing which can be accessed through the steering column lower cowl (Figure 1)

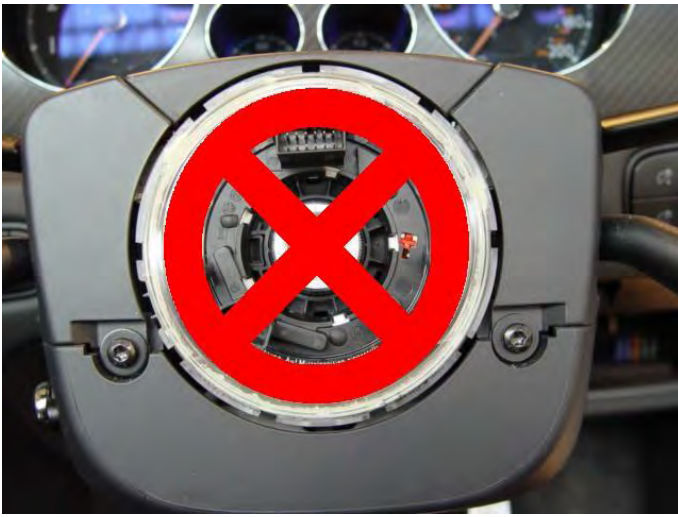
**Figure 3**

**The next procedure requires the steering column multifunction switch to be removed, during the remove and refit process Do Not under any circumstances move or turn any part within the zone shown in Figure 3, the multifunction switch ribbon cable can be damaged, leading to the possible replacement of the multi function switch**

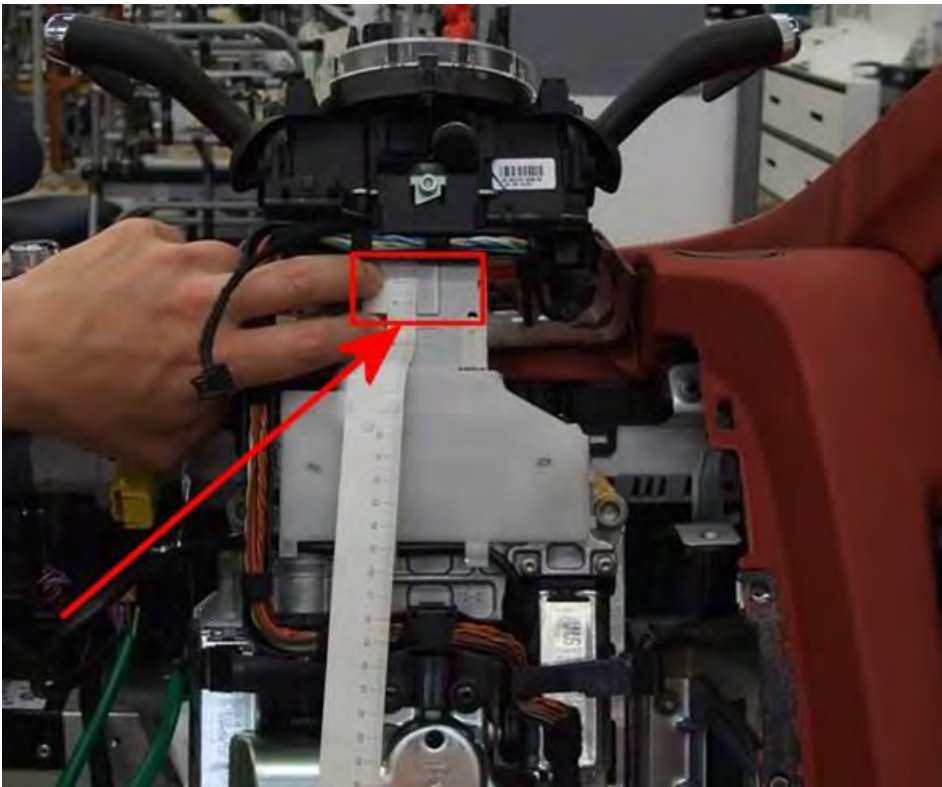
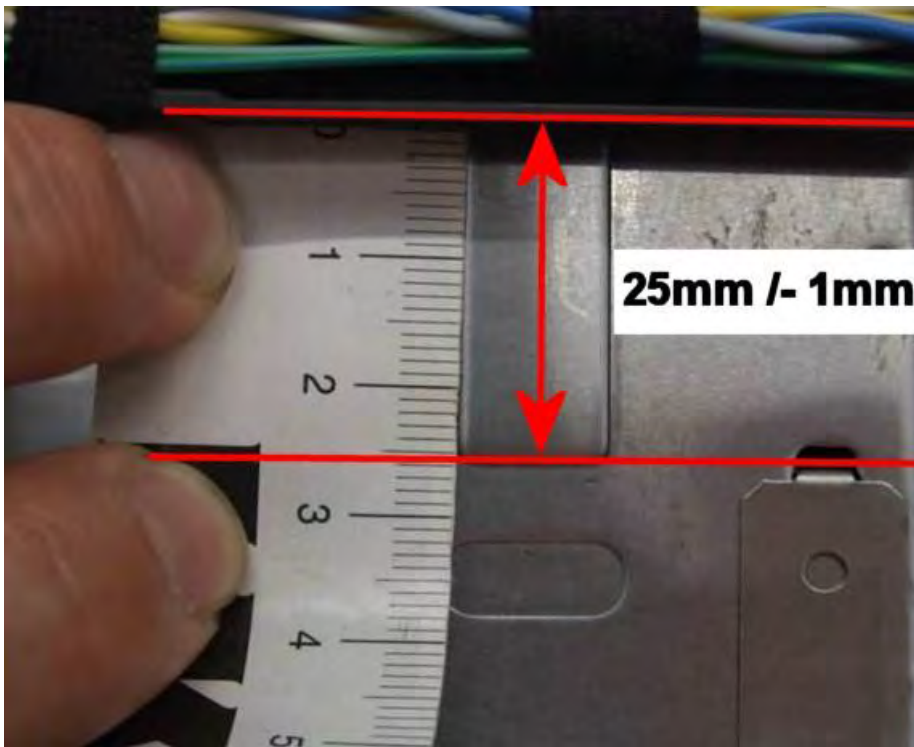
**Figure 4**

- If the distance is over the maximum tolerance of 25mm please investigate further

4. Referring to Figures 4 and 5, check the multi-function switch is between 25mm / -1mm from the indicated datum point (loom carrier to end of datum point), this will confirm the switch is in its natural resting position
