<b>Topic</b>	Blaupunkt premium amplifier software update (ASW 09.07) (SC16/40)
<b>Market area</b>	Bentley: worldwide (2WBE),Hongkong-Macau (5HK)
<b>Brand</b>	Bentley
<b>Transaction No.</b>	2046230/1
<b>Campaign number</b>	EA78
<b>Note</b>	
<b>Type</b>	Workshop Campaign
<b>US code</b>

Workshop Campaign EA78

Blaupunkt premium amplifier software update (ASW 09.07) (SC16/40)

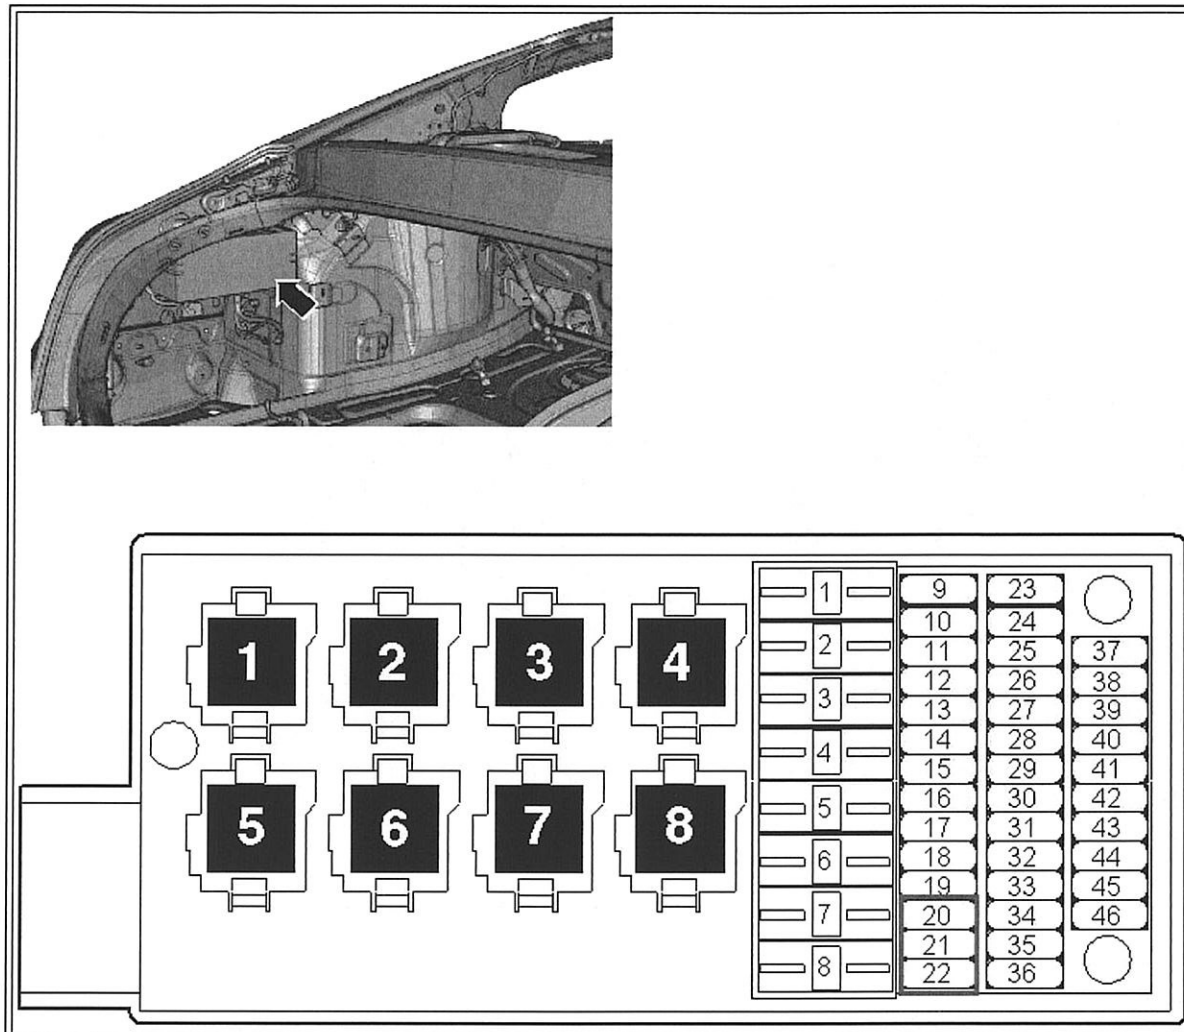
In the event that the audio system fails to function following a diagnostic sweep of the vehicle then perform a hard reset by removing the following audio amplifier fuses waiting one minute before refitting the fuses

Remove and refit fuses 20,21 and 22, fuse box SC

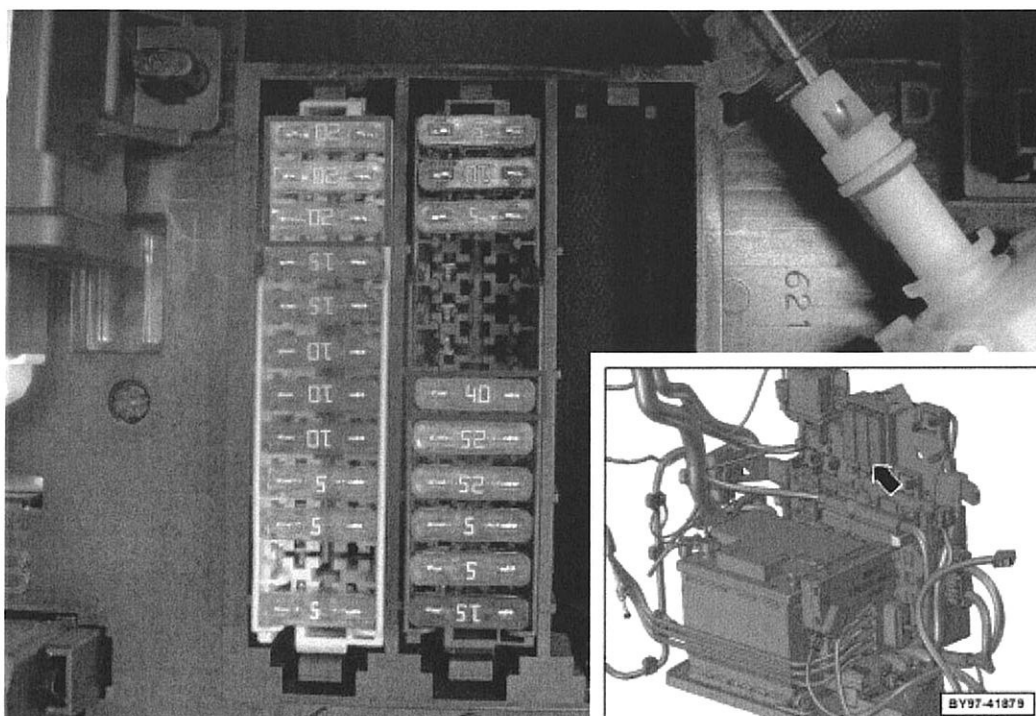
In the event that the audio system fails to function following a diagnostic sweep of the vehicle then perform a hard reset by removing the following audio amplifier fuses waiting one minute before refitting the fuses

Remove and refit fuses 1, 2, 3 and 7 fuse box D
