Technical Service Bulletin

19 Coolant warning light on, coolant level close to or below minimum

19 16 64 2039777/3 January 12, 2016. Supersedes Technical Service Bulletin Group 19 number 15-56 dated February 26, 2015 for reasons listed below.

Model(s)	Year	VIN Range	Vehicle-Specific Equipment
A3	2015 - 2016	All	Not Applicable

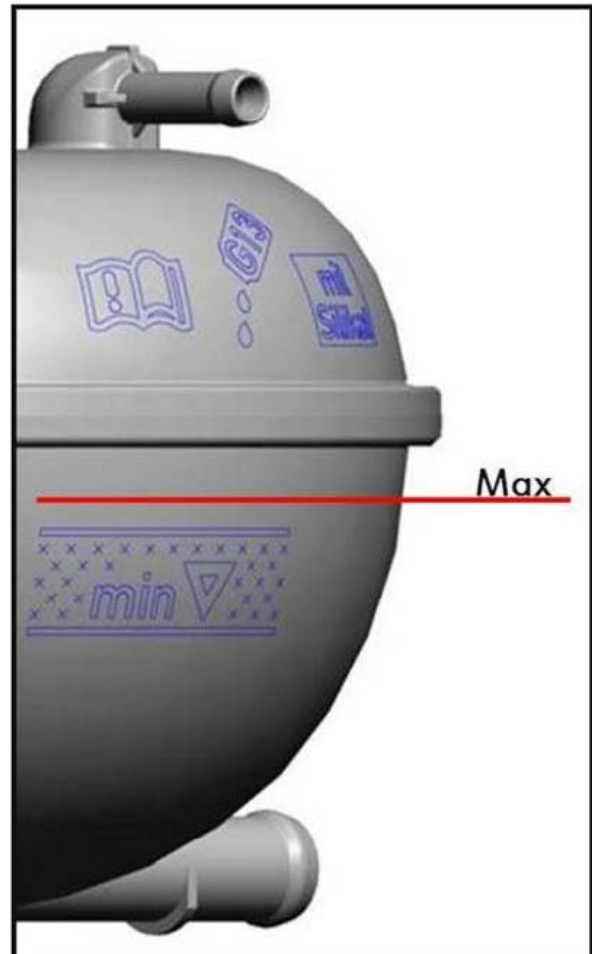
- The coolant temperature warning light is on.
- The coolant level in the coolant expansion tank is close to or below minimum.
- The customer had to top off the coolant several times.

Air gets into the cooling system during production or when refilled during previous repairs. As this air escapes, the coolant level in the coolant expansion tank can drop below the minimum. A drop of the coolant level because of air in the system is possible even after the vehicle has exceeded 15,000 miles. Because of the remaining air, the coolant level can drop a few times.

Figure 1. Coolant fill level.

1. Double-check the cooling system to ensure that there are no leaks causing the condition. Use the instructions in the Elsa repair manual:
 - If no leak is found, top off the coolant level to the mark (Figure 1). No repair is necessary. Explain the *Technical Background* to the customer.
 - If a leak is found, repair the cooling system according to the repair manual.
