# Technical Service Bulletin

## 35 Gearbox warning light on (DTCs P179E00, P179F00, P0700, P060A)

35 16 19 2032211/3 January 11, 2016. Supersedes Technical Service Bulletin Group 35 number 14-17 dated September 25, 2014 for reasons listed below.

Model(s)	Year	VIN Range	Vehicle-Specific Equipment
S4, S5 Cabriolet	2010 - 2014	All	0B5 S tronic
S5, RS5, S6, S7	2013 - 2014	All	0B5 S tronic

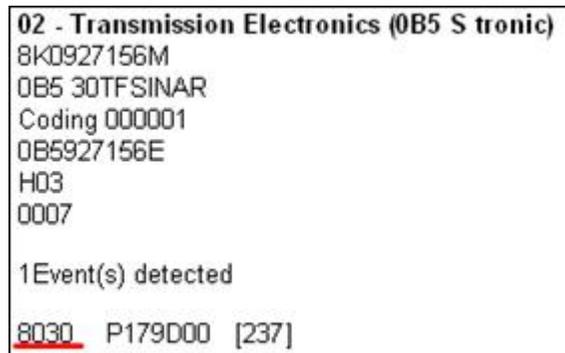
The DFCC is the 4-6 digit code that is typically listed before the fault code (Figure 1).

**Figure 1.** DFCC 4-6 digit code listed before the fault code, underlined in red.

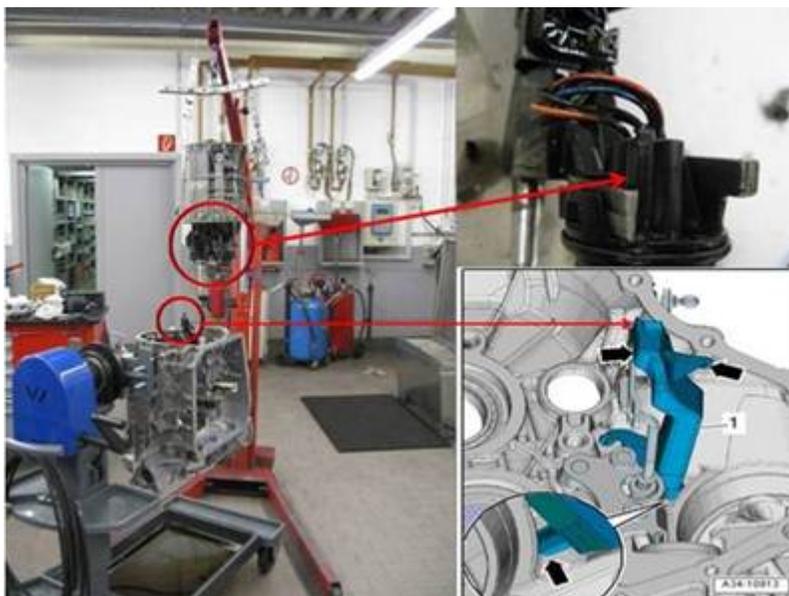
**Figure 2.** Caution points: drip tray and sensor module connector.

**Tip:** Use caution when lifting or lowering intermediate housing to avoid damage to components (Figure 2).
