# Technical Service Bulletin

## 91 Audi connect is not functioning and the message "Please wait.." continually appears

91 16 27 2042942/1 January 26, 2016.

Model(s)	Year	VIN Range	Vehicle-Specific Equipment
Q7	2017	All	With Audi connect

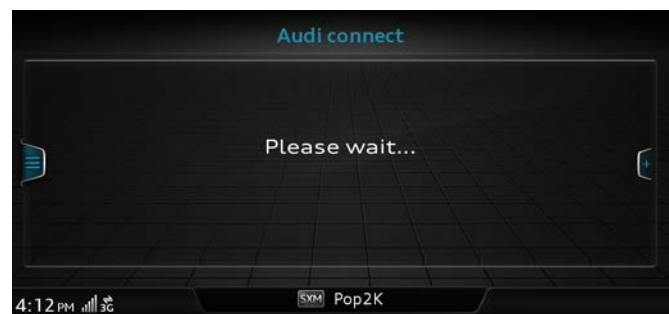
- The Audi connect Gen 2 system does not function.
- The message "Please wait..." continually appears (Figure 1).
- The system might only receive a 3G cellular connection in areas with strong 4G LTE reception.

Figure 1. "Please wait..." message.

It is possible that the Audi connect configuration is incorrect due to a communication issue with the backend server in Germany. A full factory reset of the MMI system is required to fix the incorrect configuration, as a factory reset of only the Audi connect settings may not correct the issue.

Perform a full factory reset of the MMI system using the following instructions. Note that this process will clear all customer configurations in the MMI system.

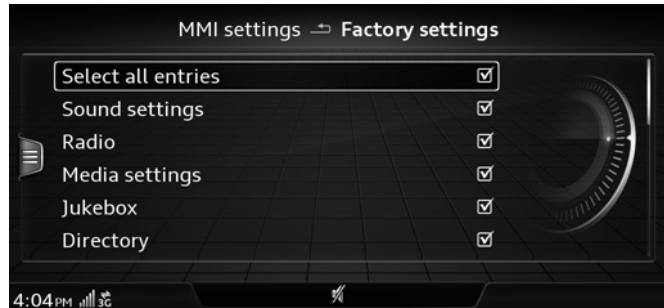
Figure 2. Choose “Select all entries”.

1. In the MMI settings, select “Factory settings”, then “Select all entries” (Figure 2).

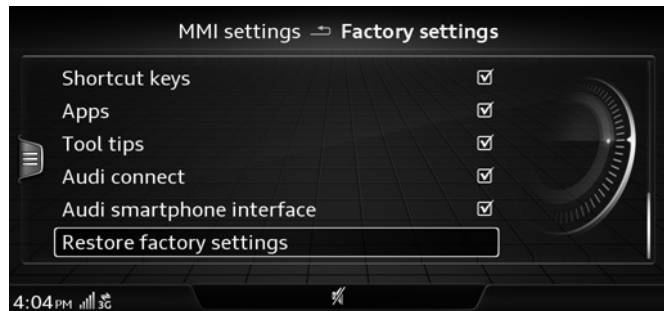
Figure 3. Select “Restore factory settings”.

2. Next, select “Restore factory settings” (Figure 3).

The MMI screen will retract after about 10-15 seconds, then the system will take 1-2 minutes to fully reset.

After the reset, the screen will open. If the screen fails to open after two minutes, press down on the volume knob to force the system to power on.
