## 40 Cracking noise from front end of vehicle when driving direction changed from reverse to forward

40 16 49 2043033/1 February 2, 2016.

Model(s)	Year	VIN Range	Vehicle-Specific Equipment
Q3	2015	000001 - 030788	Not Applicable

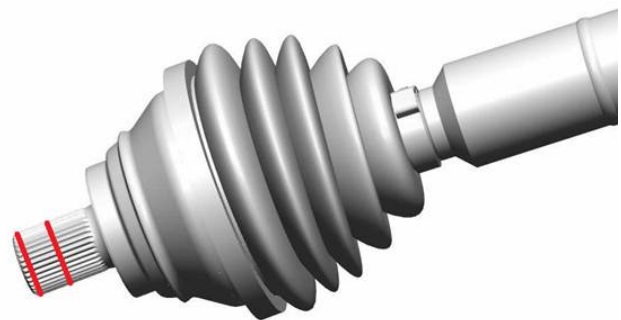
**Figure 1.** Application locations of liquid locking compound.

1. Road test the vehicle to ensure that the *Condition* applies and to determine if the noise is coming from one or both front axles.
2. Remove the affected front axle(s) according to the instructions in Elsa.
3. Clean the axle splines and wheel hub splines to ensure that they are free of debris and grease.
4. Apply two continuous beads of liquid locking compound (part number D 185400A3) to the axle splines. One bead of compound should be near the end of the splines and the other bead should be in the center of the splines (Figure 1).

For proper bonding, the vehicle must not be operated for 8 hours after the repair.
