Technical Service Bulletin

72 Rattle from left rear seat back

72 16 16 2030729/5 February 19, 2016. Supersedes Technical Service Bulletin Group 72 number 13-12 dated October 21, 2013 for reasons listed below.

Model(s)	Year	VIN Range	Vehicle-Specific Equipment
Audi Q5	2009 - 2012	All	Not Applicable
Audi Q5	2013	000001 - 009164	Not Applicable

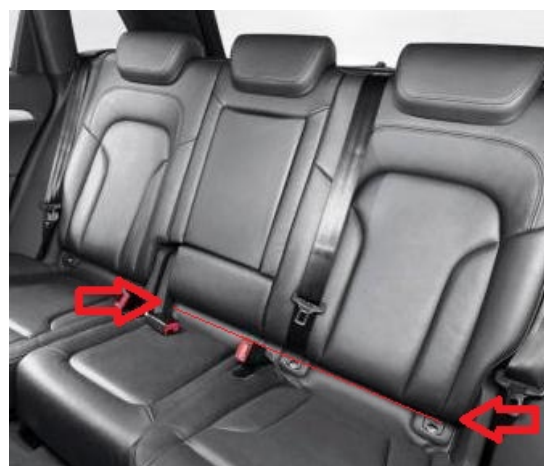
- The rattle sound may be caused from the pivot point of the torsion bar (Figure 1) within the 2/3 rear seat backrest pivot assembly.

Figure 1. Left rear seat noise area marked with red arrows.

Improved 2/3 rear seatback frame torsion bar to pivot incorporating internal plastic guides. The striker pin has also been improved to reduce the contact surface with the lock.

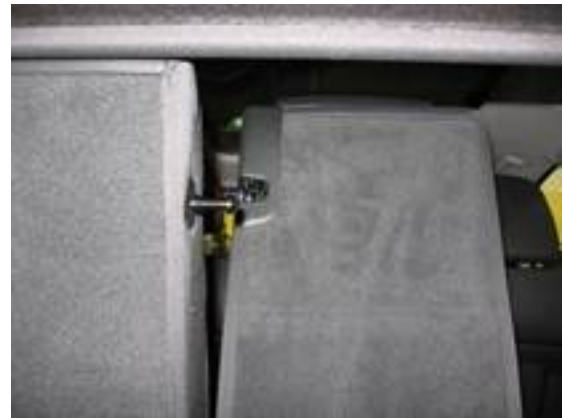
- The squeak noise may be coming from the rear seat armrest area, specifically from the contact surface between the armrest lock and the striker pin (Figure 2).

Figure 2. Armrest lock striker pin.

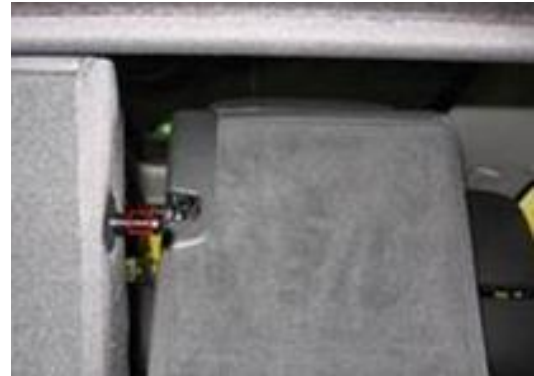
Figure 4. Area of striker pin to be lightly sanded.

1. Confirm that the source of the squeak is the armrest lock.
2. Lightly sand the contact surface of the striker pin to create a “knurled” effect (Figure 4).
