Technical Service Bulletin

72 Rattle from left rear seat back

72 16 17 2030729/6 February 22, 2016. Supersedes Technical Service Bulletin Group 72 number 16-16 dated February 19, 2016 for reasons listed below.

Model(s)	Year	VIN Range	Vehicle-Specific Equipment
Q5	2009 - 2012	All	Not Applicable
Q5	2013	000001 - 009164	Not Applicable

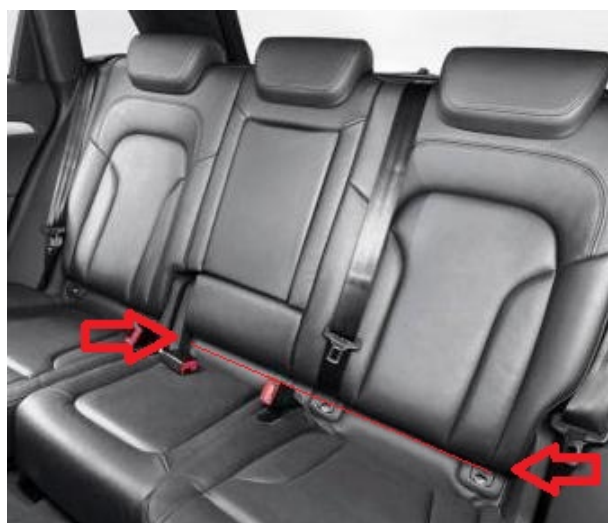
- The rattle sound may be caused from the pivot point of the torsion bar (Figure 1) within the 2/3 rear seat backrest pivot assembly.

Figure 1. Left rear seat noise area marked with red arrows.

Improved 2/3 rear seatback frame torsion bar to pivot incorporating internal plastic guides. The striker pin has also been improved to reduce the contact surface with the lock.

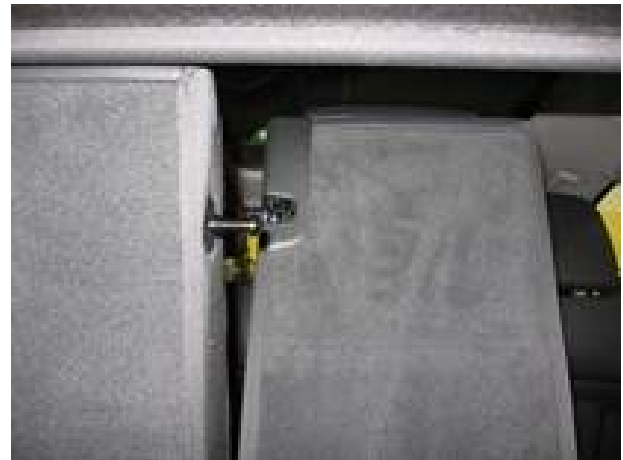
- The squeak noise may be coming from the rear seat armrest area, specifically from the contact surface between the armrest lock and the striker pin (Figure 2).

Figure 2. Armrest lock striker pin.

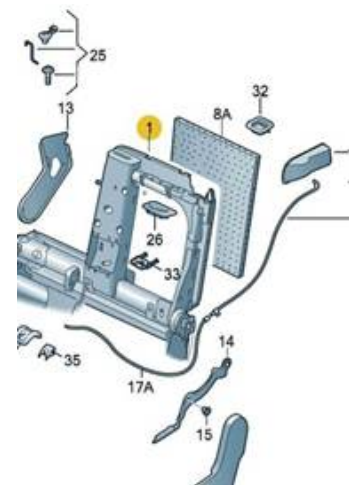
Figure 3. 2/3 seatback frame

1. Start diagnosis by performing a test drive. Sit in the right rear seat of the vehicle while someone drives.
2. Ensure that there are no objects or passengers in the left rear seat, as the rattle is best diagnosed under these conditions.
3. If the 2/3 rear seatback is confirmed as the source of the rattle, the 2/3 rear seatback frame must be replaced because it is not serviceable (Figure 3).

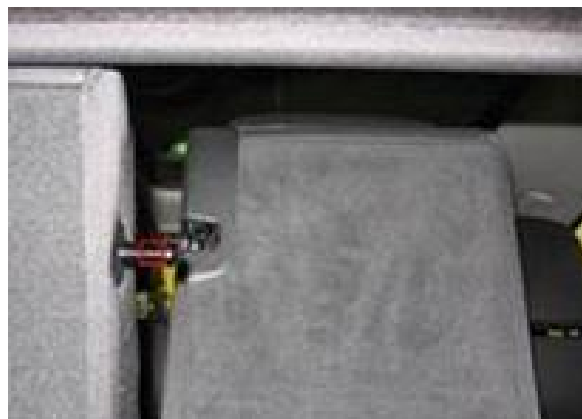
Figure 4. Area of striker pin to be lightly sanded.

1. Confirm that the source of the squeak is the armrest lock.
2. Lightly sand the contact surface of the striker pin to create a “knurled” effect (Figure 4).
