Technical Service Bulletin

91 MMI3G+ Audi connect only reaches 2G service - Telephone module replacement instructions for A4, A5, A5 cab, Q5, Q7, A8

91 16 31 2039476/6 February 25, 2016. Supersedes Technical Service Bulletin Group 91 number 15-21 dated October 16, 2015 for reasons listed below.

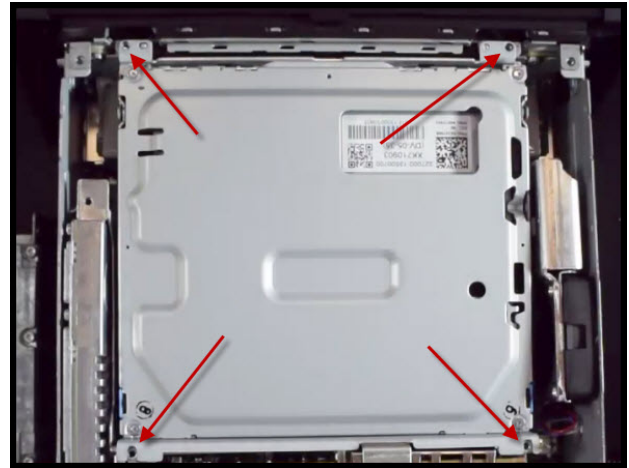
Figure 9. CD drive mounting points are free to move.

Do not flip the main unit over at this point. The CD drive, which was held in place by the top cover screws, is no longer secured. If it moves significantly, the ribbon cable can detach from the circuit board and disable the CD drive's functionality (Figure 9).
