Technical Service Bulletin

91 MMI3G+ Audi connect only reaches 2G service - Telephone module replacement instructions for A6 & A7

91 16 30 2039515/6 February 25, 2016. Supersedes Technical Service Bulletin Group 91 number 15-20 dated October 16, 2015 for reasons listed below.

Model(s)	Year	VIN Range	Vehicle-Specific Equipment
A6, A7	2011 - 2013	All	Audi connect

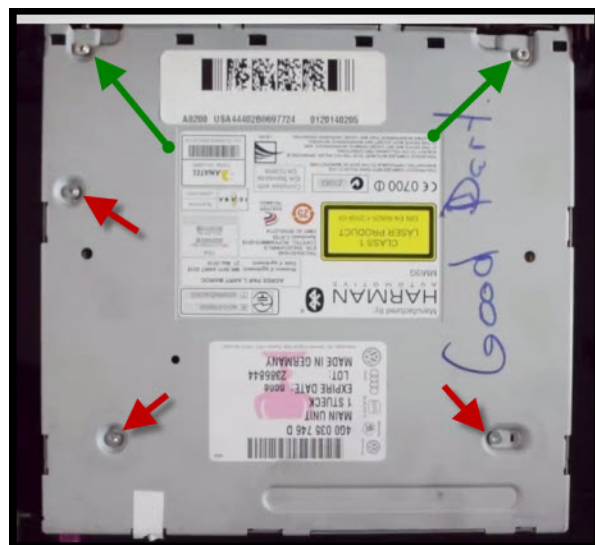
Figure 6. MMI main unit with screw locations for top cover.

7. Start by touching the screw driver to the ESD mat to discharge any static that may be built up in the tool. Next, remove the five screws that are holding the MMI top cover in place. The two screws near the faceplate (Figure 6, green arrows) are longer than the others, have thread lock on them, and may require extra effort to remove. Keep these screws separated from the others at all times.

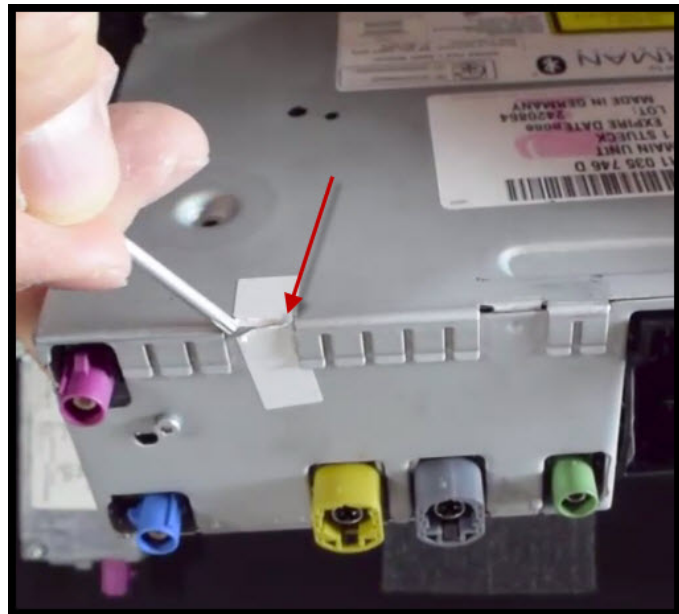
Figure 7. Break the white warranty seal.

8. Break the white warranty seal on the back of the main unit (Figure 7).

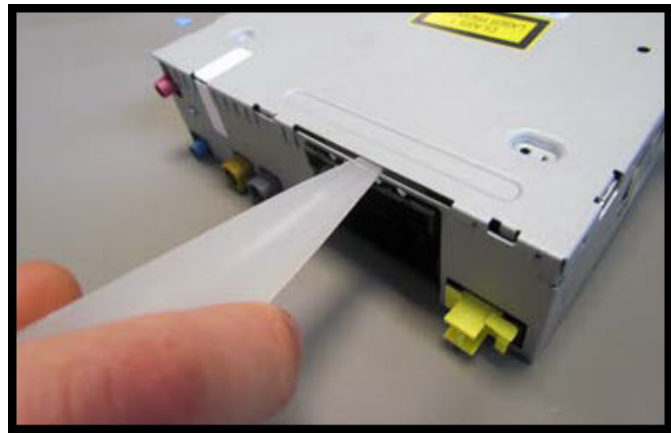
Figure 8. Pry to cover off using plastic trim wedge tool.

9. Using a flat head screw driver, your fingers or a plastic wedge trim tool, remove the top cover by prying it from the back of the cover at the location seen in Figure 8. If a flat head screw driver is used then touch the tool to the ESD mat to discharge the tool prior to touching the main unit.

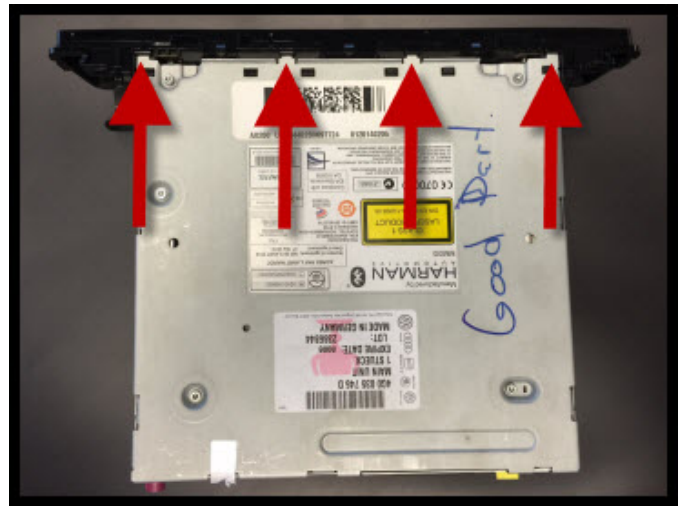
Figure 9. Top cover metal tabs indicated by the red arrows.

The top cover of the main unit has four metal tabs that are slotted into the plastic front face plate (Figure 9). Slightly lift on the rear of the cover and pull back on the cover until the metal tabs are released. Lift up on the cover and pull it away from the face plate at the same time to prevent bending the top cover's metal tabs (Figure 10). If the metal tabs bend during this process, straighten them with a pair of pliers.

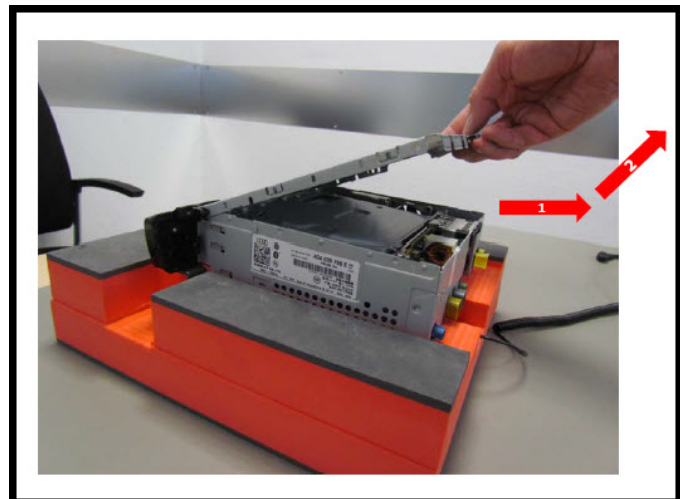
Figure 10. Pull up and back to prevent damaging the faceplate slots (Note: the orange/black holder is not required).

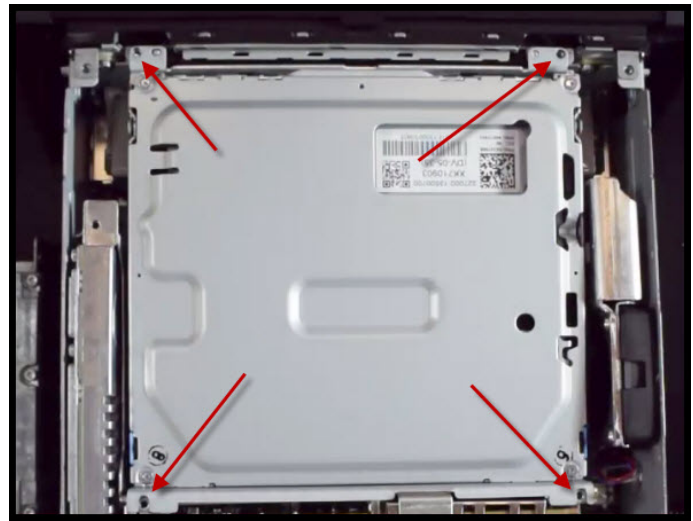
Do not flip the main unit over at this point. The CD drive, which was held in place by the top cover screws, is no longer secured. If the CD drive moves significantly, the ribbon cable can detach from the circuit board and disable the CD drive's functionality (Figure 11).

Figure 11. CD drive mounting points are now free.

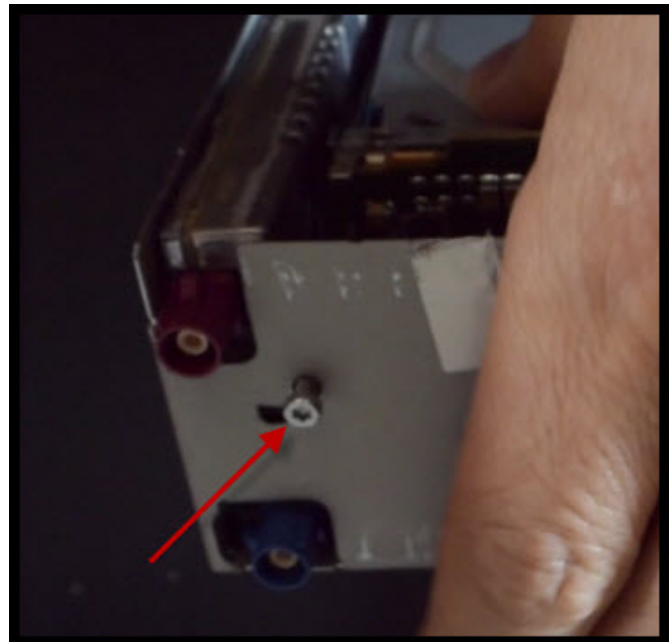
Figure 12. Telephone module retaining screw indicated by the red arrow.

10. On the back of the main unit, remove the retaining screw that holds the telephone module in place (Figure 12).

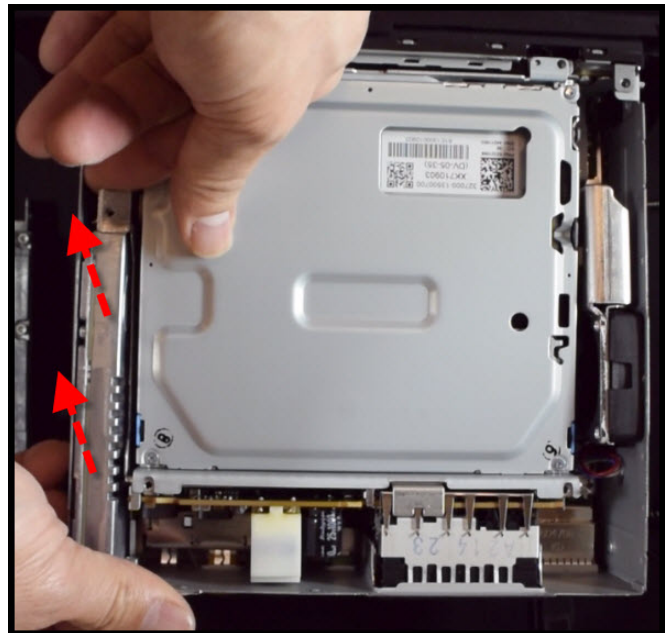
Figure 13. Lift up on both ends of the telephone module as indicated by the red arrows.

- Carefully lift up the telephone module, using both ends as points of contact when pulling up (Figure 13). The module is held in place with a computer socket-type attachment and will release when enough force is used.

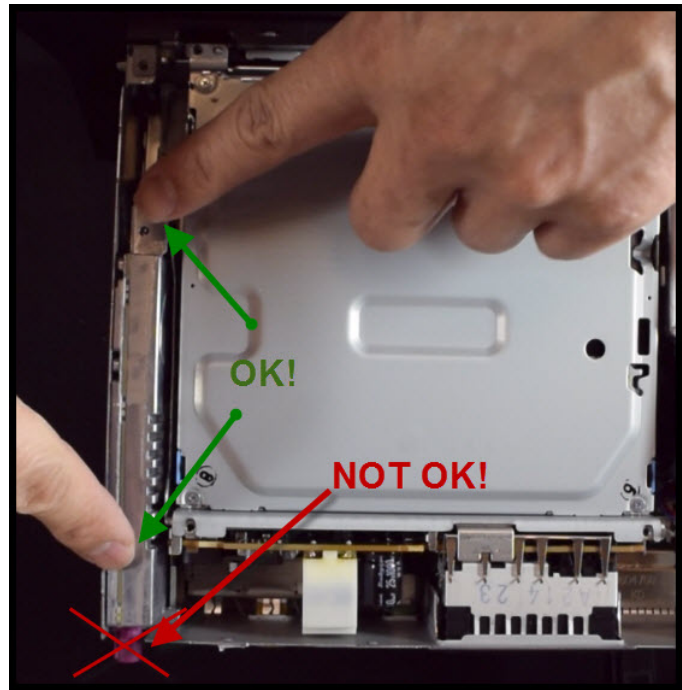
Figure 15. Do not press down using the purple FAKRA connector.

13. Place the new UMTS telephone module into the socket, making sure it is level before snapping it into place. Use both ends of the telephone module when pressing it into place. Do not press down using the purple FAKRA connector (Figure 15).

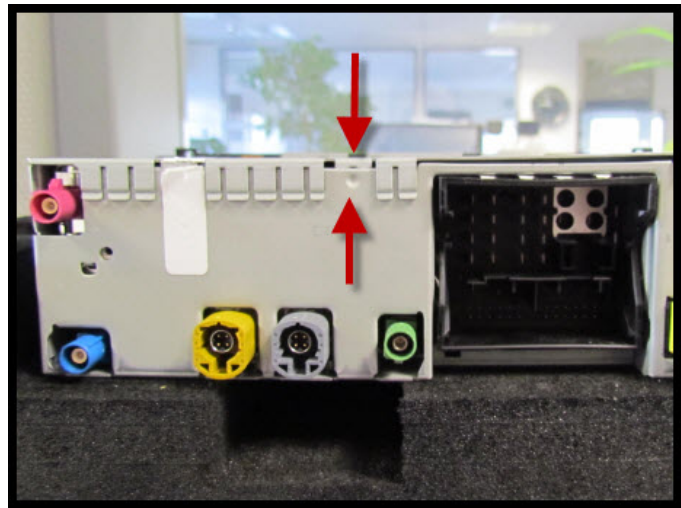
Figure 14. Place the new warranty seal over the location indicated by the red arrows.

17. Place the new warranty seal from the retrofit kit next to the original warranty seal (Figure 14).

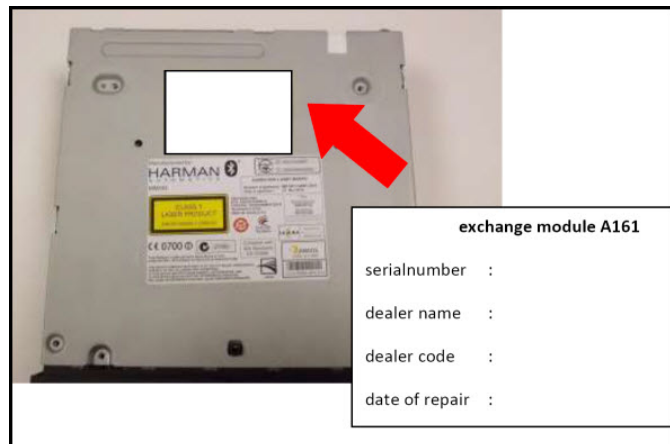
Figure 15. The white area indicates the suggested location for the repair label on the top cover of the main unit. Do not cover any existing part number labels or the laser warning.

18. Place the repair label on the top of the main unit cover. Do not cover any part number label with the repair label and do not cover the yellow laser warning (Figure 15). Fill out all fields on the repair label.

Do not cover the yellow laser warning label. The repair label may need to be placed on sideways due to space limitations
