Technical Service Bulletin

94 Xenon headlights are aimed too low or passenger side is too high

94 16 74 2037810/2 February 29, 2016. Supersedes Technical Service Bulletin Group 94 number 14-45 dated July 22, 2014 for reasons listed below.

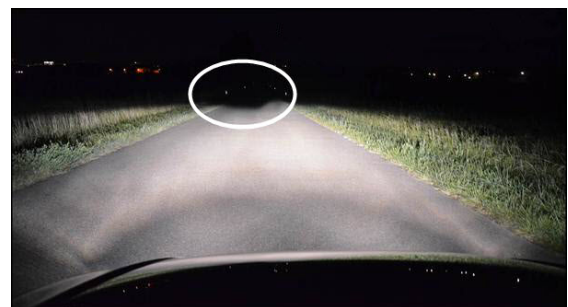
The “dark spot” in the headlight illumination pattern is normal. It is a result of the geometry and structure of the xenon headlight (Figure 1 and Figure 2).

Figure 1. Illumination of xenon headlight.

The xenon headlight meets all legal regulations. This condition is normal. Adjusting or replacing the headlight will not remove the dark spot.

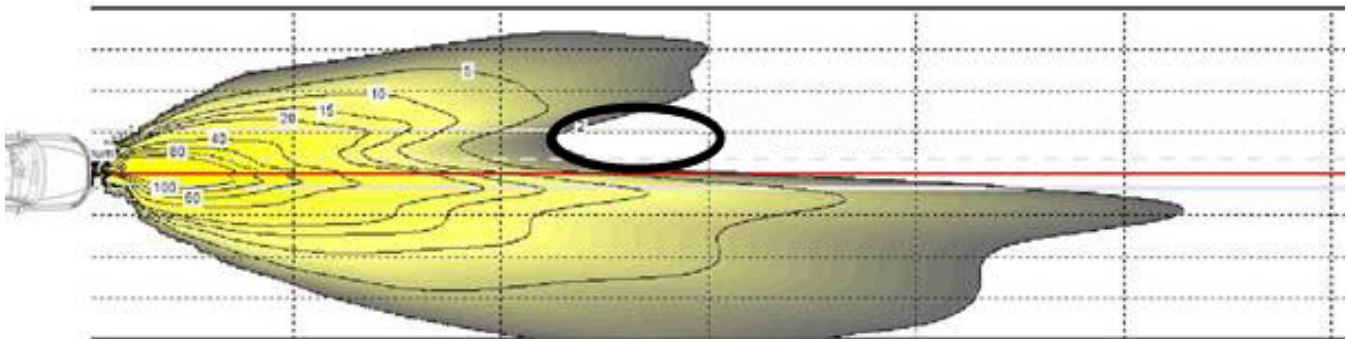
Figure 2. Light distribution of A3 xenon headlights.
