# Technical Service Bulletin

## 01 MIL on (DTC P0491/P0492 secondary air system bank 1/2 through-flow too low/malfunction)

01 16 55 2035002/4 March 14, 2016. Supersedes Technical Service Bulletin Group 01 number 15-47 dated October 22, 2015 for reasons listed below.

Model(s)	Year	VIN Range	Vehicle-Specific Equipment
A8	2010 - 2012	All	4.2FSI

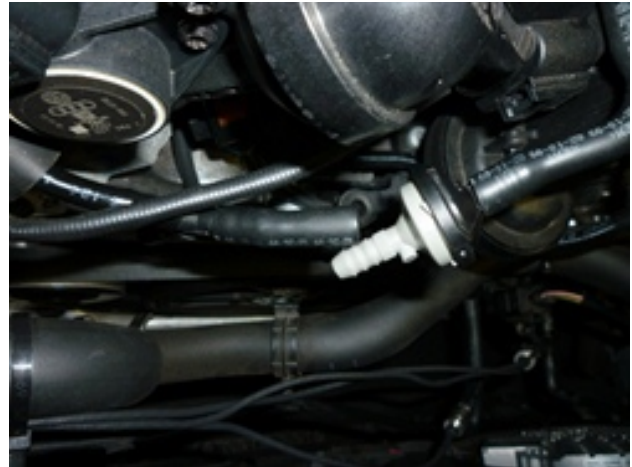
1. Check the vacuum check valve for leaks (Figure 1). The direction of flow should only be towards the intake manifold.

*Figure 1. Vacuum check valve.*

If a leak is found at the check valve, replace the valve and recheck.

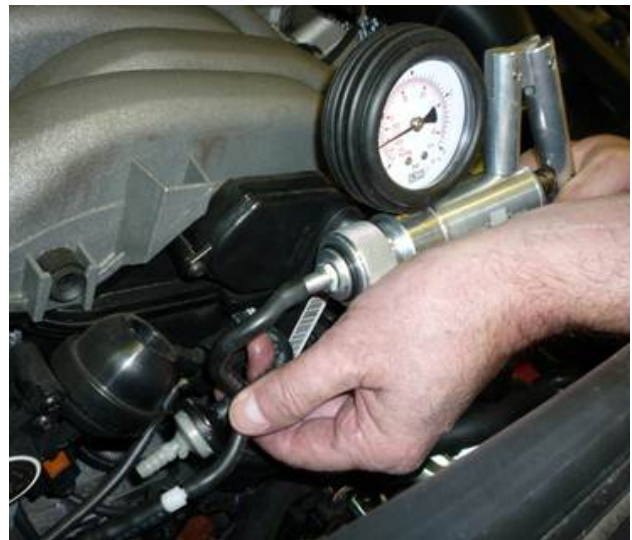
2. With the hose to the check valve disconnected, apply 400 mmHG of vacuum with the VAS 6213 hand vacuum pump (Figure 2).

*Figure 2. VAS 6213 hand vacuum pump*

If the vacuum supply drops during the first 10 minutes of the test, check all pipes of the vacuum system and solenoid changeover valves for leaks. Repair as necessary.
