NUMBER: 18-012-16

Flash: 3.0L Powertrain Diagnostic and System Improvements

2014 (WK) Jeep Grand Cherokee

NOTE: This bulletin applies to vehicles equipped with a 3.0L diesel engine (Sales Code EXF) and 8 speed transmission (Sales Code DFD).

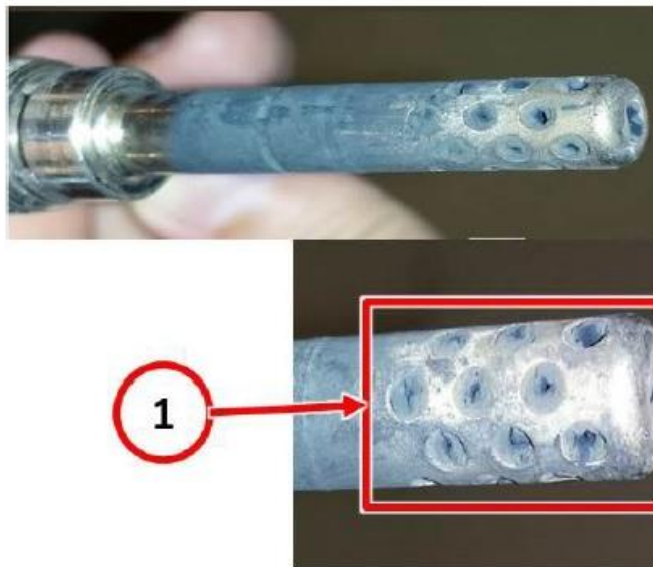
Fig. 1 EGT Sensor Bank 1 Sensor 1

10. Remove the EGT Sensor 1/2 located in the inlet of the Diesel Particulate Filter (DPF)/Diesel Oxidation Catalyst (DOC) assembly. Refer to detailed removal procedures available in DealerCONNECT> TechCONNECT> Service Info Section 11 - Exhaust System> Sensor, Exhaust Temperature> Removal> Exhaust Gas Temperature Sensor 1/2.
11. Remove the Catalyst Temperature Sensor located in the middle of the Diesel Particulate Filter (DPF)/Diesel Oxidation Catalyst (DOC) assembly. Refer to detailed removal procedures available in DealerCONNECT> TechCONNECT> Service Info Section 11 - Exhaust System> Sensor, Exhaust Temperature> Removal> Catalyst Exhaust Temperature Sensor.
12. Inspect the sensor body and probe for any signs of damage or excessive soot. See (Fig. 1).

1 - Excessive soot blocking sensor ports

-
13. Was excessive soot found on the sensor?
 - a. Yes>>> Proceed to [Step #14](#).
 - b. No>>> Proceed to [Step #15](#).
 14. Using shop air set to a maximum of 80 psi, clean all excessive soot from the sensor probe.
 15. Using a suitable multi-meter with appropriate test probes, test the resistance between the sensor connector terminals 1 and 2. With the sensor at room temperature, 65-75 °F (18-25 °C), the resistance should measure between 200 and 240 ohms.
 16. Is the temperature sensor resistance within specifications?
 - a. Yes>>> Install the original EGT sensor 1/2 and/or Catalyst Temperature Sensor. Refer to detailed installation procedures available in DealerCONNECT> TechCONNECT> Service Info Section 11 - Exhaust System> Sensor, Exhaust Temperature> Installation> Exhaust Gas Temperature Sensor 1/2.
