# Service Bulletin

Bulletin No.: 16-NA-042

Date: September, 2016

**Subject: Infotainment System Upgrade for Android Auto Feature**

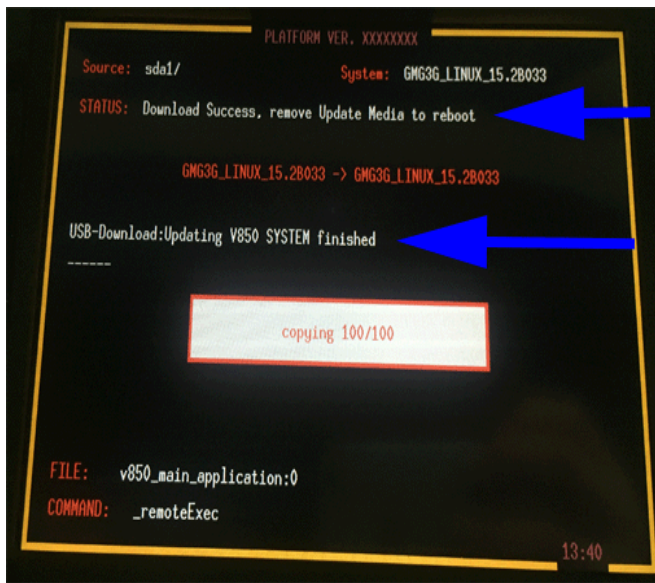
4448895

**Important:** Once the updating file hits 90% the screen may go blank, DO NOT REMOVE the USB at this time. The illustration above shows when the programming is complete. (See blue arrows above.)
