Service Bulletin

Bulletin No.: 16-NA-107

Subject: DTC U0184 Set, Radio Inoperative, Blue Screen, AM Clipping Noise, HD On/Off Status Not Retained in Stations, Time Lag on Transitions, No Audio with Internal Amp, Park Assist Symbol Position Wrong in Rear View Camera

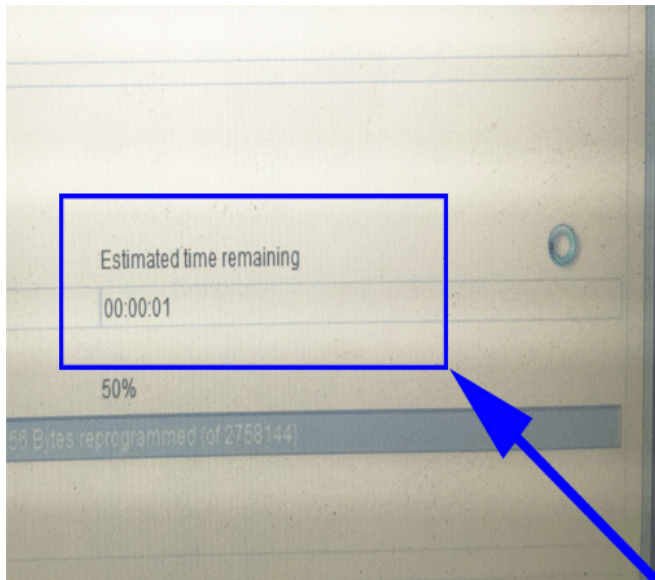
Important: During the SPS procedure, when the estimated time remaining reaches 00:00:01, it may take a few minutes to complete the reprogramming. Be sure to wait until the reprogramming is completed.

If you encounter a vehicle with the above concern, reprogram the radio with the latest calibrations. Refer to the proper SPS radio reprogramming procedure in SI.
