Service Bulletin

Bulletin No.: 16-NA-197

Subject: Sunroof Glass and/or Sunroof Sunshade Inoperative

Brand:	Model:	Model Year:		VIN:		Engine:	Transmission:
		from	to	from	to		
Buick	LaCrosse	2017	2017				
Cadillac	CT6	2016	2016				
Cadillac	XT5	2017	2017				
Chevrolet	Malibu (VIN Z)	2016	2016	March 01, 2016	June 30, 2016

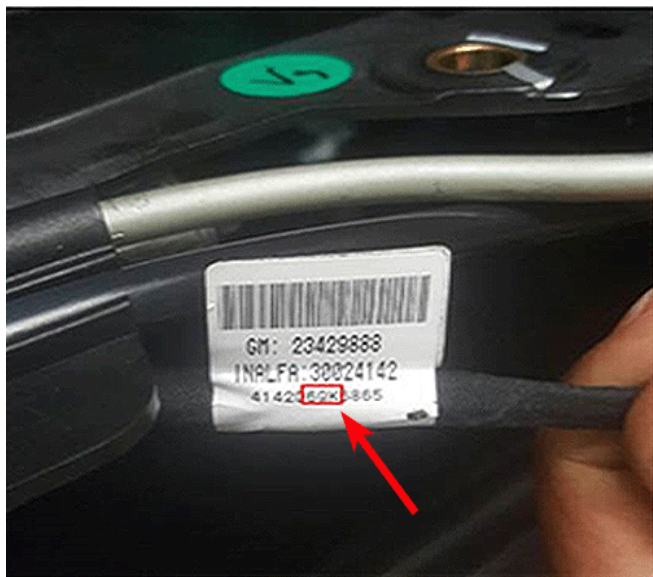
4580218

Follow the information listed below for inspecting the sunroof wiring harness label for date codes.

Date codes

- If the harness code is prior to 6QK (June 25, 2016), then the harness is suspect and needs to be replaced following the procedure below.
- If the harness code is after 6QK, then the sunroof motors should be inspected. Refer to further diagnostics in SI.

Note: DO NOT replace the sunroof motor or sunshade motor for this concern.

Follow the procedure listed below for lowering the rear headliner and replacing the sunroof wiring jumper harness:

1. Disable the SIR system. Refer to *SIR Disabling and Enabling* in SI.
2. Lower the headliner from the rear up to the B-pillar. Refer to *Headlining Trim Panel Replacement (With Sunroof)* in SI.
3. Disconnect the sunroof wiring jumper harness from the sunroof window motor to the headliner harness.
4. Connect the new sunroof wiring jumper harness starting from the sunroof motor while re-clipping it to the headliner down to the headliner harness.
