# Service Bulletin

Bulletin No.: 16-NA-281

**Subject:** Service Advanced Forward Lighting Message Displayed, Malfunction Indicator Light (MIL) Illuminated

Brand:	Model:	Model Year:		VIN:		Engine:	Transmission:
		from	to	from	to		
Buick	Cascada	2016	2016

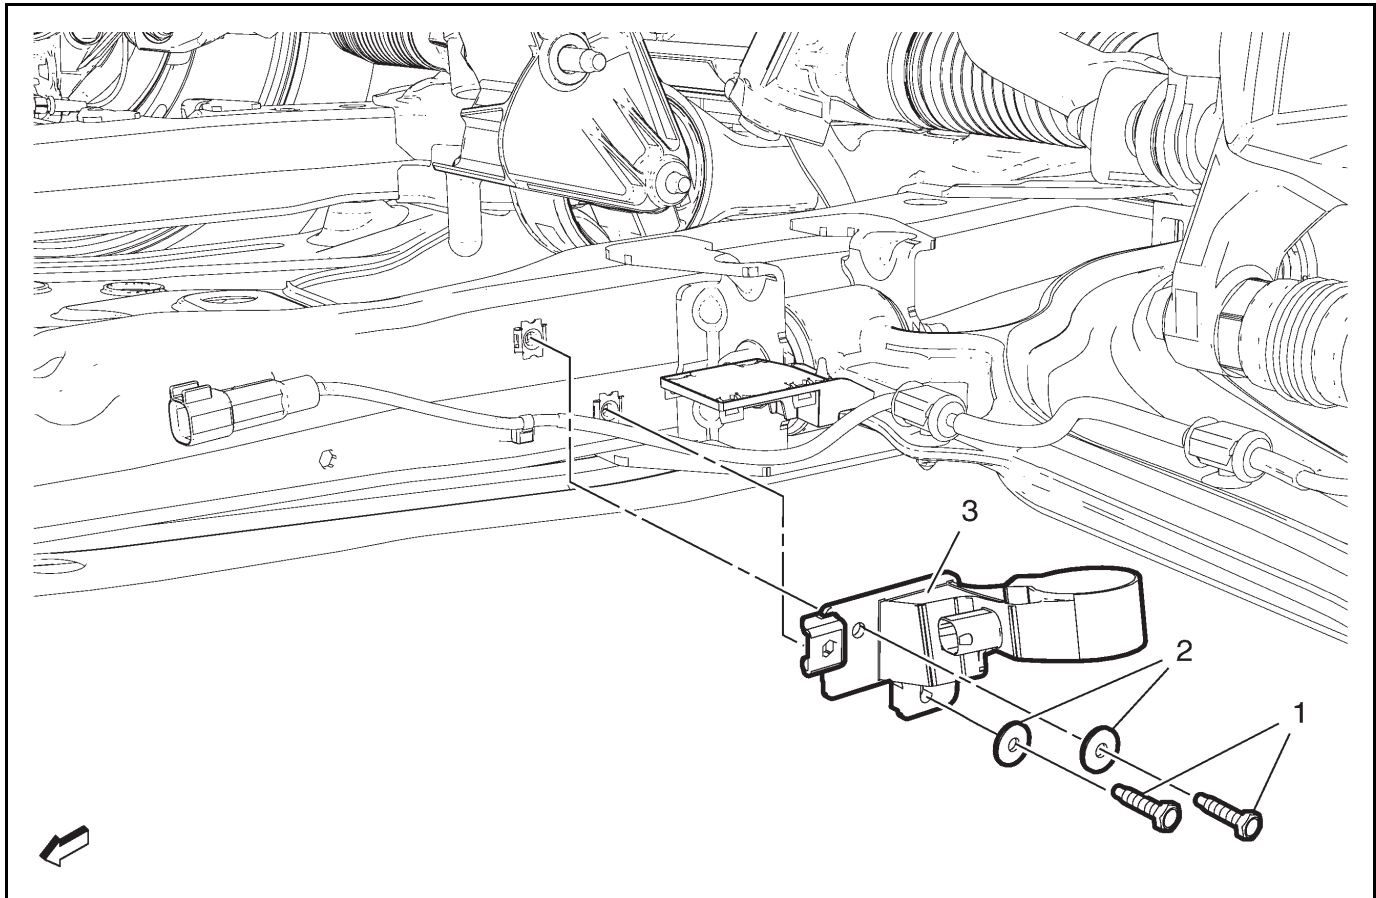
2190255

<b>Involved Region or Country</b>	North America
<b>Condition</b>	Some customers may comment on the following conditions: <ul style="list-style-type: none"><li>• Service Advanced Forward Lighting message displayed in the DIC.</li><li>• Malfunction Indicator Light (MIL) Illuminated.</li></ul> The Technician may find DTC B3410 set.
<b>Cause</b>	A weak solder joint to the printed circuit board in the front level sensor may be causing an intermittent connection.

If the front headlamp leveling sensor (3) has been found to be the cause for the customer concern, the leveling sensor must be replaced.
