Service Bulletin

Bulletin No.: 16-NA-285

Subject: Information on Elimination of Passenger Seat Belt Flop or Knock Noise

Brand:	Model:	Model Year:		VIN:		Engine:	Transmission:
		from	to	from	to		
Buick	Cascada	2016	2017			All	All

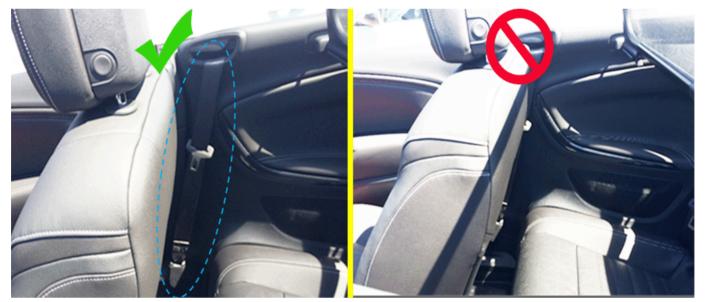
4580022

Involved Region or Country	North America			
Condition	Some customers may comment that when driving with the folding top down and no passenger, the passenger shoulder belt gets caught by the wind and flops or knocks against the B-pillar trim.			
Cause	The cause of the condition may be wind rushing between the seat back and B-Pillar, catching the seat belt and causing it to flop against the trim.

To eliminate, or significantly improve this condition, advise the customer to move the passenger seat forward until the passenger shoulder belt is positioned rearward of the seat back. This will allow the wind to flow around the seat belt instead of having the belt in the middle of the air rush between the seat and the B-pillar.
