Service Bulletin

Bulletin No.: 16-NA-286

Subject: Information on Various Hydraulic Brake Issues that Could Be Seen on Electric/ Hybrid Vehicles and Possible DTC C05AD, C0580 or P05FF

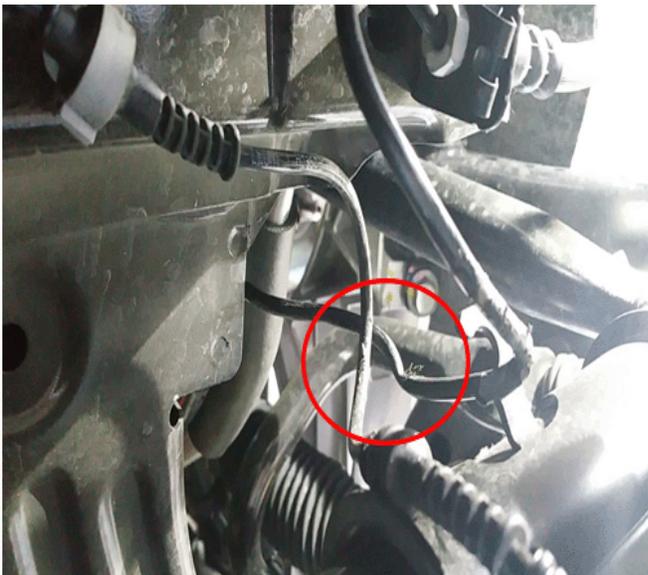
4565441

Kinked Metal Brake Line

Example on the front brake line misrouted, causing the brake line to get kinked from hitting the shock tower when the wheel is turned.

This could cause a concern of brake apply pressure is reduced to the wheel. Could set code C05AD.

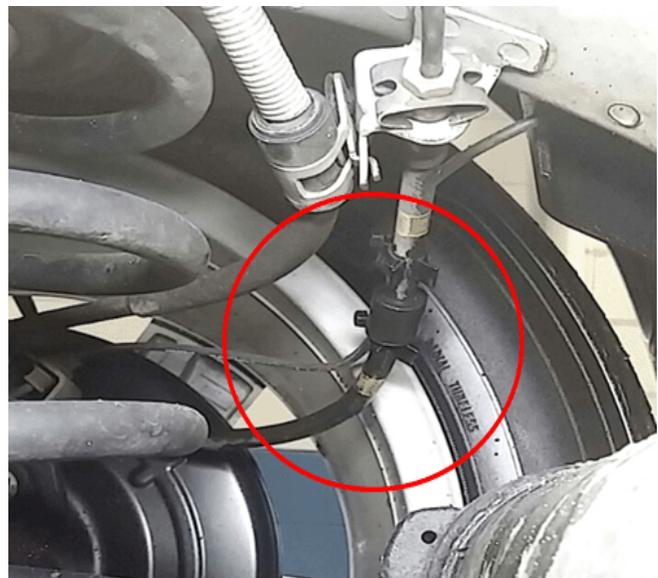
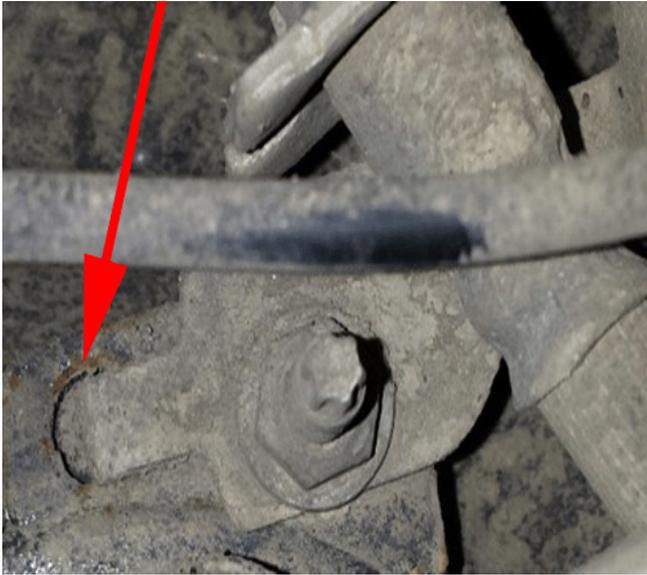
Rubber Brake Hose Rubbing on Tire

Brake hose is misrouted allowing the hose to rub through on the front wheel.
Cause could be the anti-rotation bracket not seated into the hole, which pushes the hose into the wheel.
This could cause a concern of a loss of brake fluid and brake apply. Could cause code(s): C05AD, C0580, P05FF.

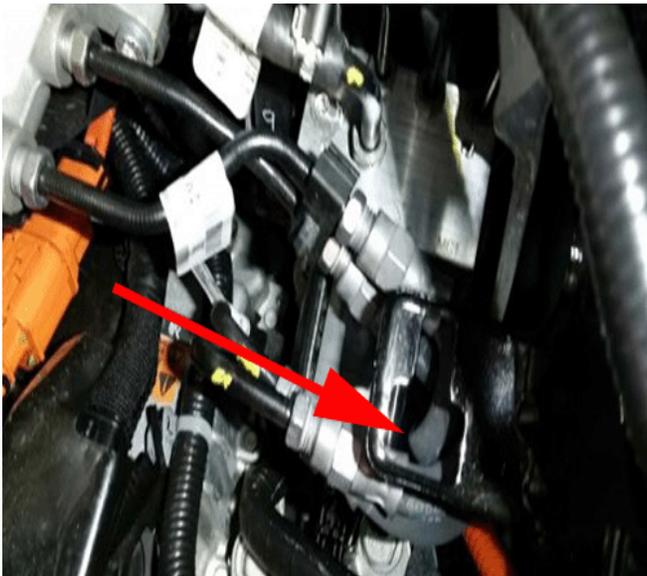
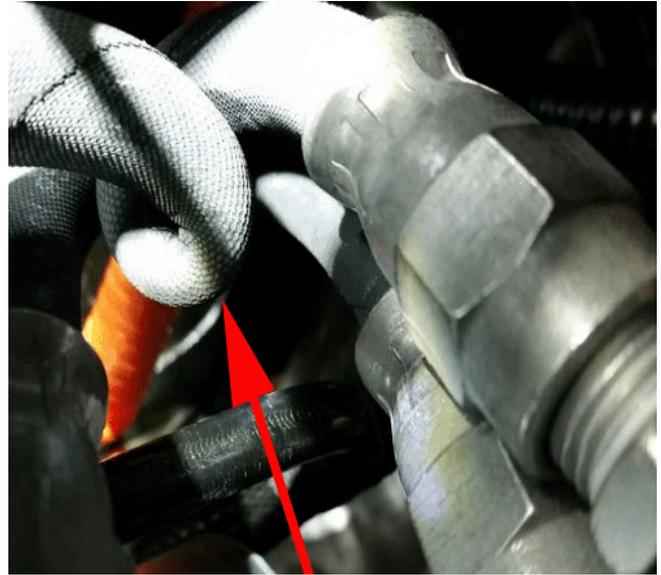
Twisted Rubber Brake Hoses

Master Cylinder (MC) line from Secondary Port to MC2 is found twisted 360 degrees, causing pressure to get trapped in the brake system causing fault.
This could cause a concern at a speed of 45 mph (72 km/h) light coast with a light brake apply C05AD code setting ABS, Traction and Check engine light.

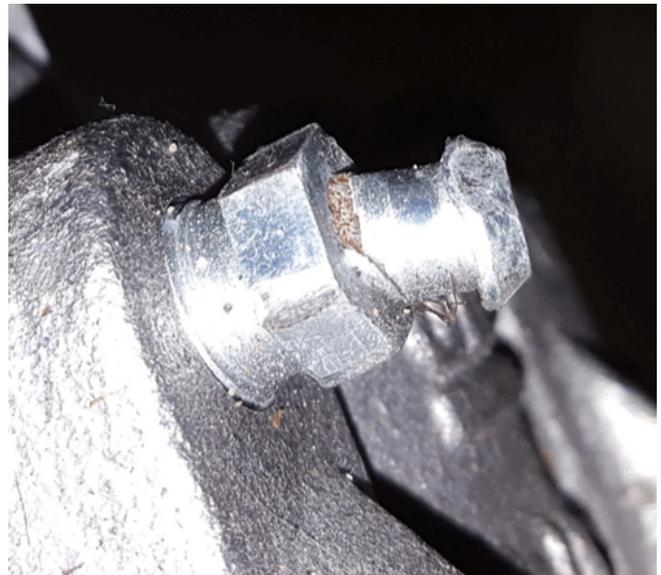
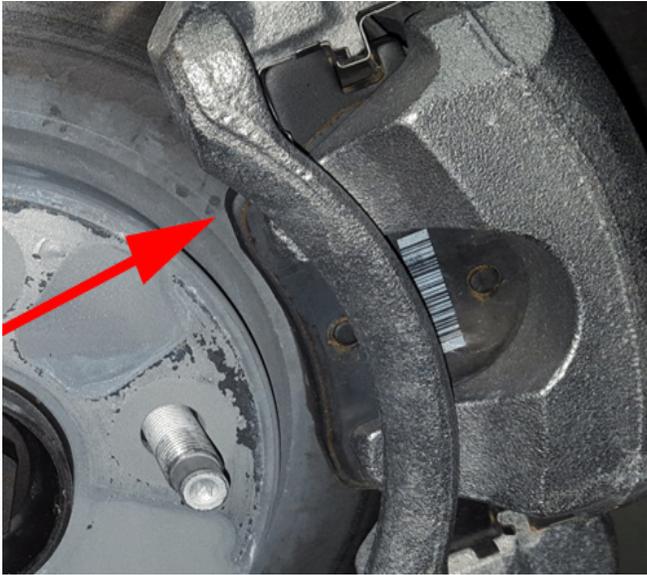
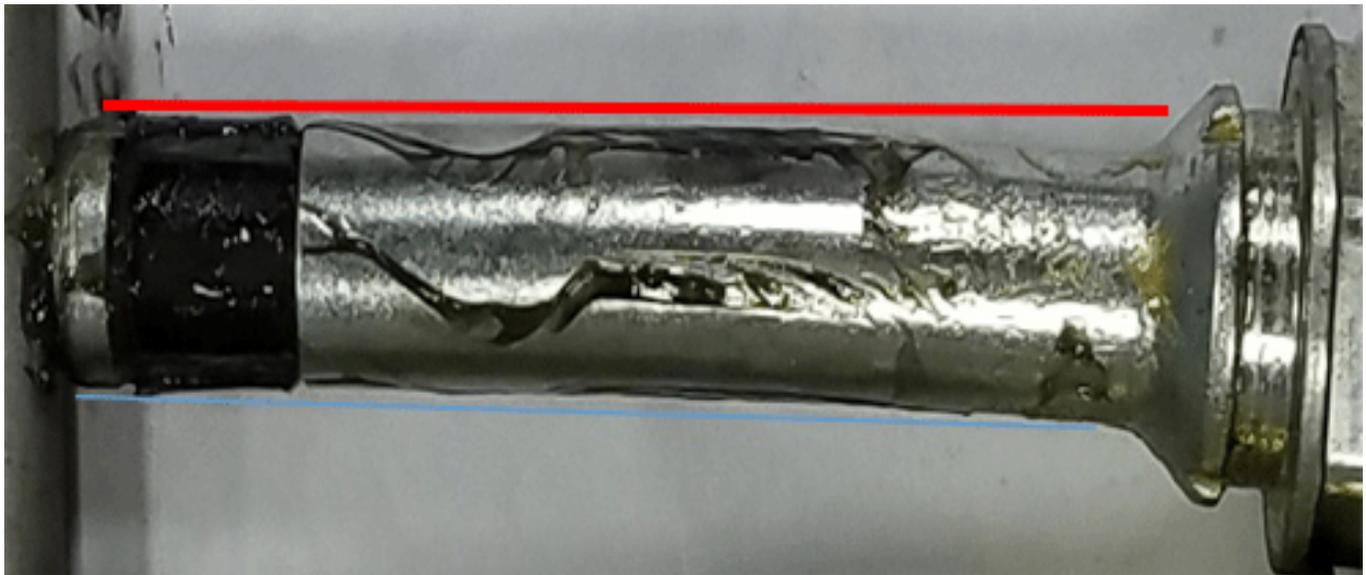
Bent Brake Caliper Slide Pins

Upon visual inspection a technician may find the right front bleeder screw bent/cracked or brake rotor shows uneven pad contact.

Inspection of the guide pins could show a display of a bent caliper guide pins.

This could cause a concern of brake light on, or possible code set C05AD.

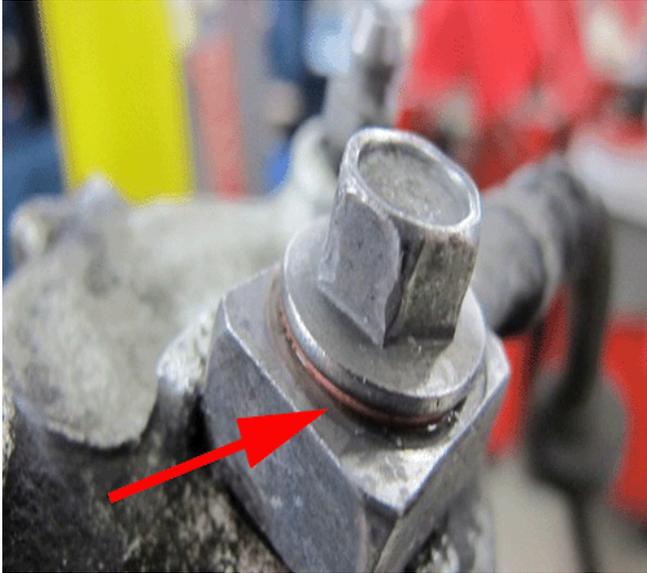
4565445

Leak at Caliper Brake Hose to Caliper

This concern could be caused by a reused brass crush washer causing a leak. The crush washer may have an oval shape and witness lines indicating multiple use.

Important: The brass crush washer can only be used one time. Always discard washer and replace with a new brass crush washers.

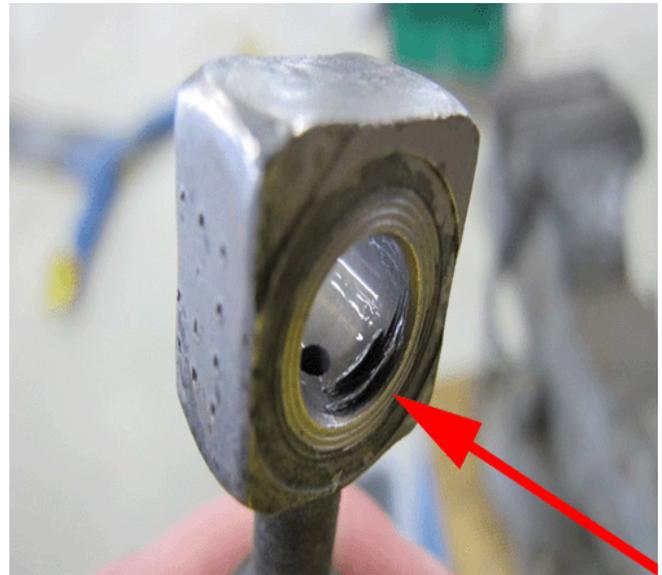
4565446

This concern may also be caused by the crush washer bolt being cross-threaded and retightened as illustrated above.

Important: When tightening the crush washer bolt, make sure to finger tight the bolt to guide to avoid cross threading when reinstalling.
