Service Bulletin

Bulletin No.: 16-NA-289

Subject: Front Seat Back Cover Material Pulling Loose Around Easy Entry Release Handle

Brand:	Model:	Model Year:		VIN:		Engine:	Transmission:
		from	to	from	to		
Chevrolet	Camaro	2016	2017			All	All

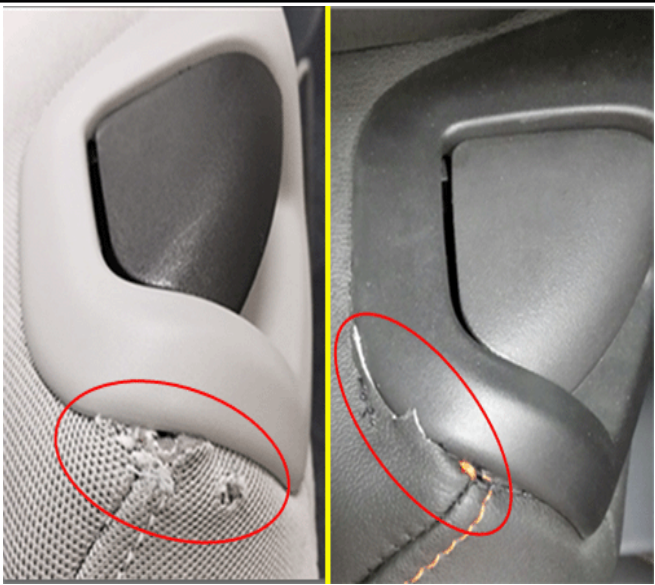
<p style="text-align: right; font-size: small;">4581014</p> <p>Some customers may comment that the cover material on the driver or passenger seat back is pulling loose around the easy entry release handle bezel. Examples of a cloth and leather seat cover are shown in the graphic above.</p>
Cause	The cause of the condition may be that the cover material is currently not secured underneath the handle.

Install a push pin (referenced in the part table below) to secure the cover material to the underside plastic retainer following the Service Procedure below.
