Service Bulletin

Bulletin No.: 16-NA-291

Subject: Normal HVAC Operation and Mechanical Controls but HVAC Screen of Radio May Freeze After Extended Press AND Hold of Fan Up or Fan Down Control Icons

Brand:	Model:	Model Year:		VIN:		Engine:	Transmission:
		from	to	from	to		
Chevrolet	Volt	2014	2015			All	All

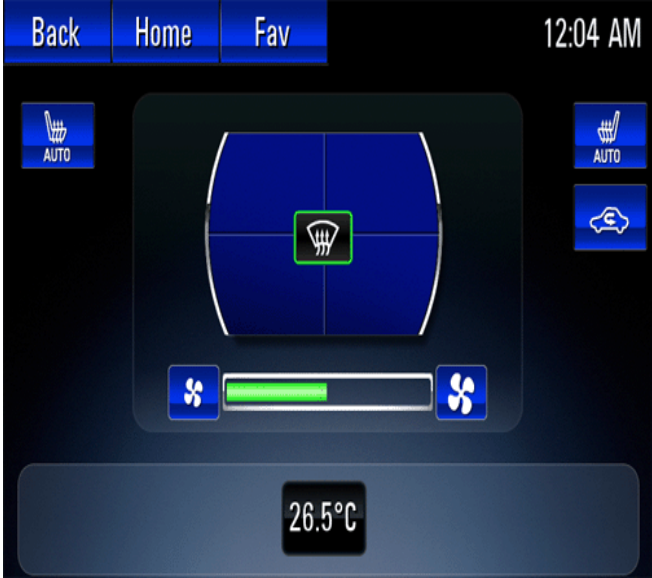
<p style="text-align: right; font-size: small;">4580681</p> <p>On very rare and intermittent occasions, the HVAC screen of the radio may freeze after an extended press AND hold of the "Fan Up" OR "Fan Down" control icons that are on the radio display as shown above.</p> <p>If this occurs, normal operation of the HVAC system and mechanical HVAC control will continue so HVAC performance is not affected.</p> <p>Normal operation of the HVAC screen will also resume during the next ignition cycle.</p>
Cause	This is the result of an internal radio concern.

If you encounter a vehicle with the above concern, replace the radio. Refer to *Radio Replacement* in SI. The replacement radio includes improvements to repair this concern and prevent it from reoccurring.
