Service Bulletin

Bulletin No.: 16-NA-294

Subject: Wave Appearance in Folding Top Cloth Between Number 1 and 2 Bow

Brand:	Model:	Model Year:		VIN:		Engine:	Transmission:
		from	to	from	to		
Chevrolet	Camaro	2011	2012			All	All

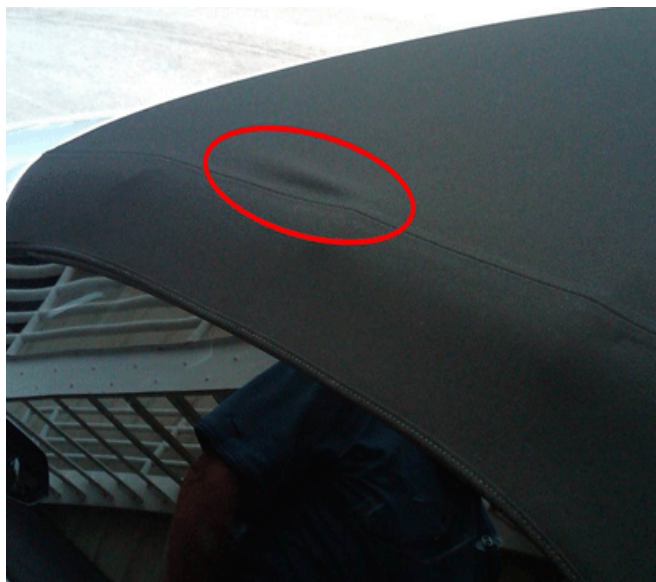
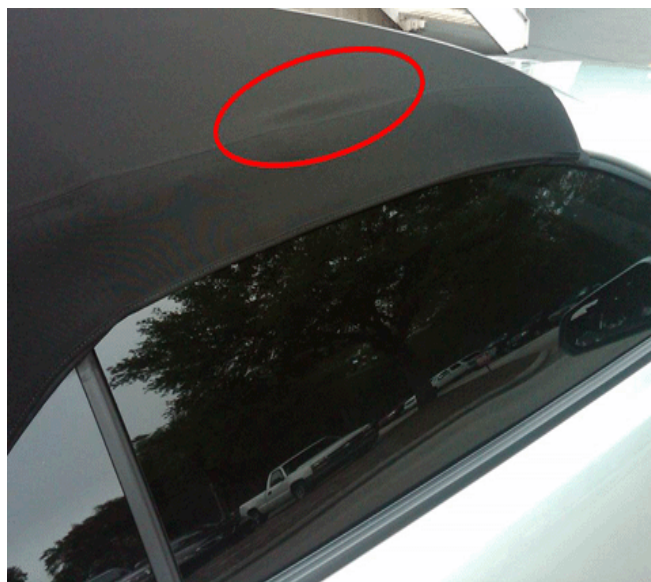
Involved Region or Country	North America, Europe, Middle East, Japan, Russia, Chile
Additional Options (RPO)	Equipped with Convertible Top
Condition	Some customers may comment on a wave in the convertible top cloth between the #1 and #2 bows on either side of the vehicle when the top is closed.
Cause	This may be due to an elastic cord pulling on the underside of the cover. This elastic cord is in place to ensure the top fabric folds properly as the top is opened.

These waves are characteristic of the design and considered normal.

Do not attempt to repair this condition. It is characteristic of design and all vehicles will exhibit this wave. Do not attempt to modify or in any way change the operation of the elastic cords.

Changes or modifications to this cord can result in permanent damage to the folding top, which would not be covered under the vehicle's warranty.
