Service Bulletin

Bulletin No.: 16-NA-298

Subject: Ratchet Click or Grind Noise from Front of Vehicle When Traveling Straight at Slow Speeds

Brand:	Model:	Model Year:		VIN:		Engine:	Transmission:
		from	to	from	to		
Chevrolet	Camaro	2010	2015			All	All

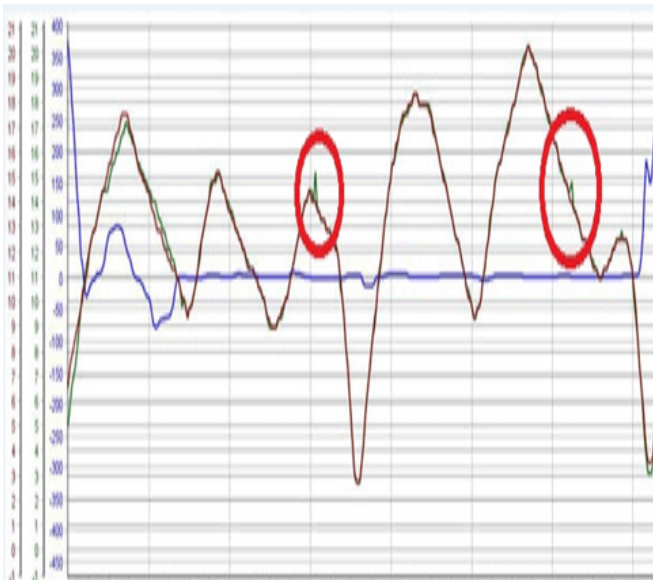
2874501

3. Review EBCM > Antilock Braking Data Session Logs in GDS2, specifically monitoring the WSS (Wheel Speed Sensor) parameters for one of the WSS inputs to either spike up or drop down in a speed inconsistent with the speed reading of the other 3 wheel speed sensors. Typically, a 3 mph or greater variance may be detected in one or more data session logs which will indicate which WSS

and hub bearing need further inspection. In rare cases, it could be as little as 1 mph variance between WSS. It is suggested to use the Line Graph to plot out the Steering Angle Sensor (to know when the car is going straight) and both rear WSS parameters first. To do so, select the parameters you wish to plot by clicking on the parameters in the Diagnostic Display Data Display Tab, then click on the padlock to move that parameter to the top of the list. Once the parameters are selected, move to the Line Graph Tab to view an overlaid plot of the selected parameters. The front WSS parameters can be viewed later if the cause is not found in the rear, but the cause is more common to be found with the rear parameters. You must zoom in to view the fine detail needed to isolate the cause as this is only a slight difference spiking down or up from the other WSS.

In the example above, the vehicle is travelling straight (Steering Column Position in Blue); the Left Rear WSS (Green) is spiking; while the Right Rear WSS (red) is not.

4. Inspect the WSS and the hub bearing for physical damage, contamination or debris.

*If there is contamination or debris, then clean the part, reassemble the vehicle and re-evaluate the concern.

*If there is physical damage, replace the damaged part.

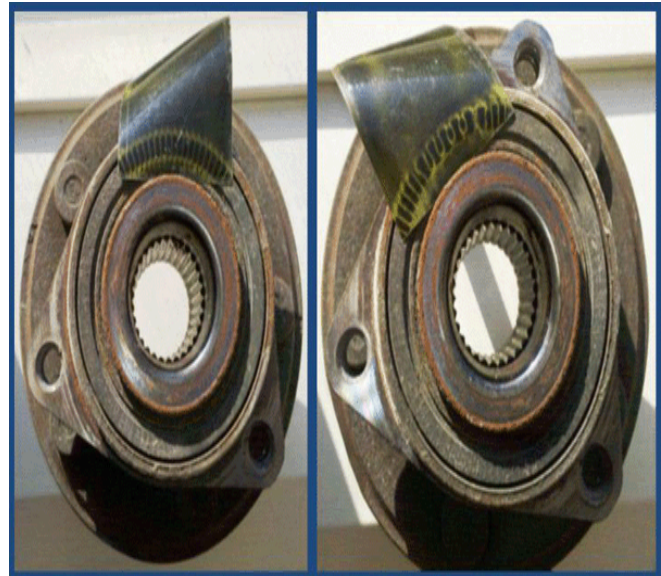
2870569

Important: There is some confusion over where the encoder is located on the hub. It is the brown rubber ring, it is not located behind this ring and this ring is NOT just a bearing seal. It is the encoder.

Note: This photo depicts a condition of the encoder magnetic poles not alternating properly. Instead of the magnets being laid North, South, North, South, as the

photo on the left illustrates, the poles may have been laid out of sequence as illustrated by the photo on the right. The magnetic paper is not readily available in most areas so this photo is only being used to illustrate that not all conditions are visible to the naked eye and that if this condition were present then swapping the WSS would not aid in isolating this cause. It may be necessary, as explained below, to swap the hub bearing from side to side to identify the condition shown in this photo.

*If there is no evidence of physical damage, contamination or debris, it is acceptable to swap the hub bearings from side to side, test drive the vehicle again and confirm the condition followed the hub. If the condition follows the hub, replace the hub. If the condition stays with the WSS, replace the WSS.
